## Inspection Tech Home Inspection Report

**620 Oak St**

**Medina, OH 44256**

Inspected on Mon, Sep 11 2017 at 12:30 PM

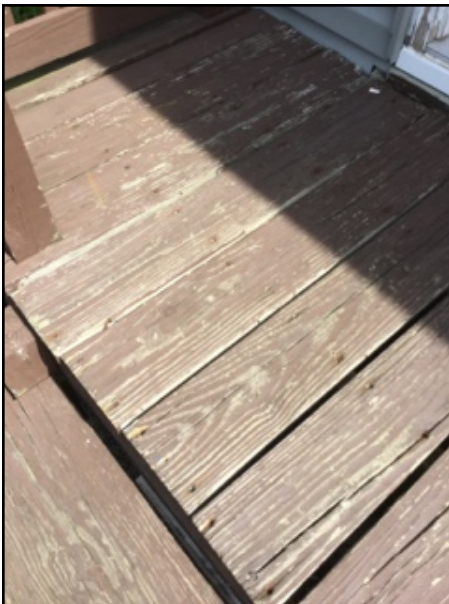
Figure 2-1

Porch is weathered and needs paint or stain. Recommend repairs.

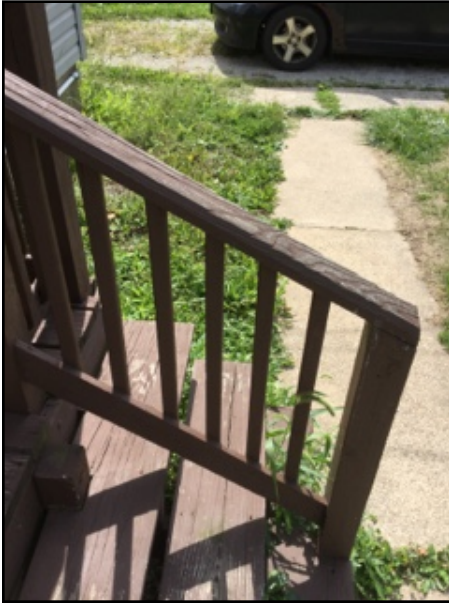
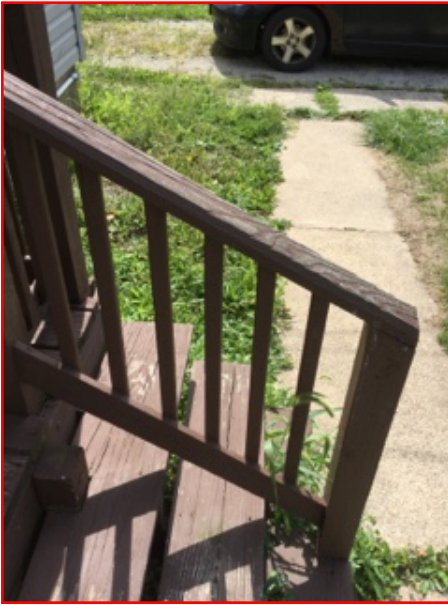
Figure 3-1

Loose railings at stairs. Safety Hazard. Recommend repair.

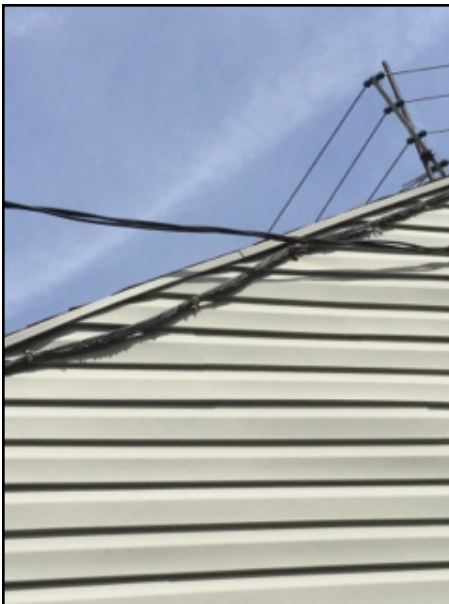
Figure 4-1

Insulation at service line is deteriorating. Recommend repair.

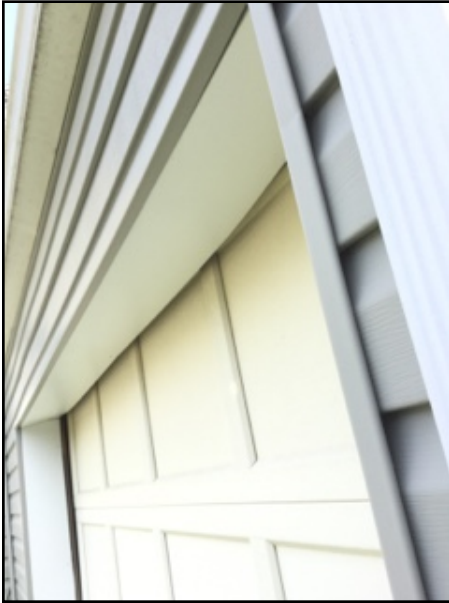
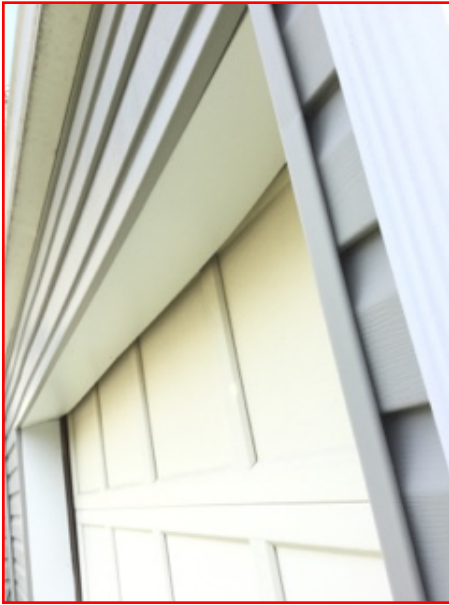
Figure 5-1

Comment 5:  
Loose trim at garage. Recommend repair.

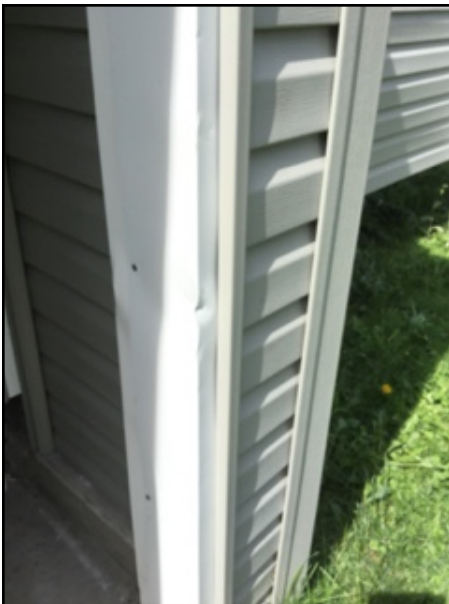
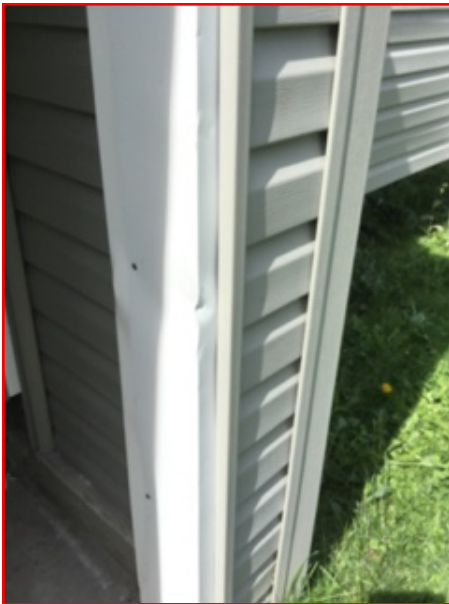
Figure 6-1

Comment 6:  
Dented trim. Recommend repair.

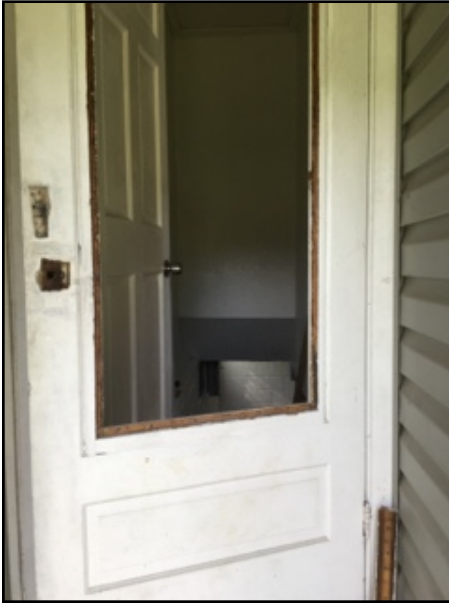
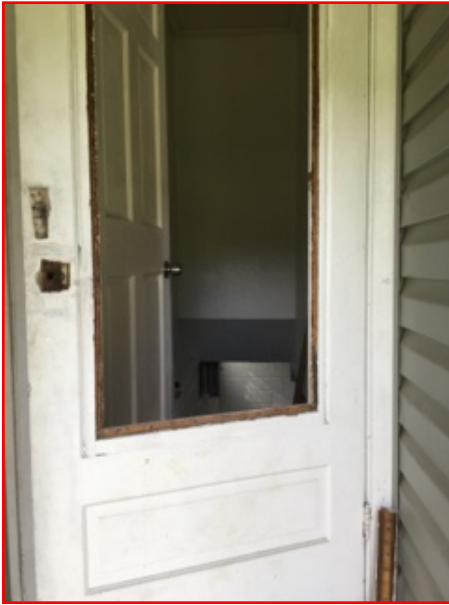
Figure 7-1

Exterior door with missing hardware. Recommend repair.

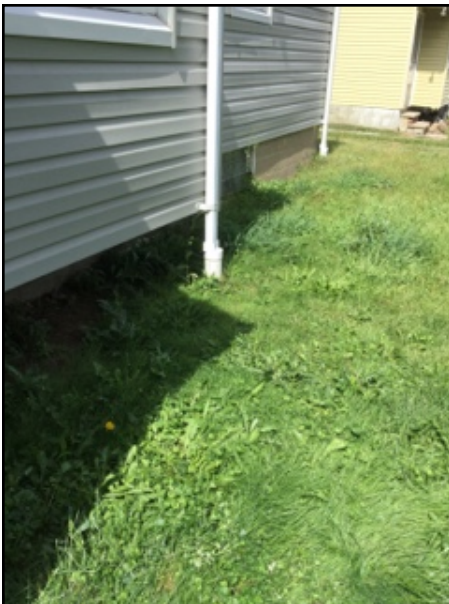
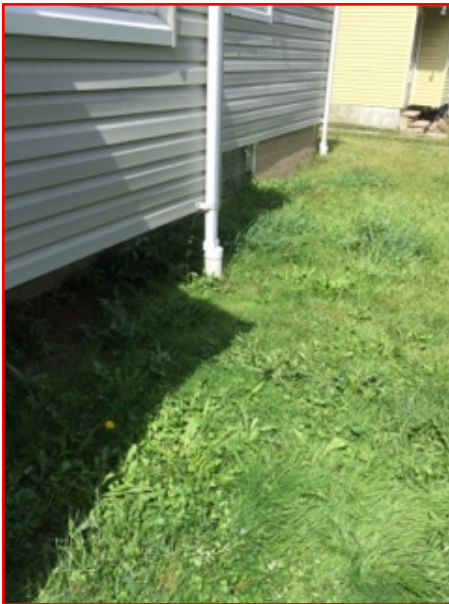
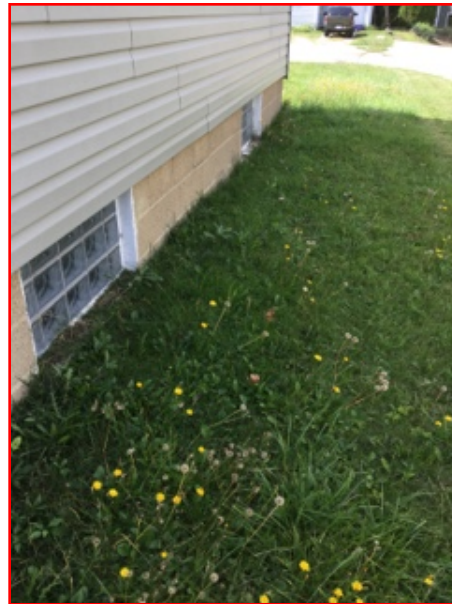
Negative grade at exterior of house. Recommend additional backfill.

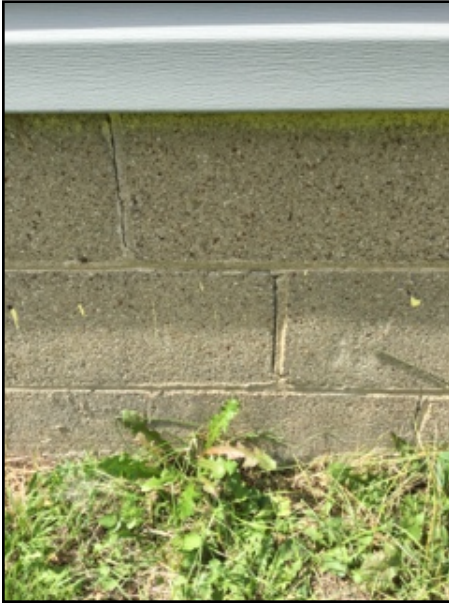
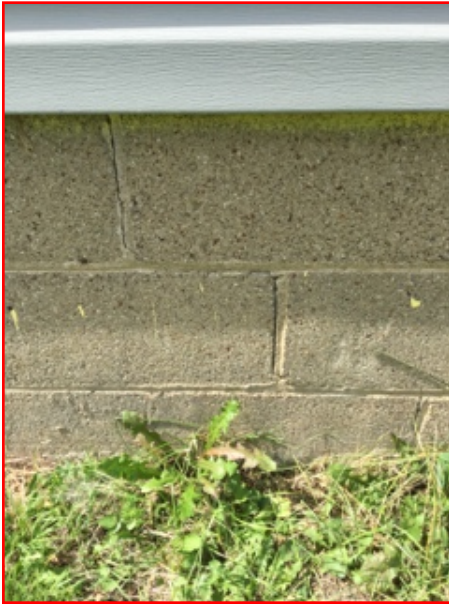
Figure 9-1

Tuck pointing needed at exterior of house. Recommend repair.

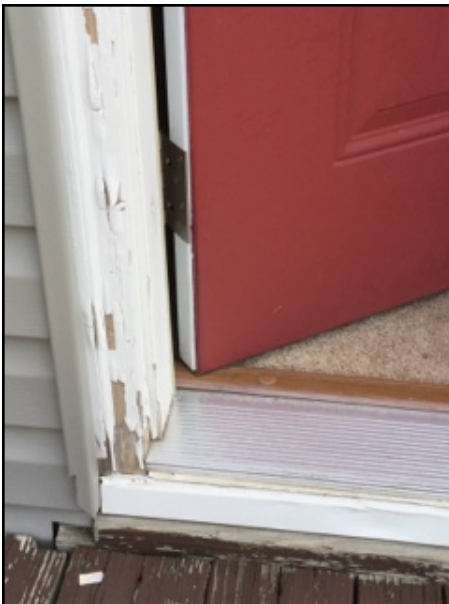
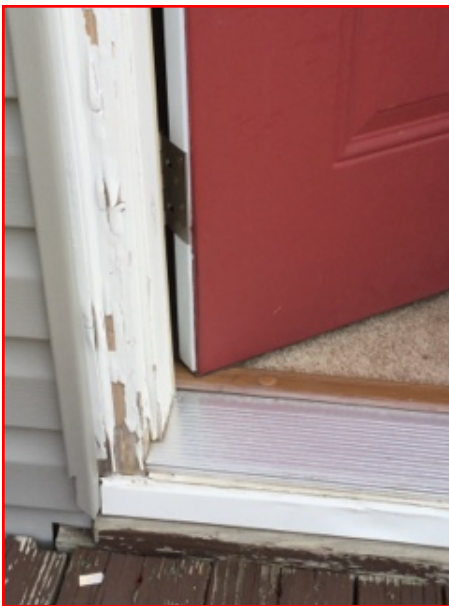
Figure 10-1

Wood trim needs paint. Recommend repair.

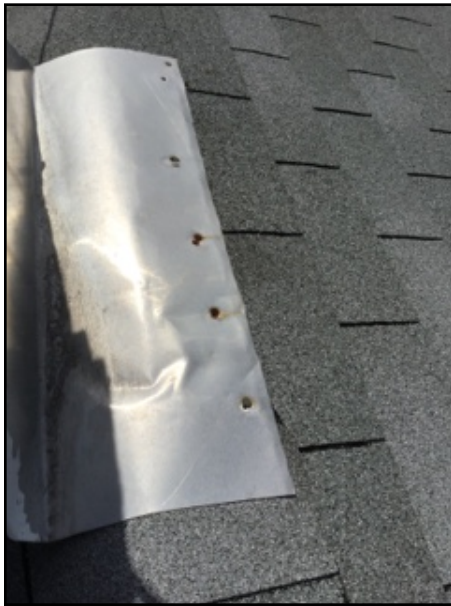
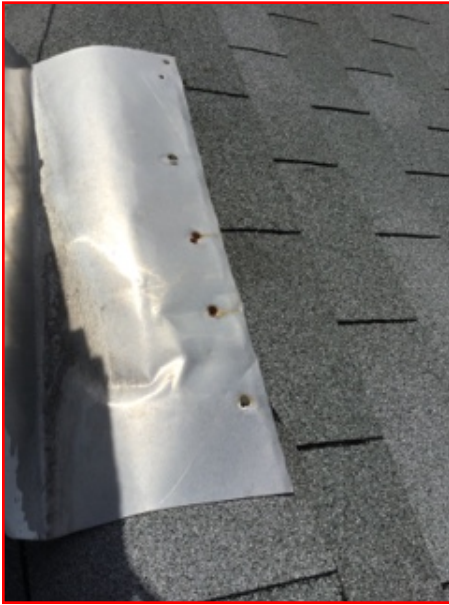
Figure 11-1

Exposed nail heads need caulking. Recommend repair.

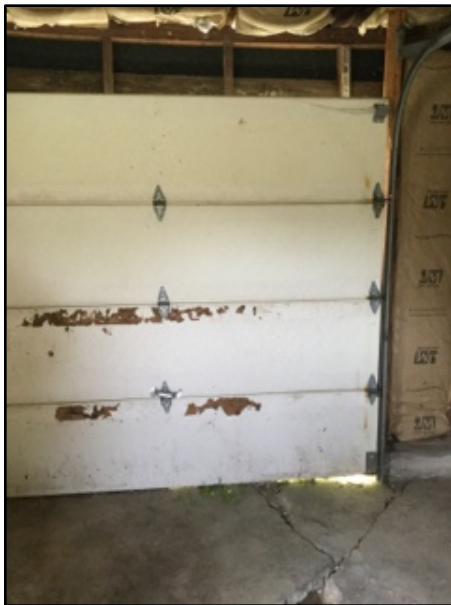
Figure 14-1

Garage door did not open properly. Recommend adjusting.

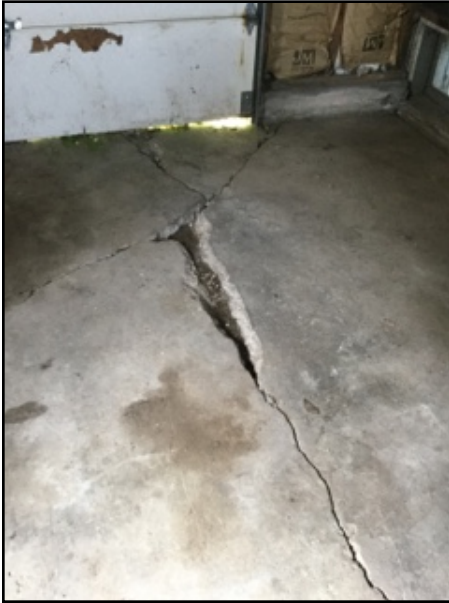
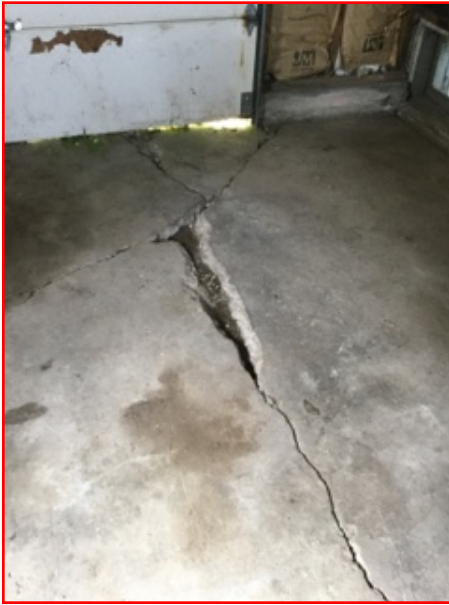
Figure 15-1

Comment 15:  
Large settling cracks in floor. Recommend repair.

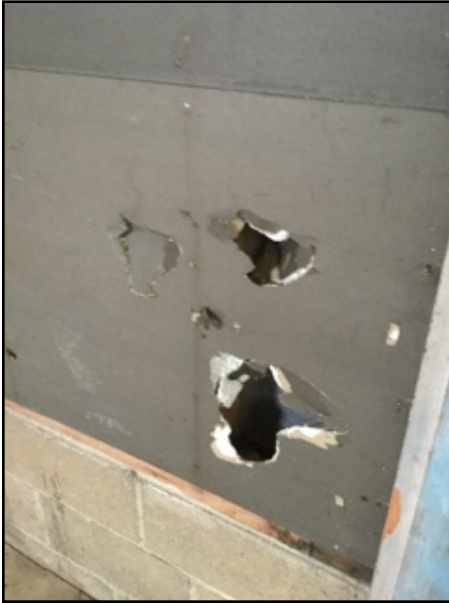
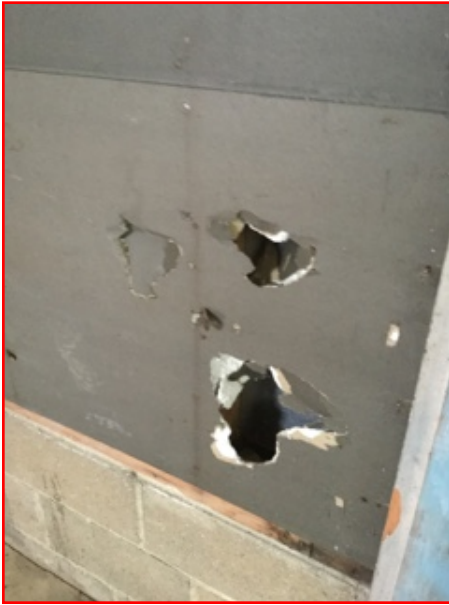
Figure 17-1

Comment 17:  
Damaged drywall. Recommend repair.

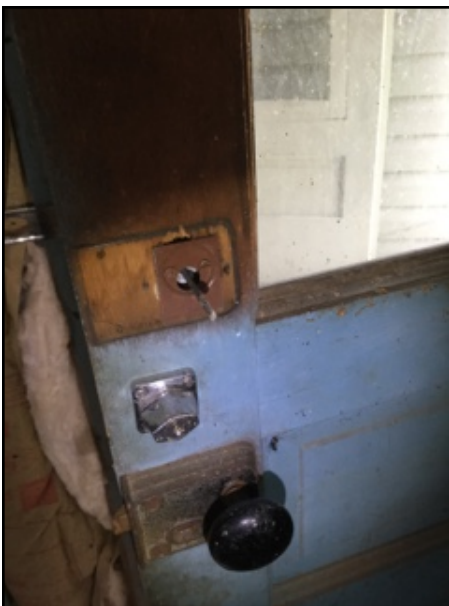
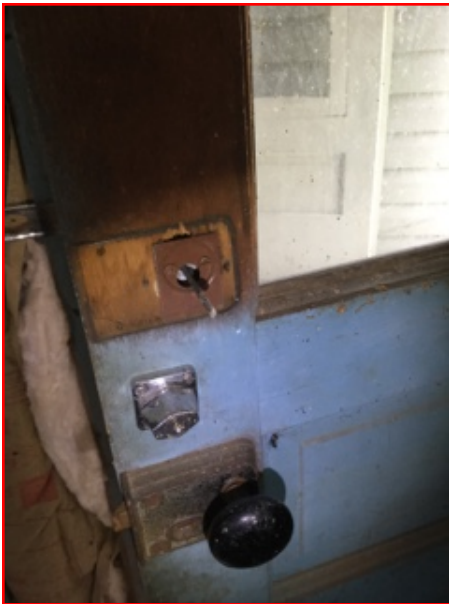
Figure 18-1

Comment 18:  
Missing lock hardware. Recommend repair.

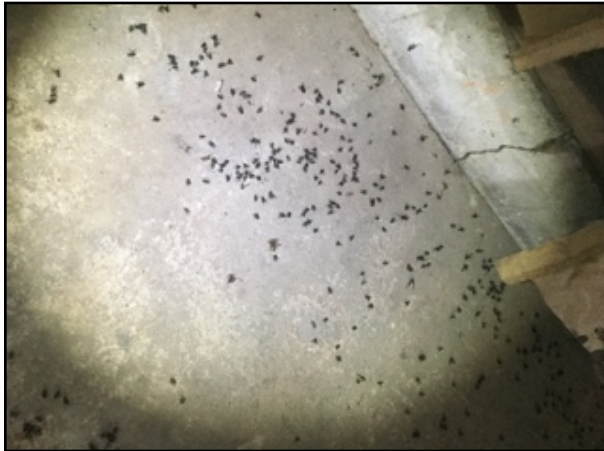
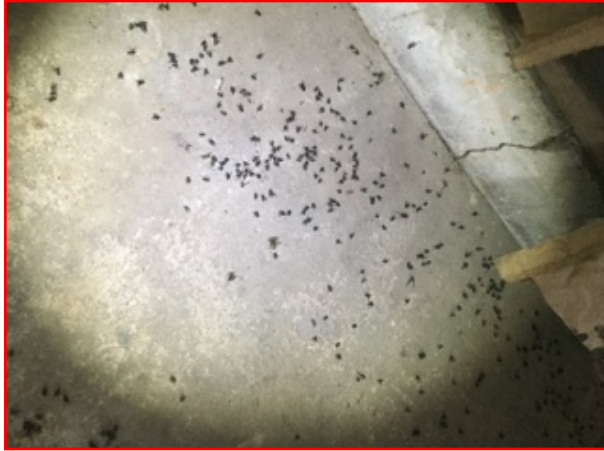
Figure 19-1

Large amount of dead flies. Recommend pest inspection.

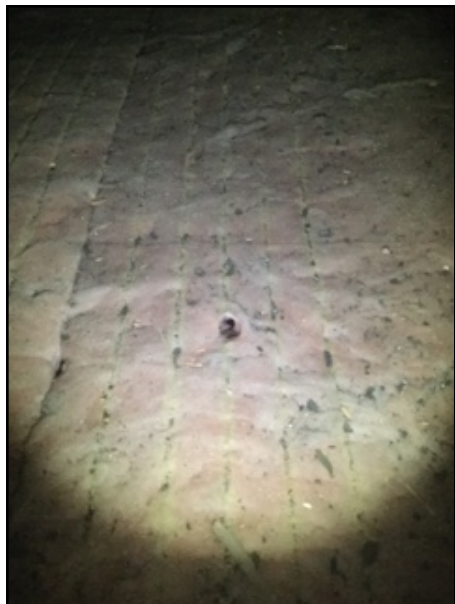
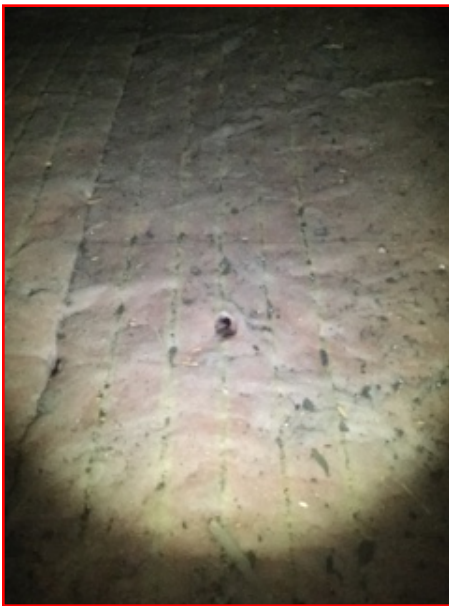
Figure 20-1

**Comment 20:**  
Rodent droppings and burrowing present in attic space. Recommend pest remediation as needed.

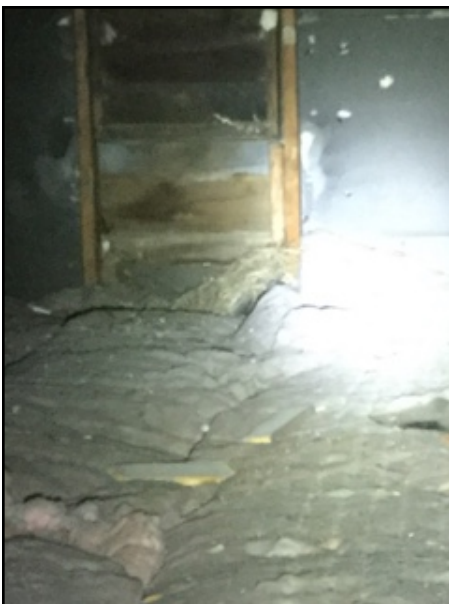
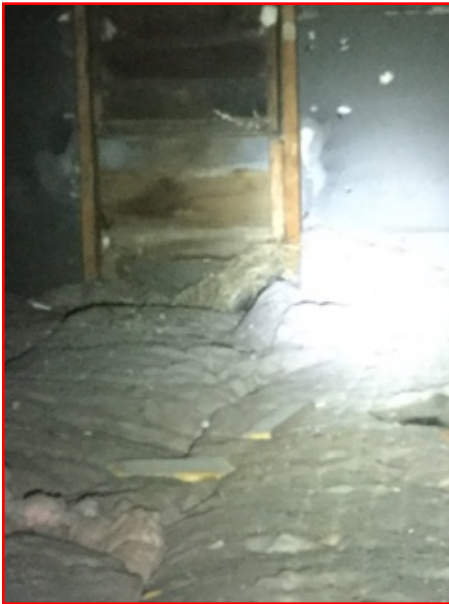
Figure 22-1

Nesting material present. No active sign of pest at time of inspection. Recommend monitor and mitigate as needed.

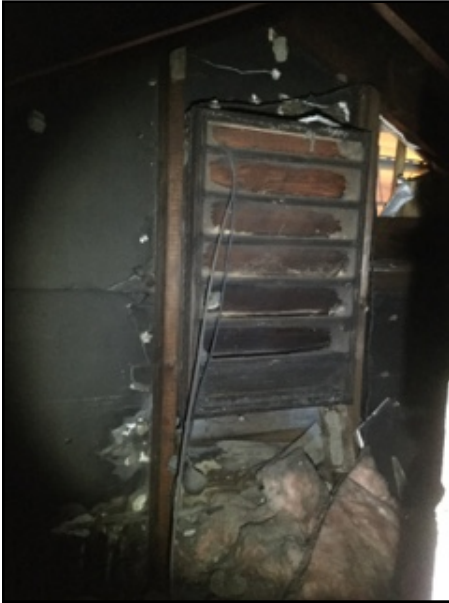
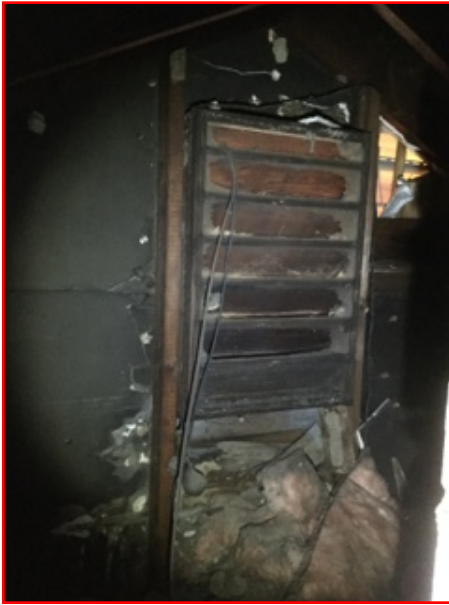
Figure 23-1

**Comment 23:**  
Gable vent screens damaged. Recommend repairs to prevent pest access.

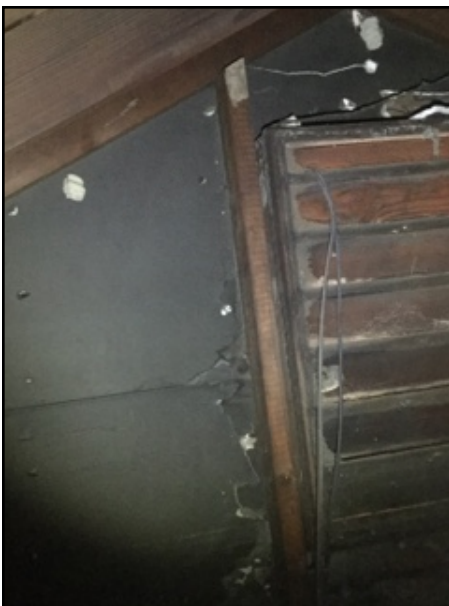
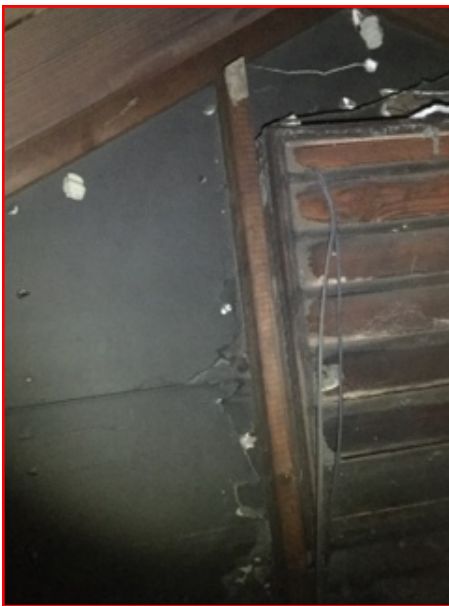
Figure 24-1

**Comment 24:**  
Wasp nests present. Active nest. Recommend repair.

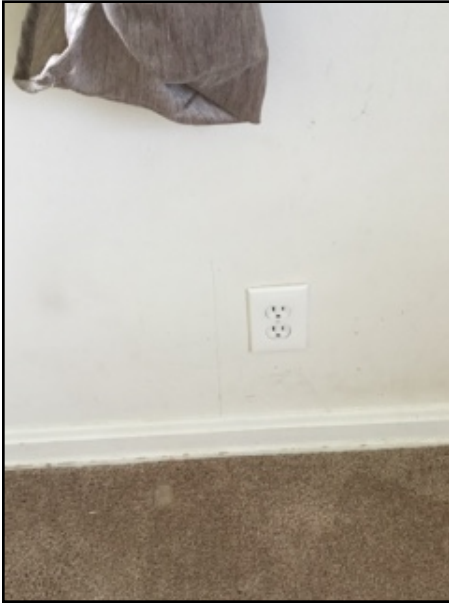
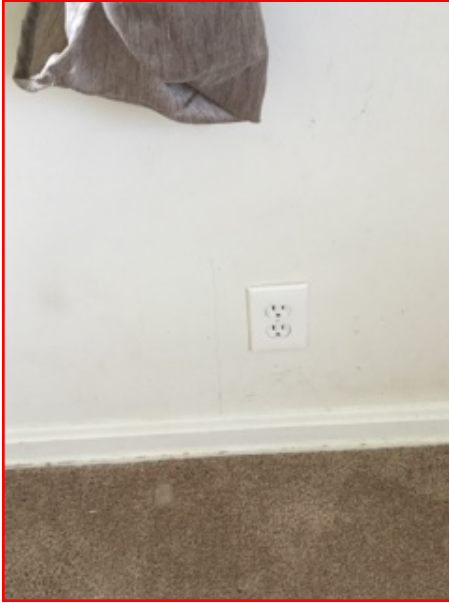
Figure 25-1

Loose electrical outlet. Safety Hazard. Recommend repair.

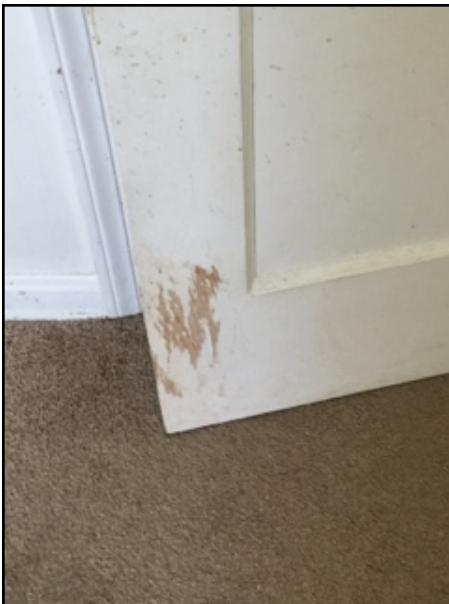
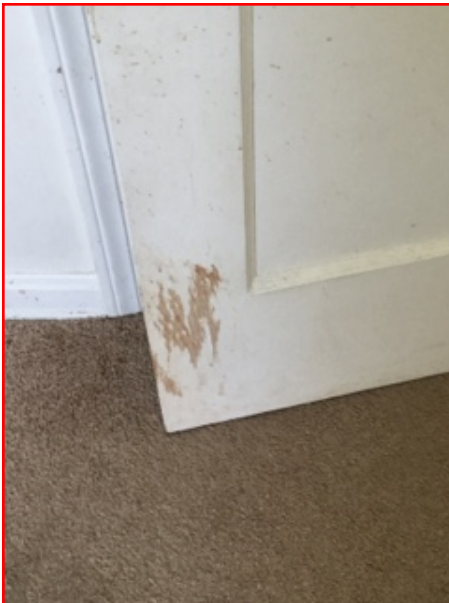
Figure 26-1

Door has surface deterioration. Recommend repair.

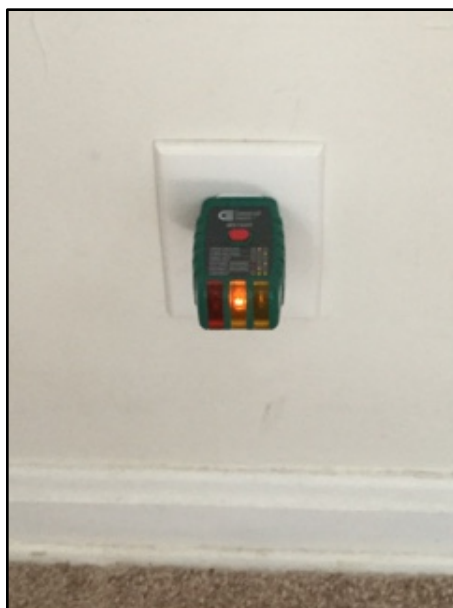
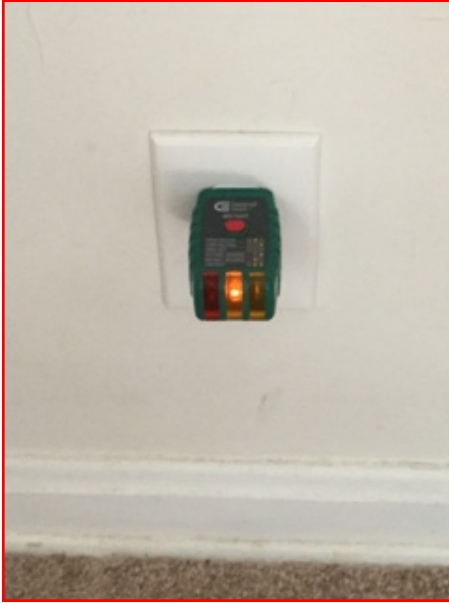
Figure 27-1

Ungrounded 3 prong outlets. Recommend repair.

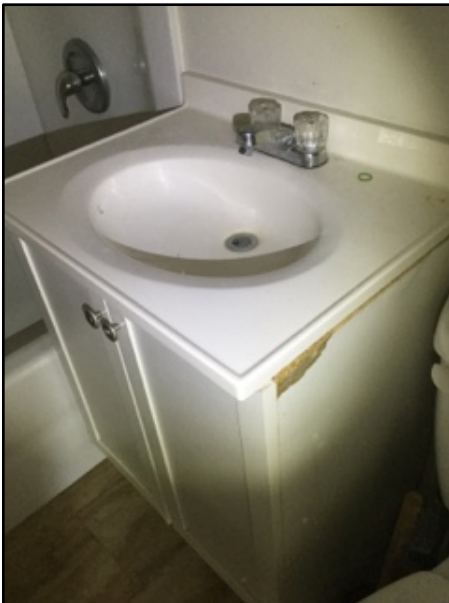
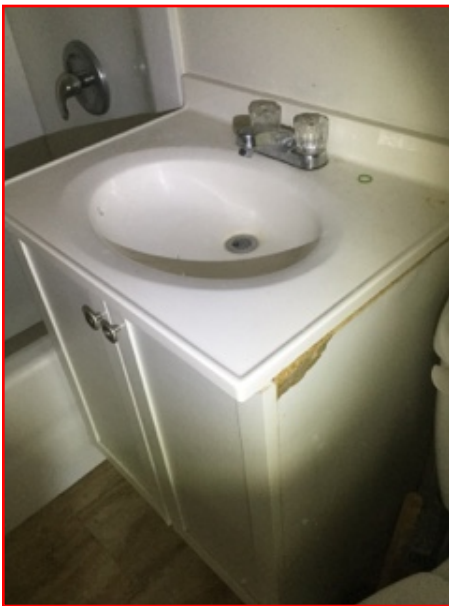
Figure 28-1

Comment 28:  
Sink loose at cabinet. Recommend securing.

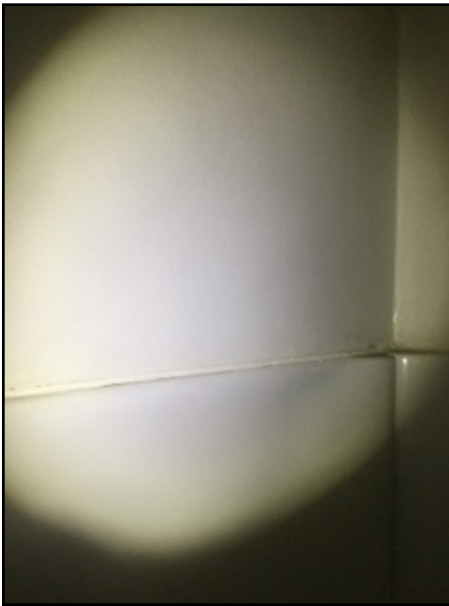
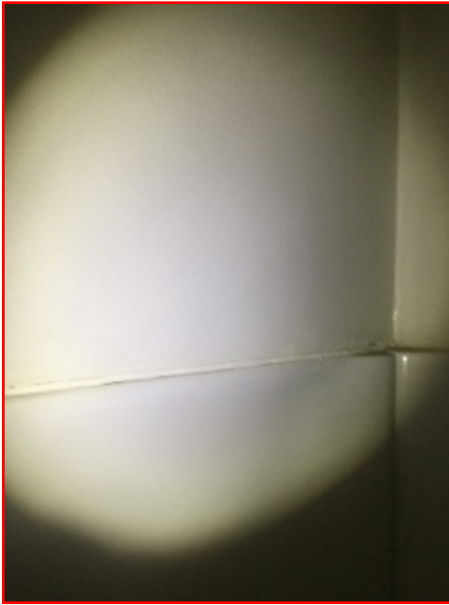
Figure 29-1

Grout and caulking needed at shower tiles. Recommend repair.

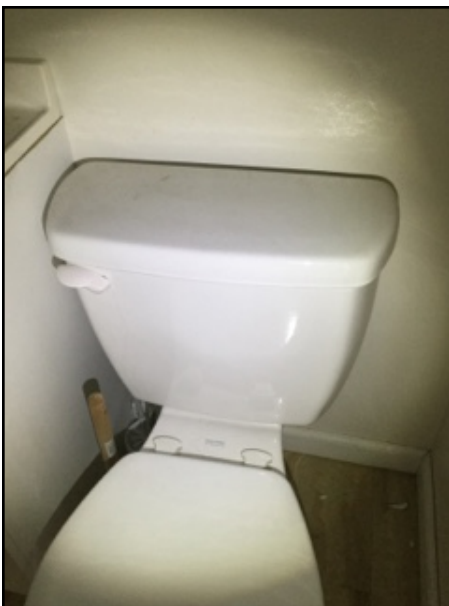
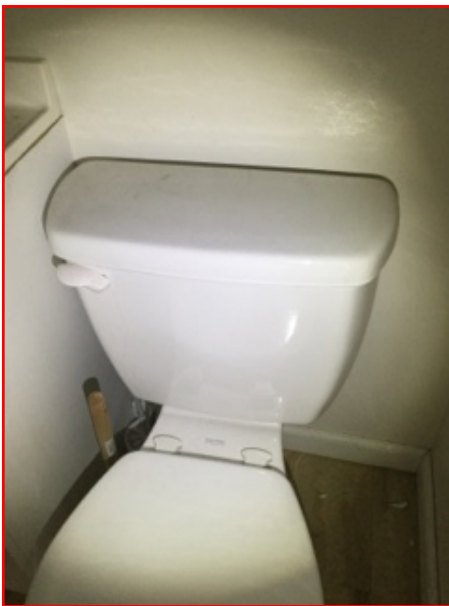
Figure 30-1

Tank is loose on toilet. Recommend repair.

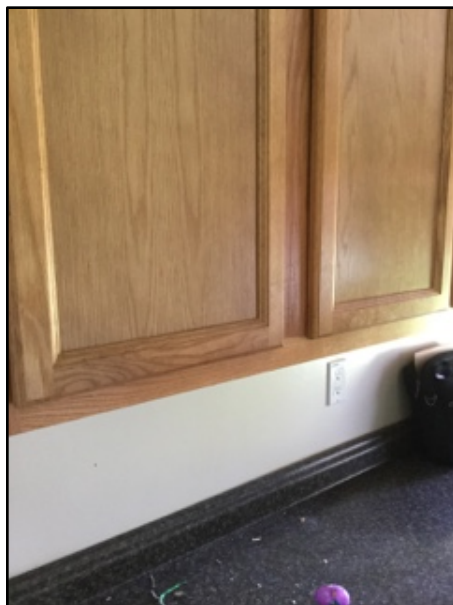
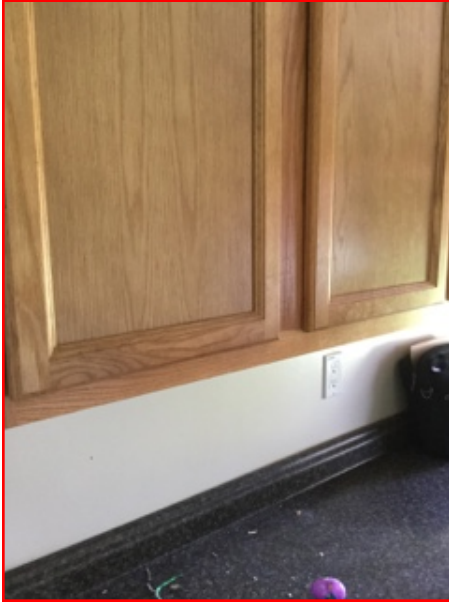
Figure 31-1

Missing handles at cabinet doors. Recommend repair.

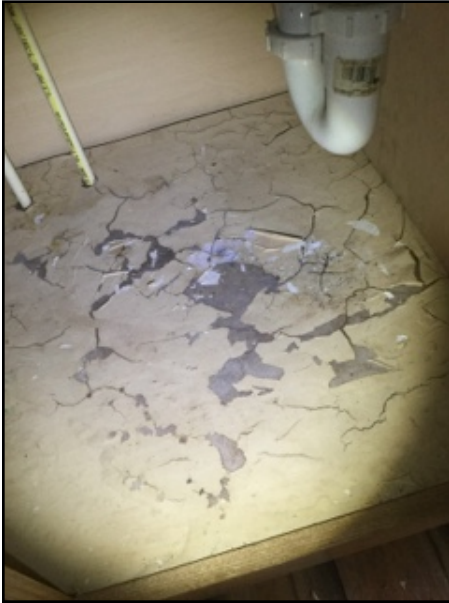
Figure 32-1

Base of cabinet has deteriorated. Recommend repair.

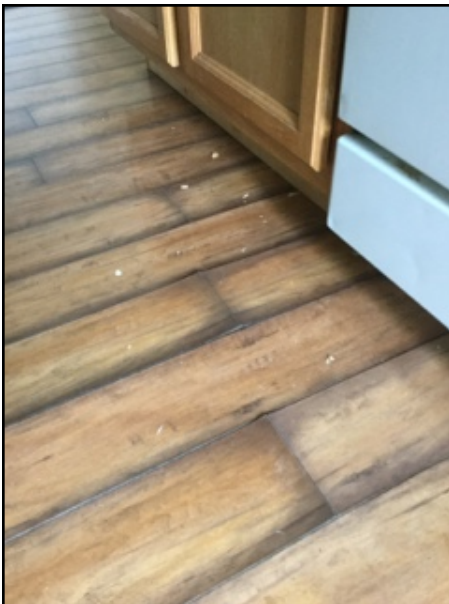
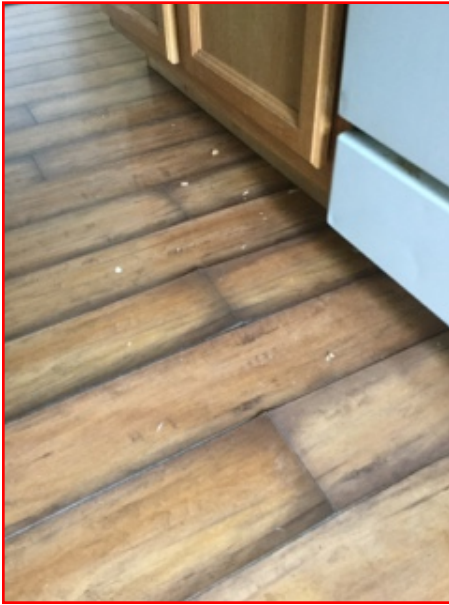
Figure 33-1

Damaged flooring. Recommend repair.

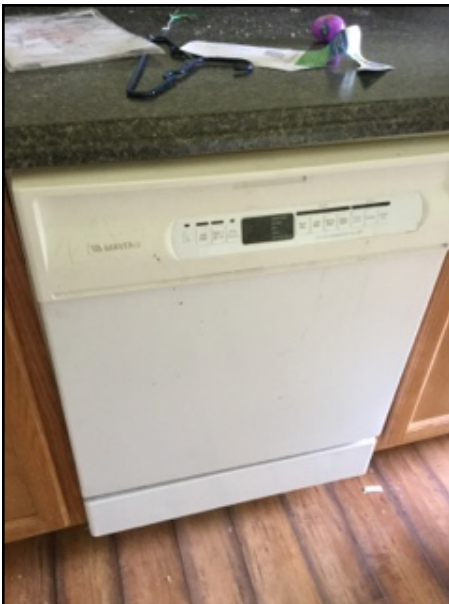
Figure 35-1

Comment 35:  
Dishwasher did not operate. Recommend repair.

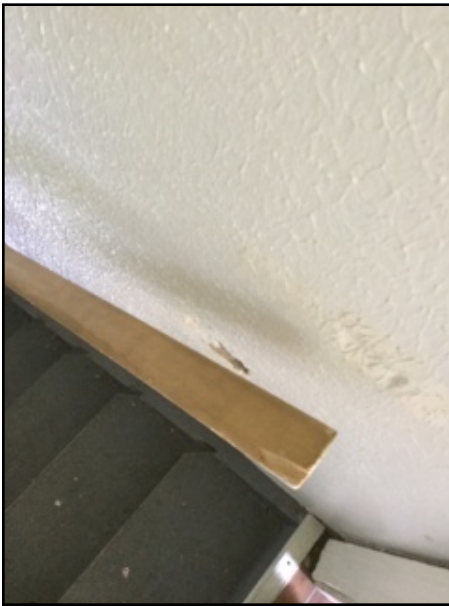
Figure 37-1

Missing hardware at railing. Safety Hazard. Recommend repair.

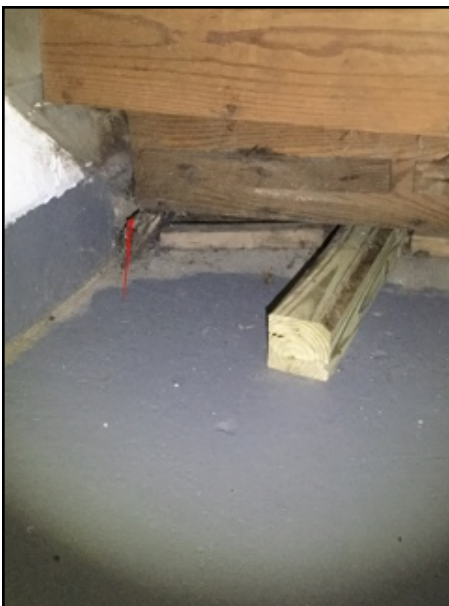
Figure 38-1

Damage present at bottom step. Recommend repair.

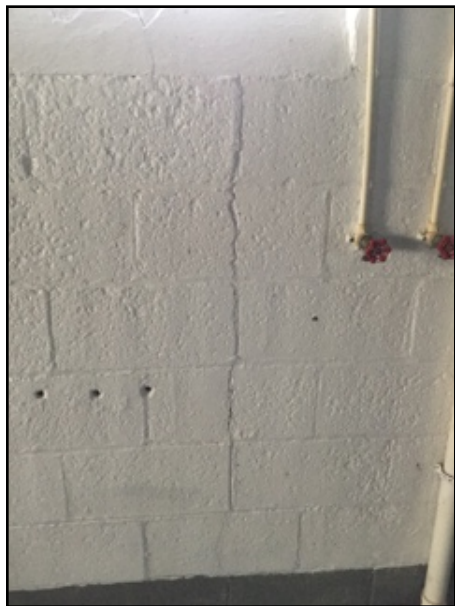
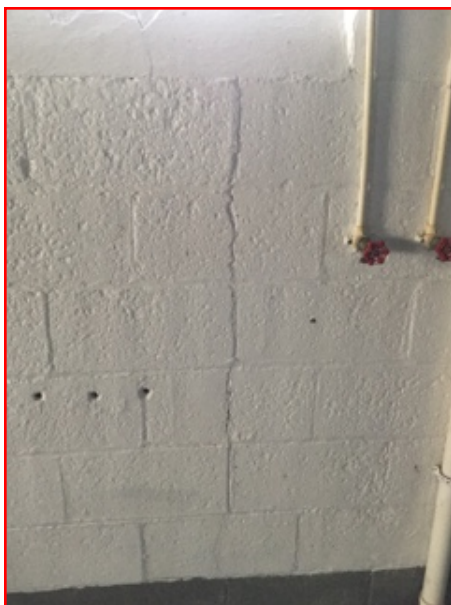
Figure 40-1

Typical vertical cracks. No movement noted. Recommend monitor and repair as needed.

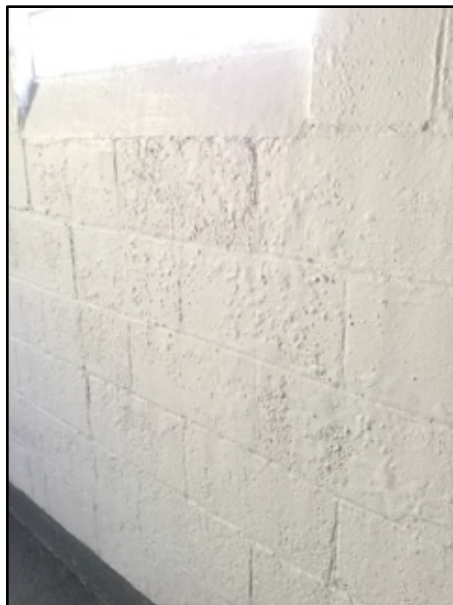
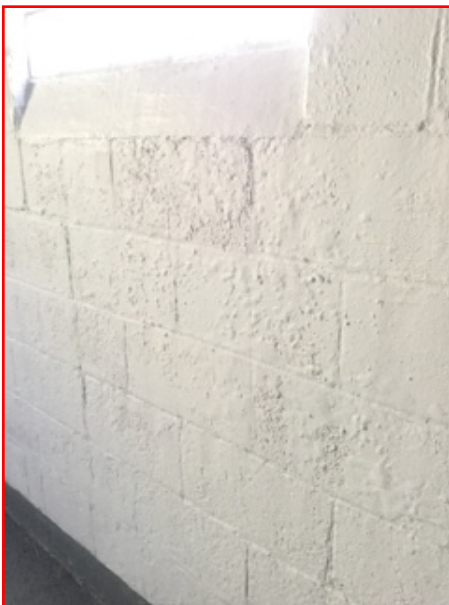
Figure 41-1

Indications Of Moisture: Yes, Efflorescence at wall(s), Excessive moisture present, Recommend running a dehumidifier, Recommend painting with Drylock, Recommend exterior grading improvements

Moderate to High levels of moisture present at foundation walls. Recommend proper exterior moisture control, painting with drylock and running dehumidifier.

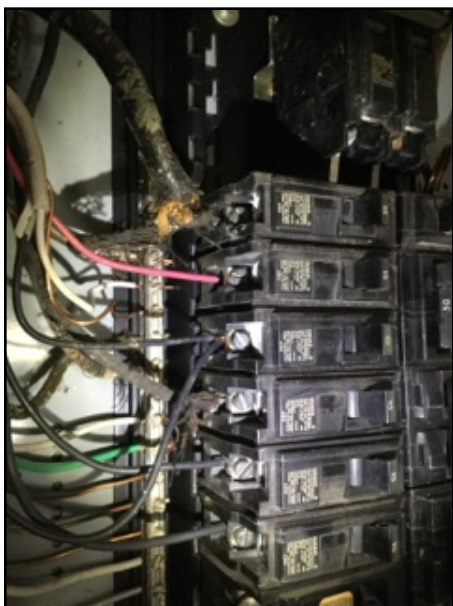
Figure 44-1

Double tapping present at breakers in main electrical panel. Recommend repair.

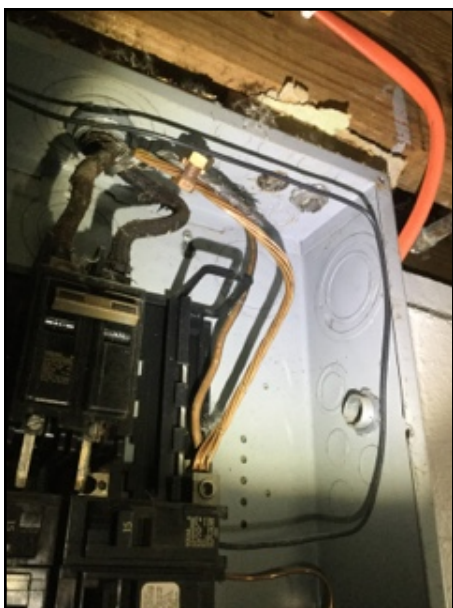
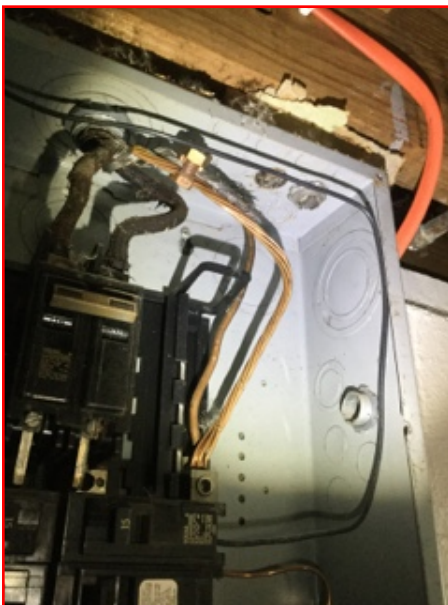
Figure 45-1

Missing knockout cover. Safety Hazard. Recommend repair.

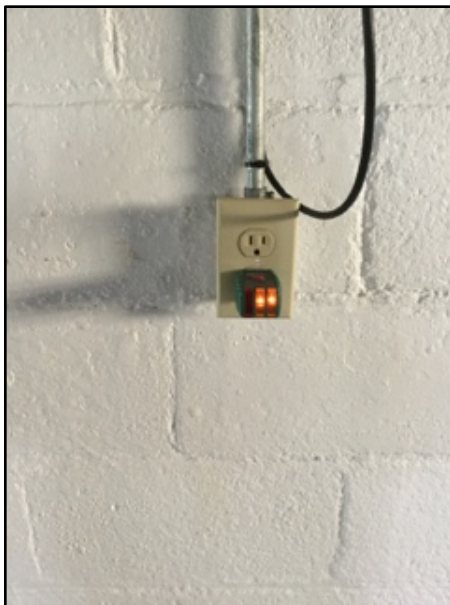
Figure 46-1

Outlet is grounded but is not GFCI protected. Safety Hazard. Recommend replace with GFCI outlets.

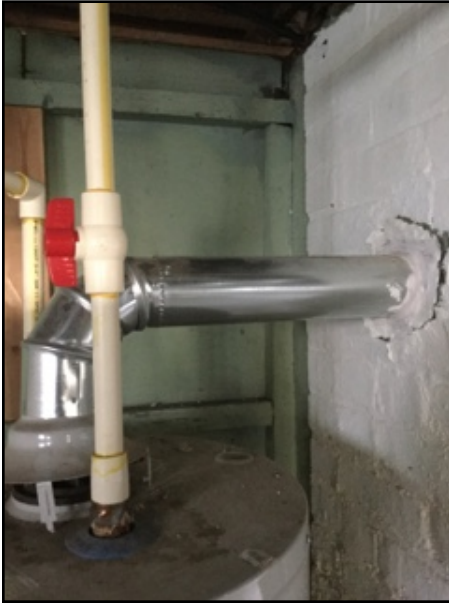
Figure 48-1

Metal Vent Pipe has improper pitch. Safety Hazard. Recommend repair or replace.

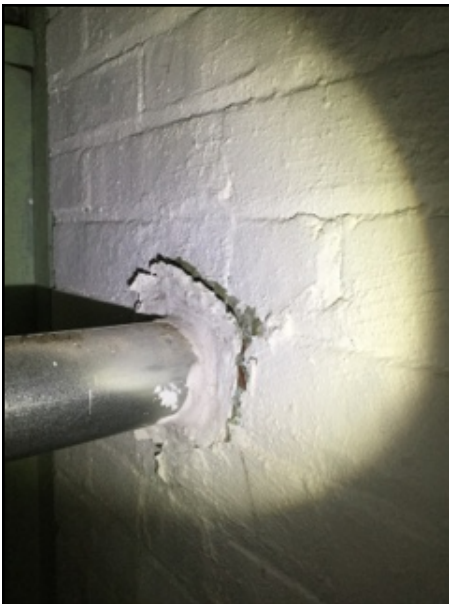
Figure 49-1

Water heater vent pipe is not properly sealed at chimney. Safety Hazard. Recommend repair.

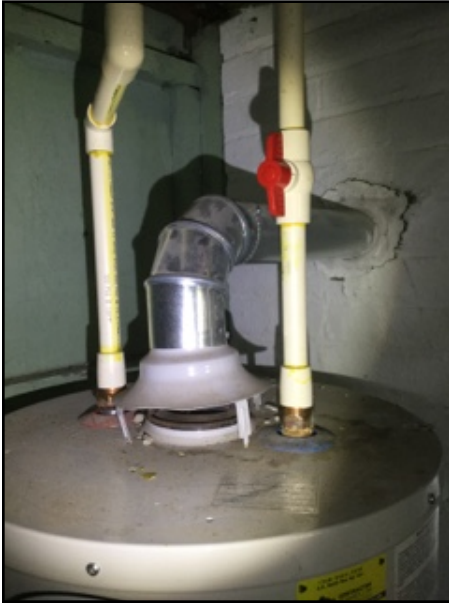
Figure 50-1

Comment 50:  
Improper piping material at water heater. Recommend repair.

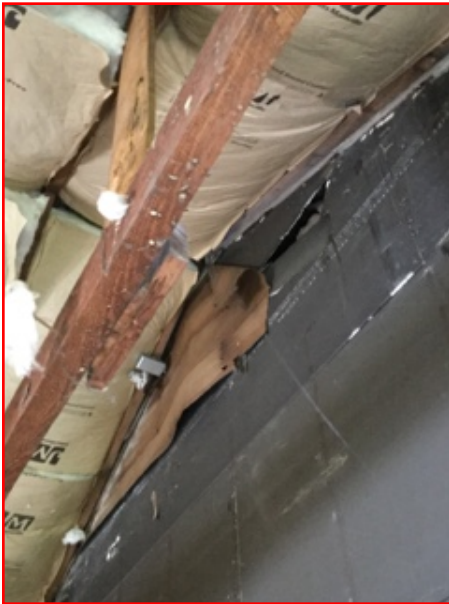
Figure 16-1

Comment 16:  
Damaged drywall at ceiling leading into attic space. Not complete firewall.  
Recommend repair.

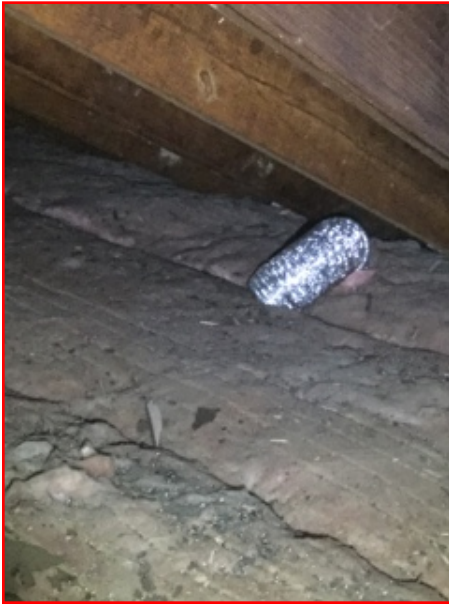
Figure 21-1

Bathroom exhaust vents into attic space. Recommend venting to outside to prevent moisture issues.
