Home Inspection Report

5235 Wedgewood Media Ohio 44256

Ambassador Construction Consultants LLC.

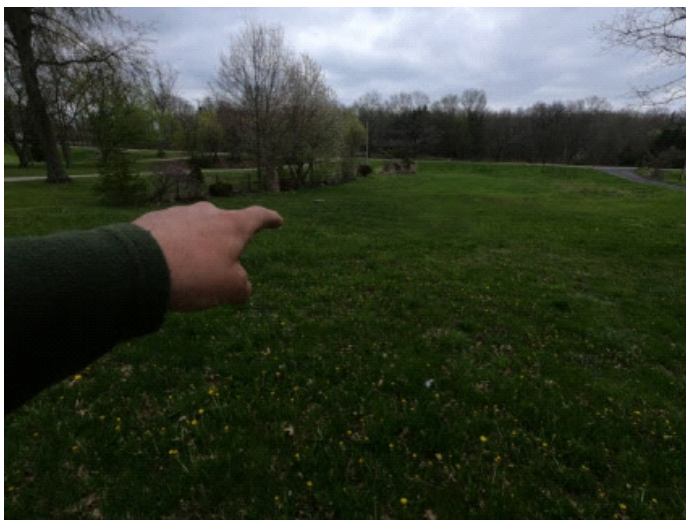
Septic system in front yard.
These systems need period cleaning and maintenance.
Recommends getting a septic company to inspect and certify.
Home inspector did not inspect the septic system.

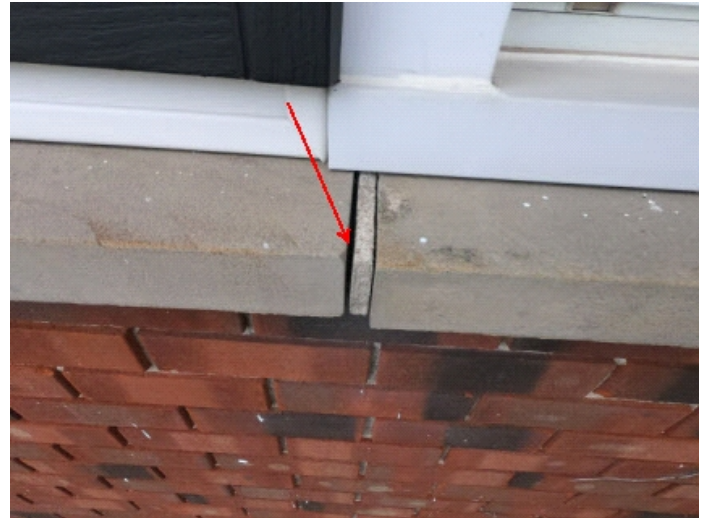
Some maintenance tuck pointing recommend.

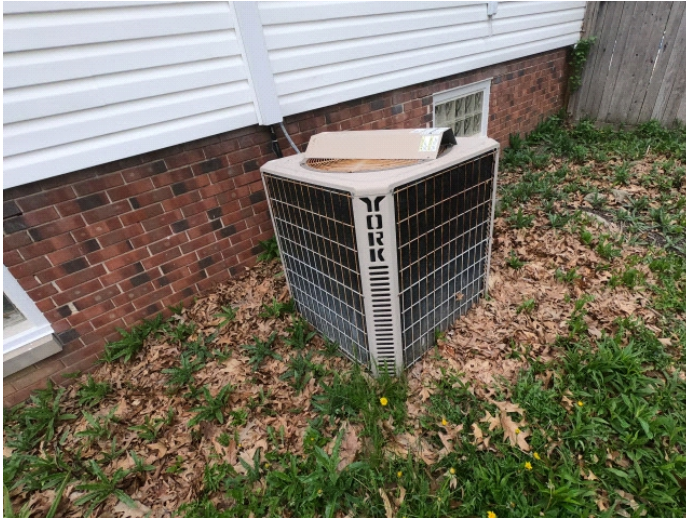
This AC unit is non functional. The attic air handier is also abandoned. Recommend removing.
This HVAC system appears to have been the older homes HVAC prior to the homes remodeling addition.

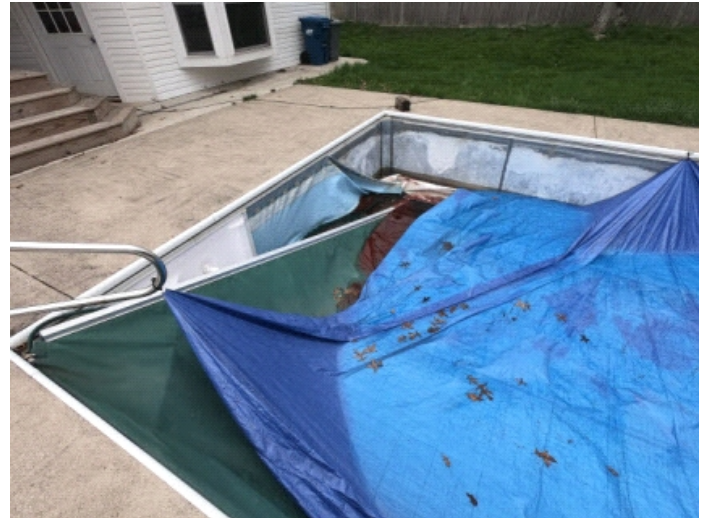
Pool not inspected.

Need pool company to repair liner and perform other poor maintenance. Pool and its components not inspected.

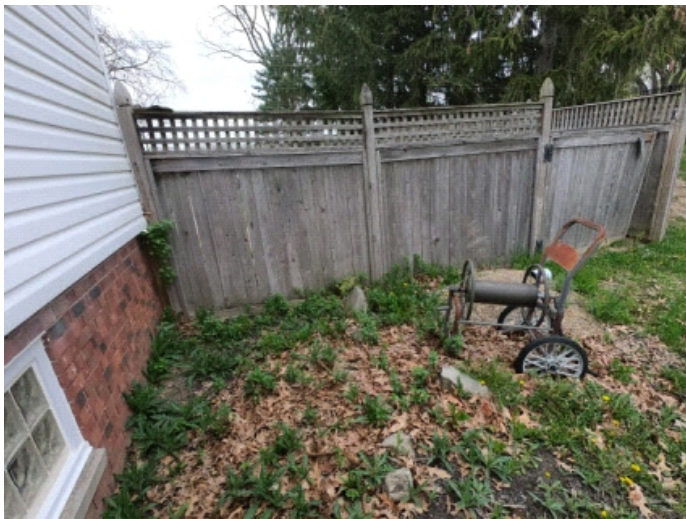
Fence old, some not level, some deteriorated and needs repair and maintenance.

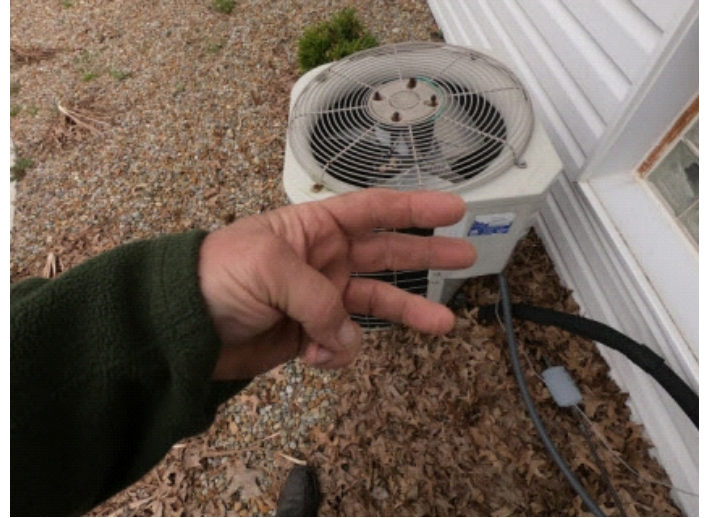
AC unit is roughly 13 years old.
The home has mostly older appliances.
We recommend getting an appliance warranty.

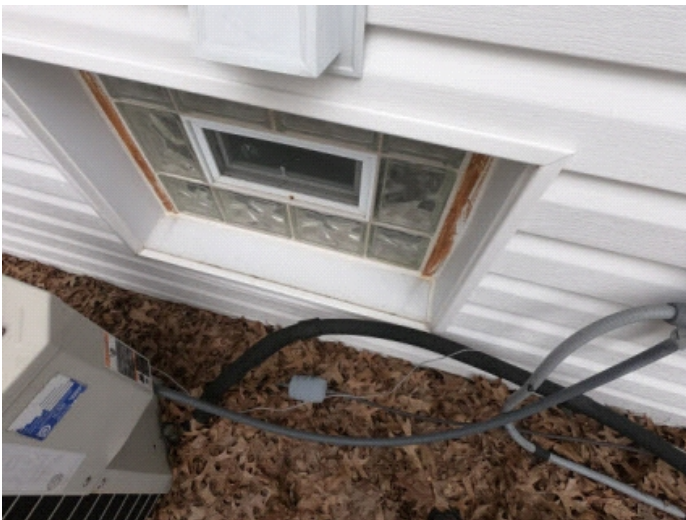
Newer glass block windows.
Some sloppy work.

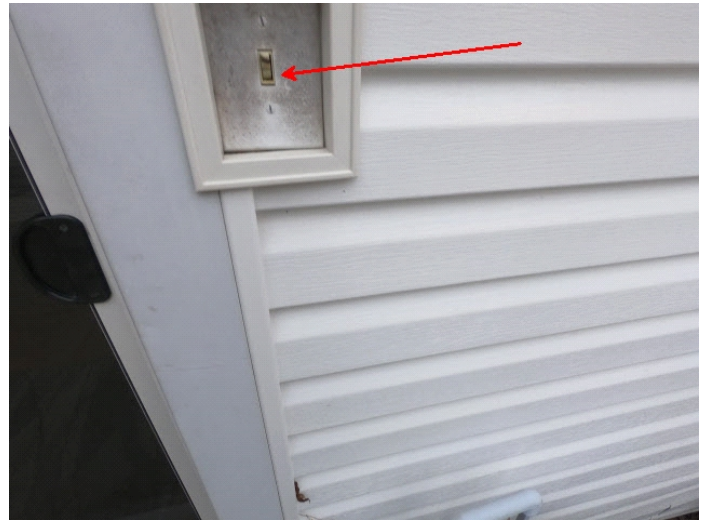
Should change this light switch to an exterior waterproof switch.

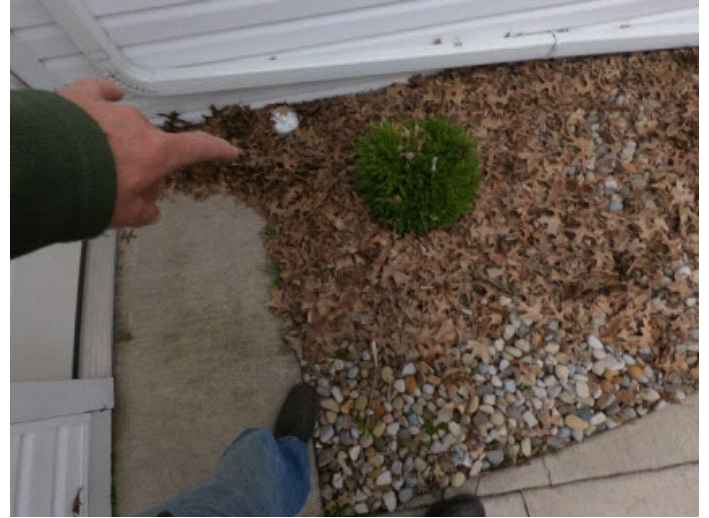
Horizontal downspout installation. Sometimes these leak.

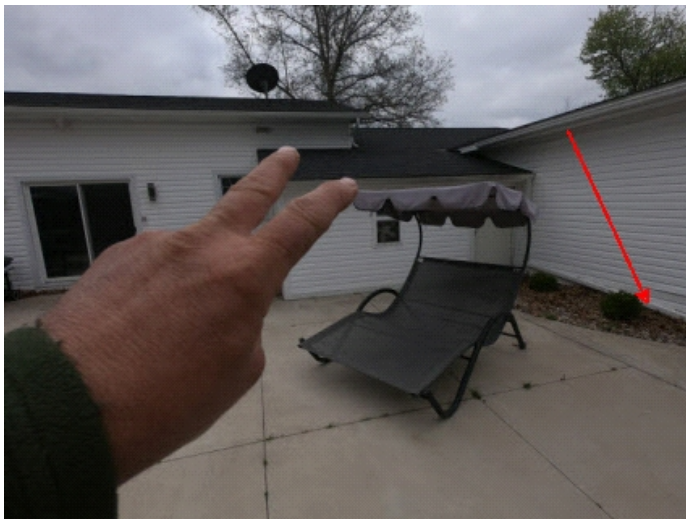
Foundation grading is a bit flat. We were informed that this area has a recent trench drain installation.

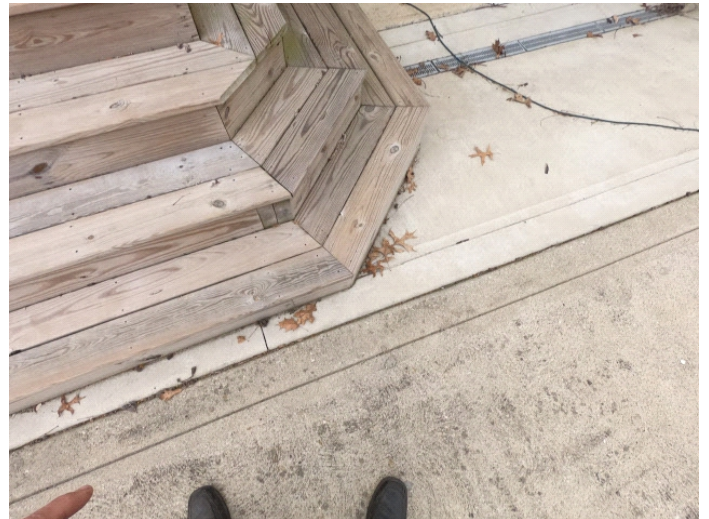
Older wood steps. No hand rail. Keep trench drain clean and operational. It was not raining at the time of inspection.

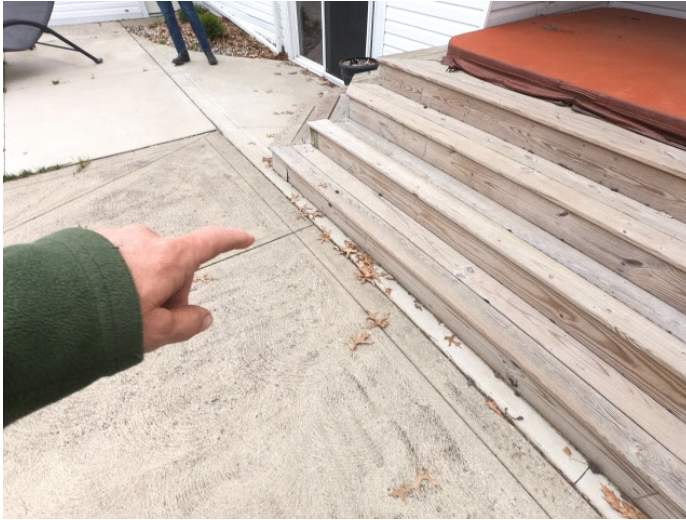
Hot tub was off and not tested.
Recommend hot tub company to energize,
clean, adjust or perform maintenance. Home
inspector did energize and did not inspect the
hot tub.

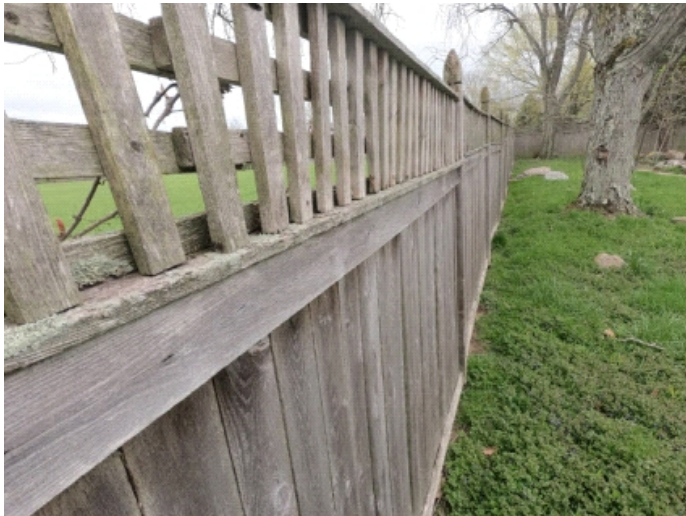
Old fence with wear and tear.

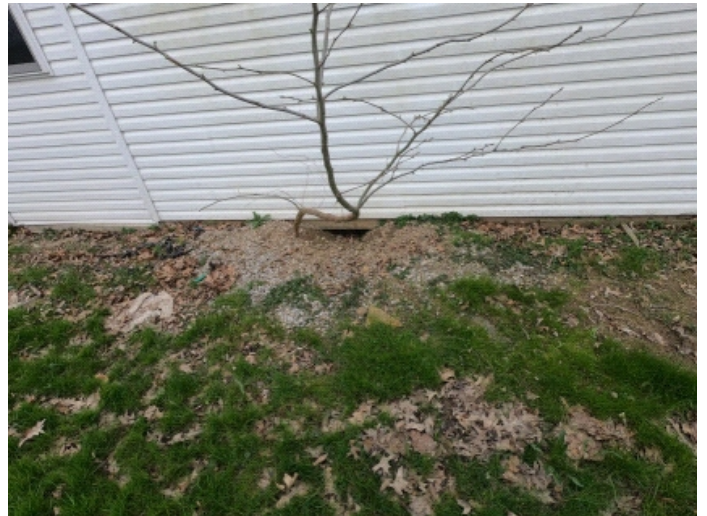
Control vermin (groundhog)

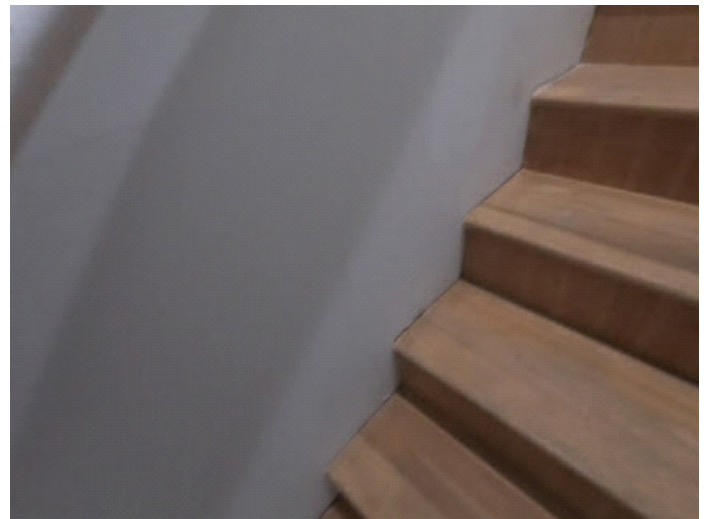
Drywall a bit sloppy.

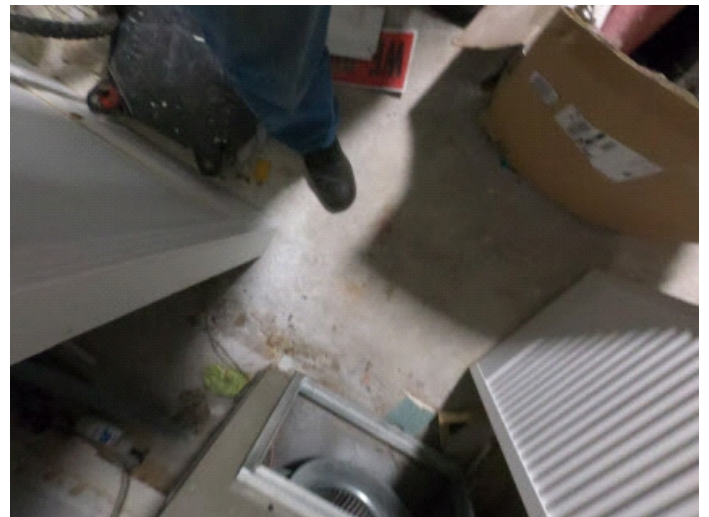
HVAC does not have cold air return other than in closet.

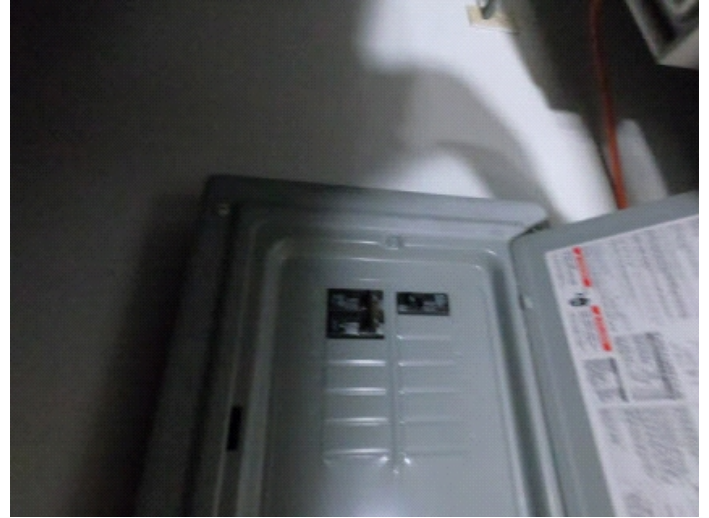
Some electrical wiring could be in conduit.

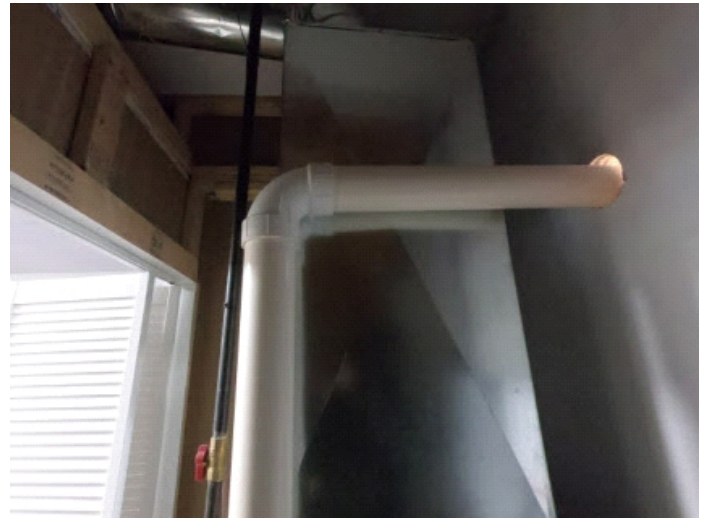
Furnace flue needs to be sealed and waterproofed to the exterior.

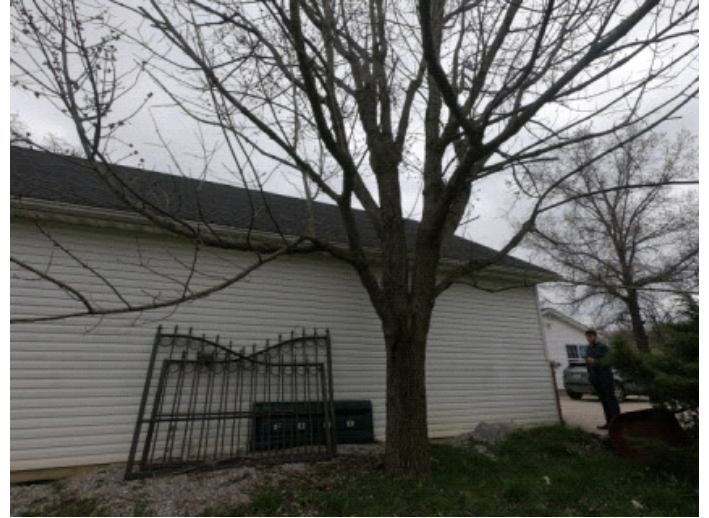
Tree may be rather close to home and cause issues with gutters roof and foundations.

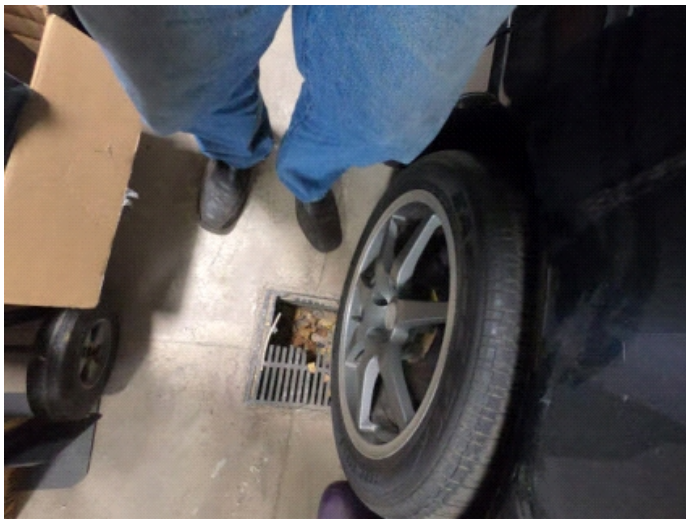
Need new drain cover.

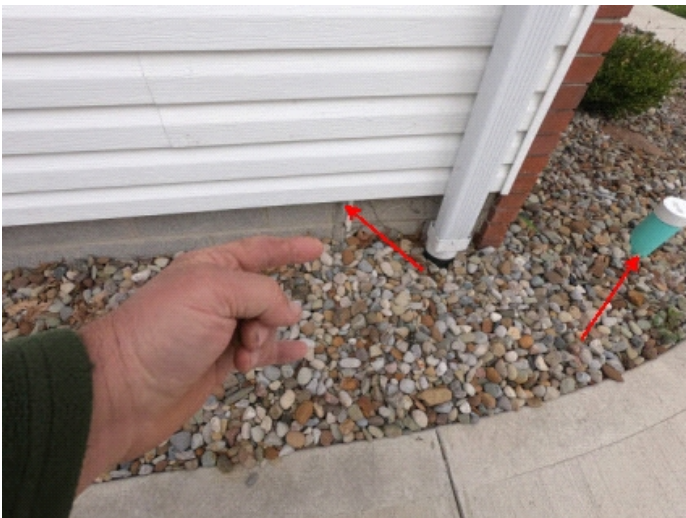
Foundation has some cracking from soil pressure or shrinkage or other.
Foundation appears to have cleanouts for drain tile or storm lines or other.
Basement finished rooms were dry at time of inspection.

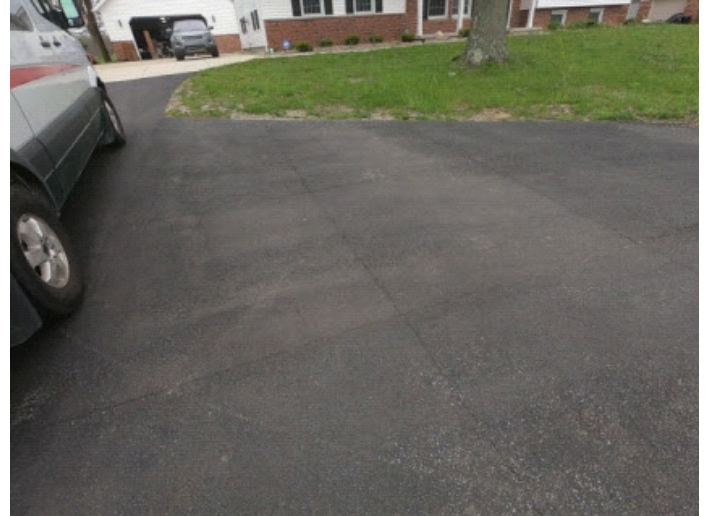
Parking turnaround area has cracks at concrete slabs. Functional with no issues at this time.

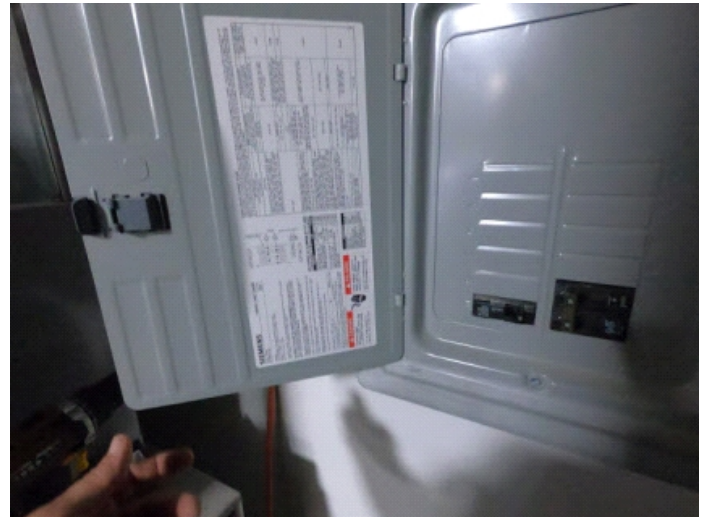
Should label all panels.

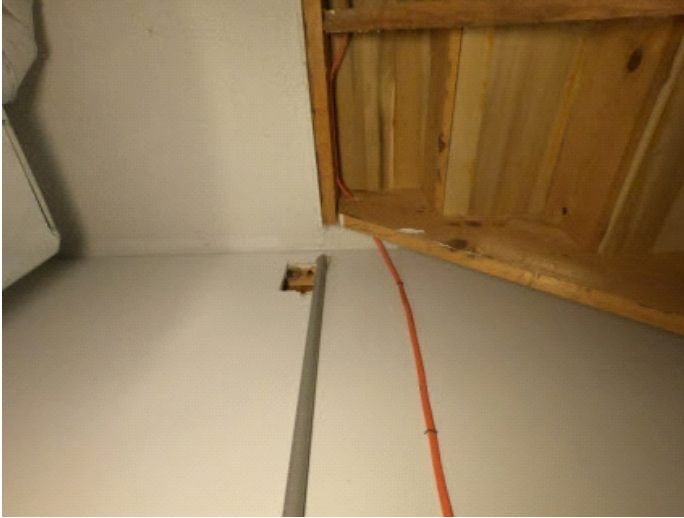
Wearing a bit sloppy.
Drywall to bit sloppy.

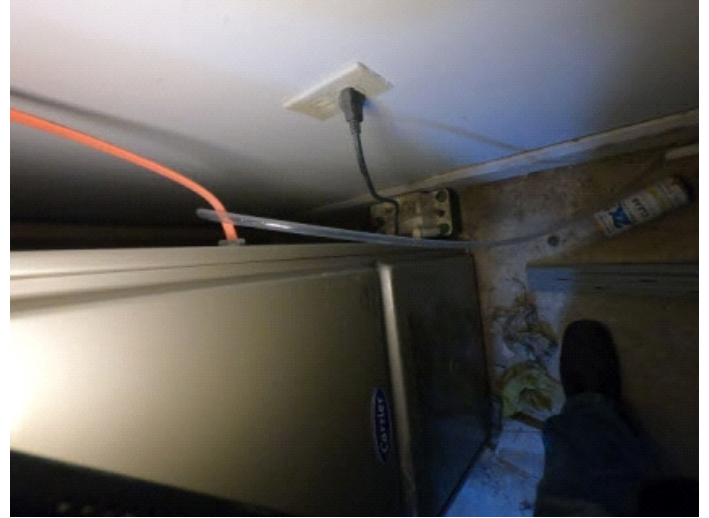
Discharge pump not connected.

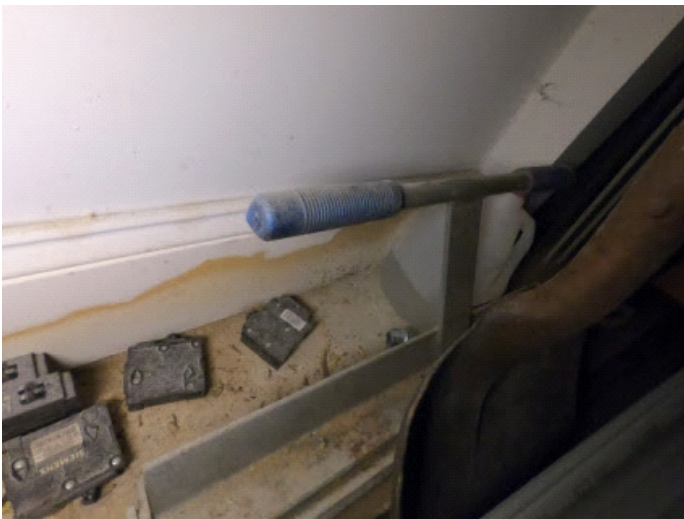
Some old stains from exterior moisture intrusion.
This appeared to be an old leak or other and
was dry at time of inspection.

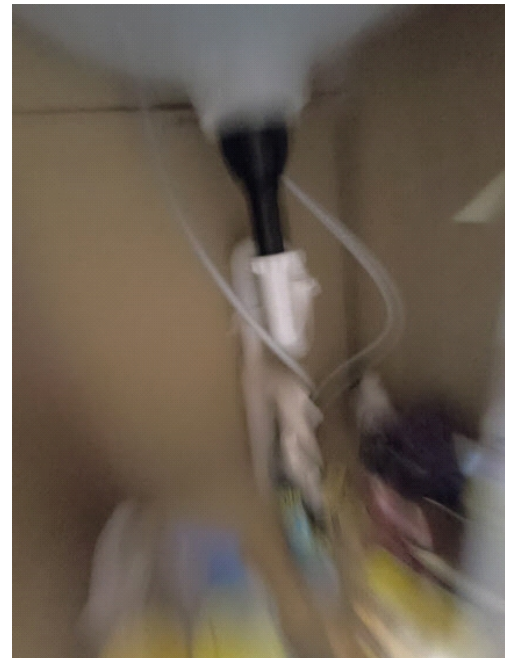
S trap. Sometimes these types traps can back siphoning and or cause odor. If this occurs, you can change to a different type of trap.

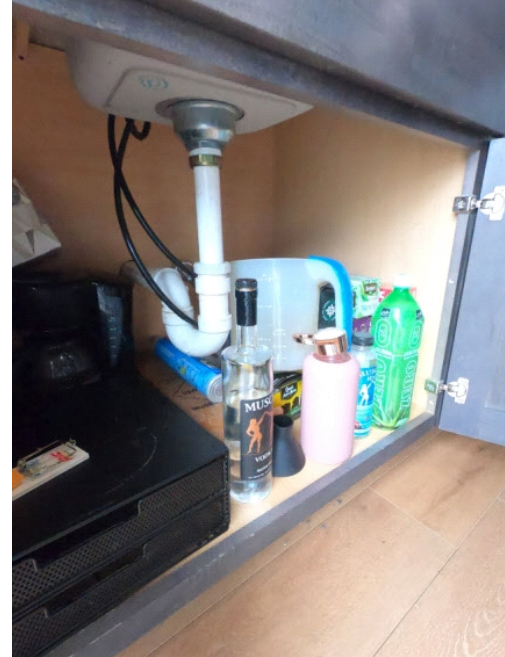
No leaks under most sinks.

Bar sink leaks in kitchen.

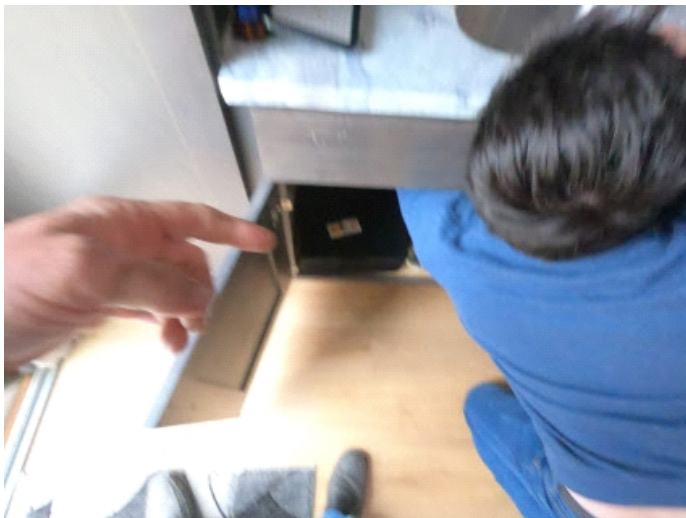
Need to control mice.

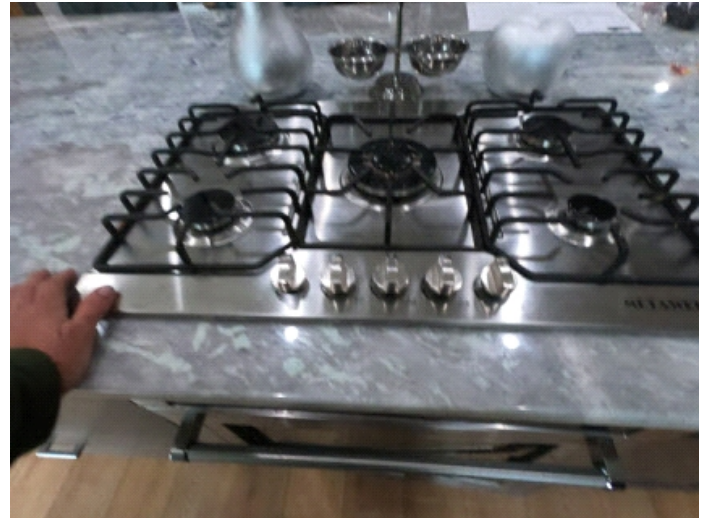
Oven door needs repair.

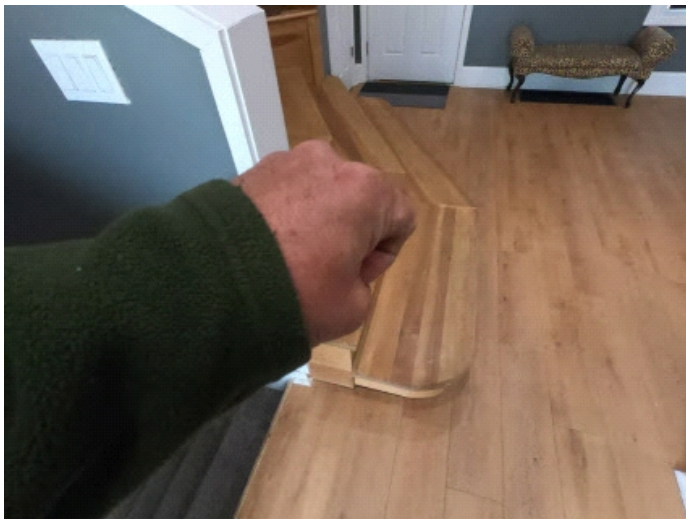
No handrail.

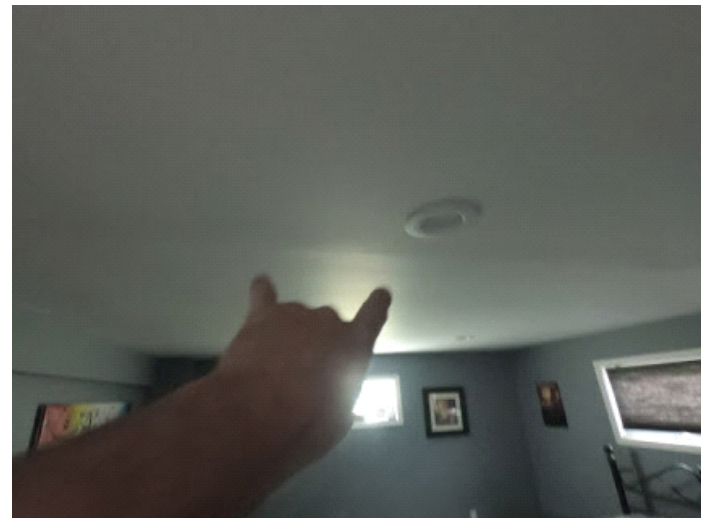
Bed rooms do not have cold air returns.
Some people will cut bottoms of doors to bring return air to cold air returns. Living room has cold air returns.

Furnace located in pole barn garage addition does not have cold air returns.

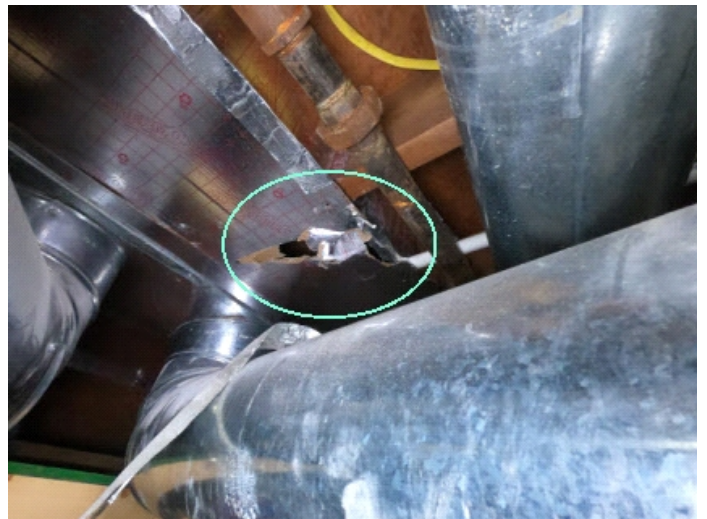
Cold air returns in basement need to be sealed
to minimize negative pressure.

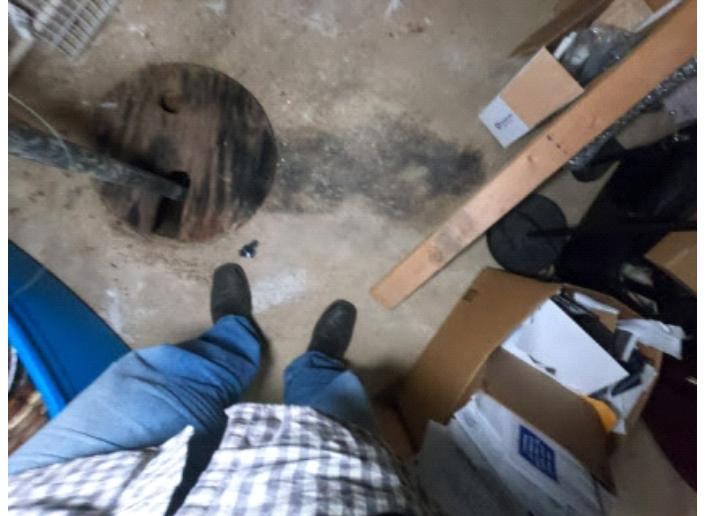
Recommend sub pump cover that is one or percent sealed and not wood. Should periodically check battery backup once installed.

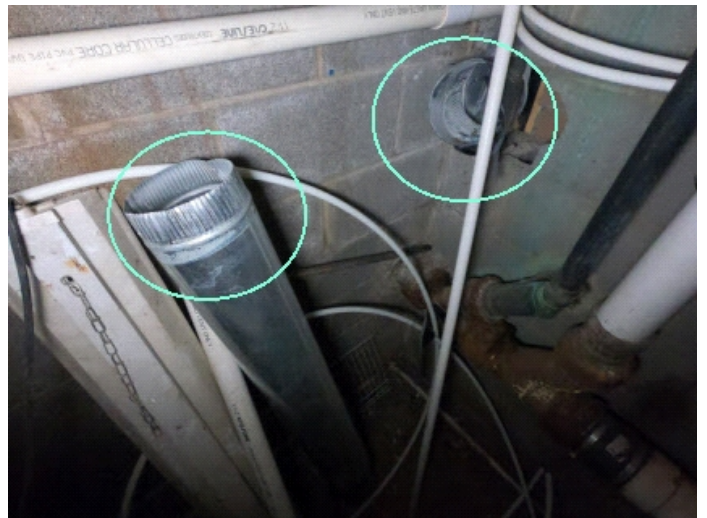
Furnace ductwork loose and not connected.

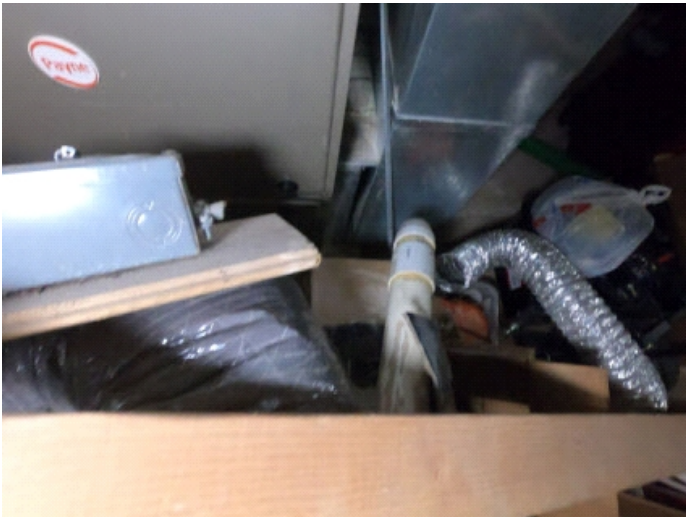
Furnace needs filter.

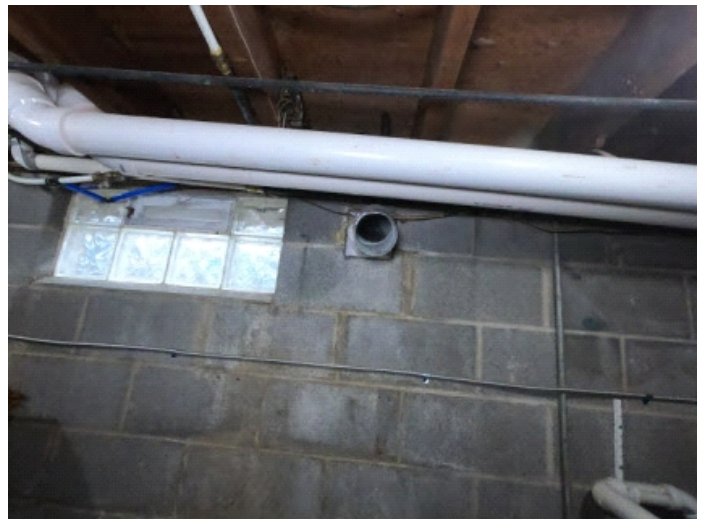
Vent not connected.
Caulk and insulation around perimeter.

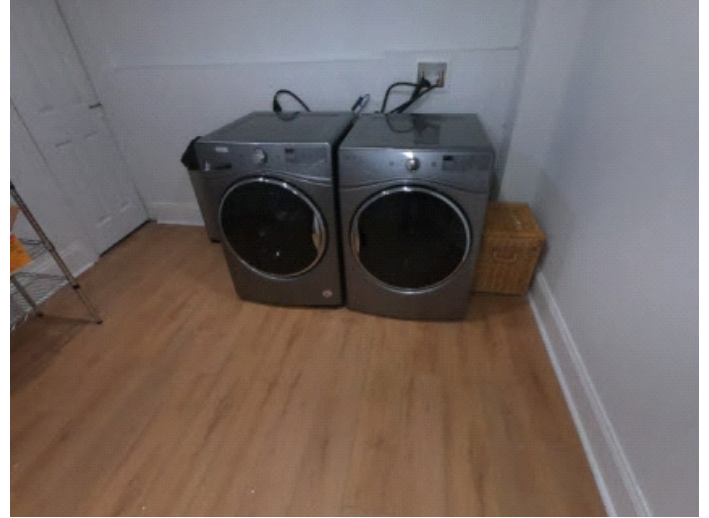
Dryer vent not connected.
Washer dryer not evaluated.
Due to older appliances we recommend getting an appliance warranty.

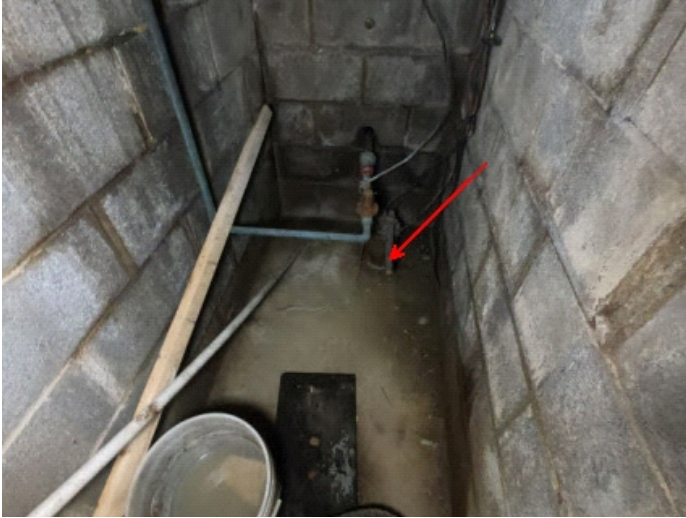
This appears to be the older original basement well room. Well access concrete above is covered or concealed.

This room get moist from condensation or exterior water intrusion. The room needs some type of water management, waterproofing, dampproofing and/or dehumidification. Should get second opinion on well.

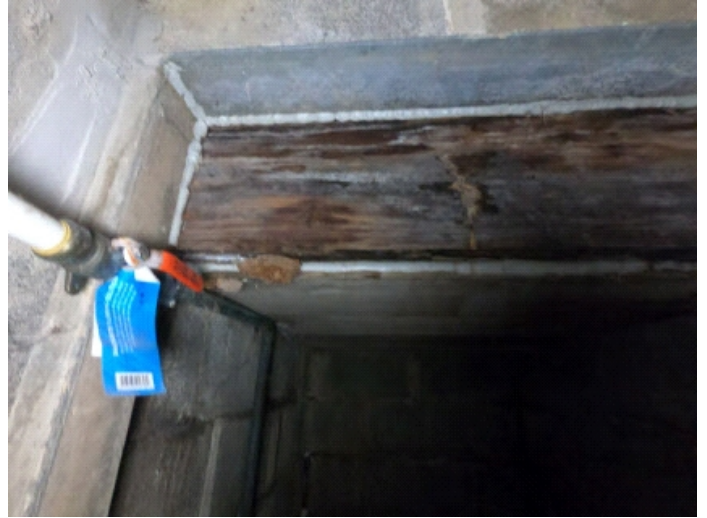
Well room wood beam as some condensation or deterioration however still functional. Conduits and piping in this room have some corrosion.

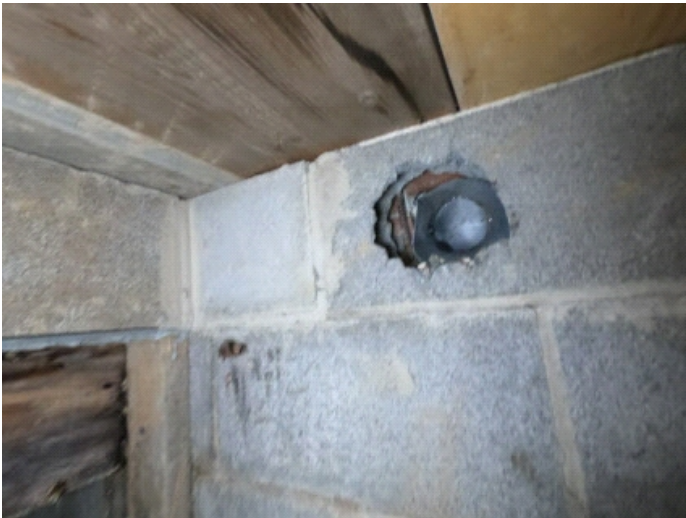
Vent hole not complete.

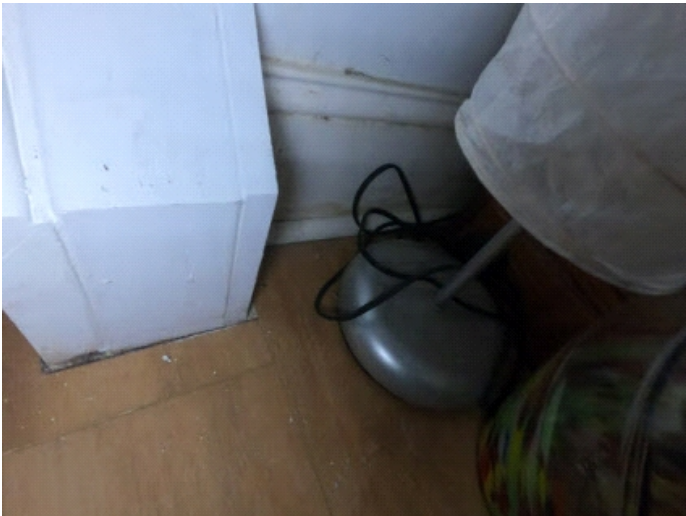
Some old water stains and basement walls. These were dry at time of inspection.

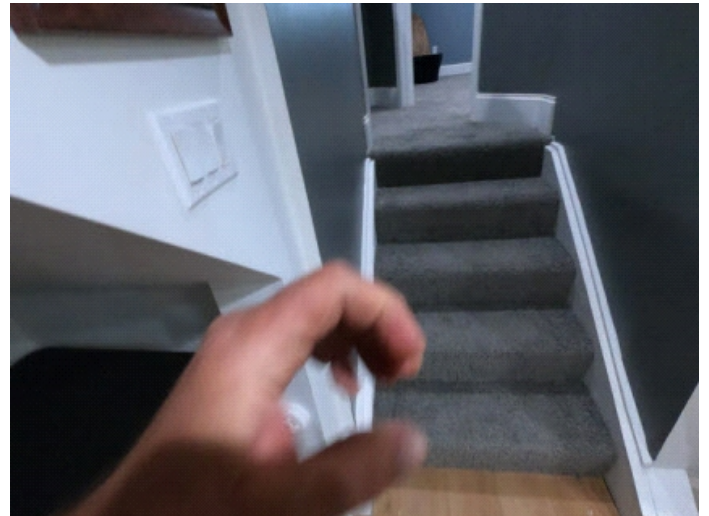
Missing handrails.

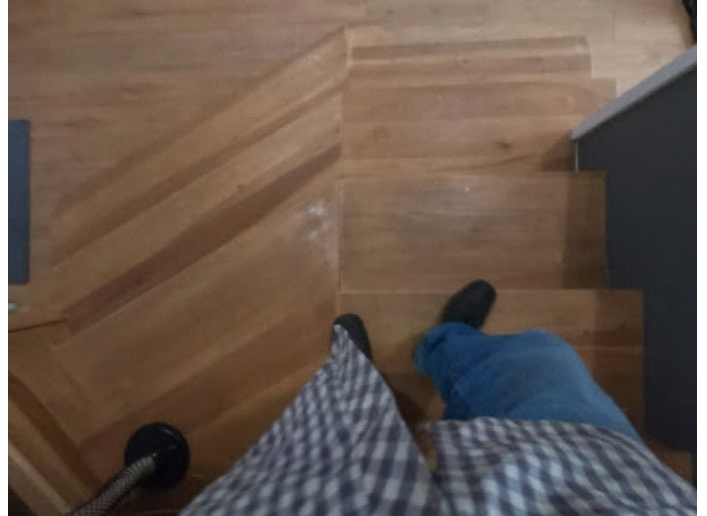
No handrails for steps.

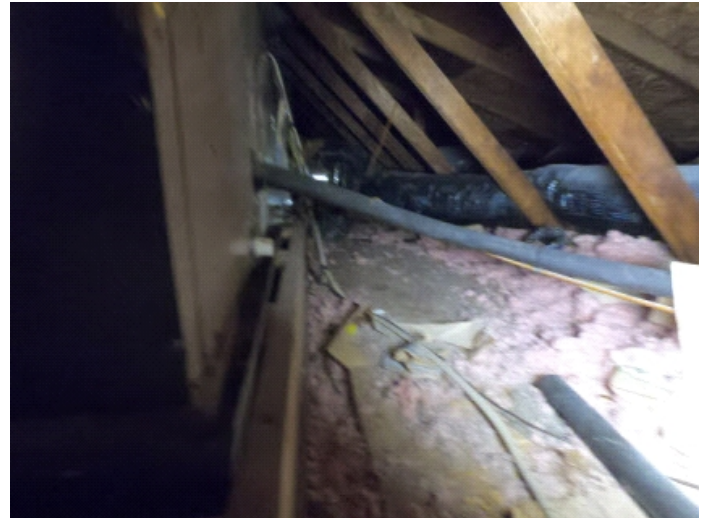
Could improve insulation in the upper attic.
Sloppy electrical an upper attic.
Some mildew or mold in sheeting (isolated).

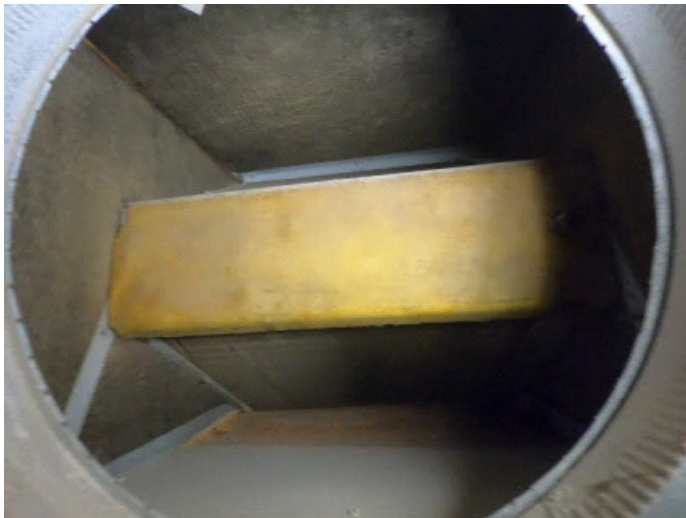
The air handler in attic nonfunctional and appears to be abandoned. Recommend removing.

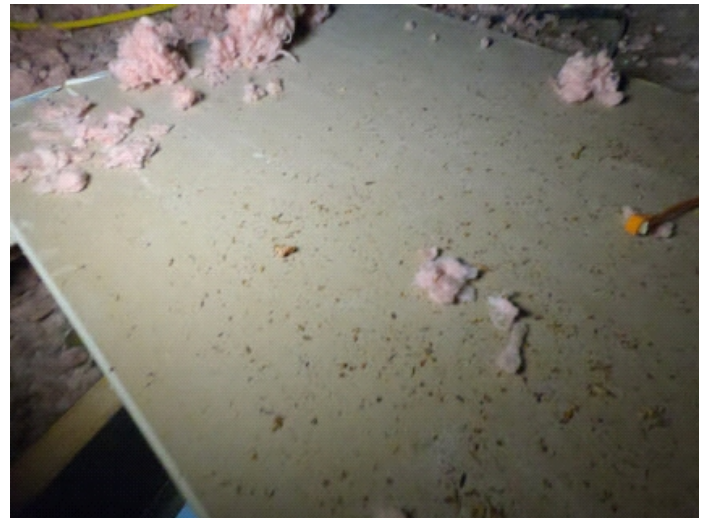
Control mice.
