Home Inspection Report

CERTIFIED INSPECTOR

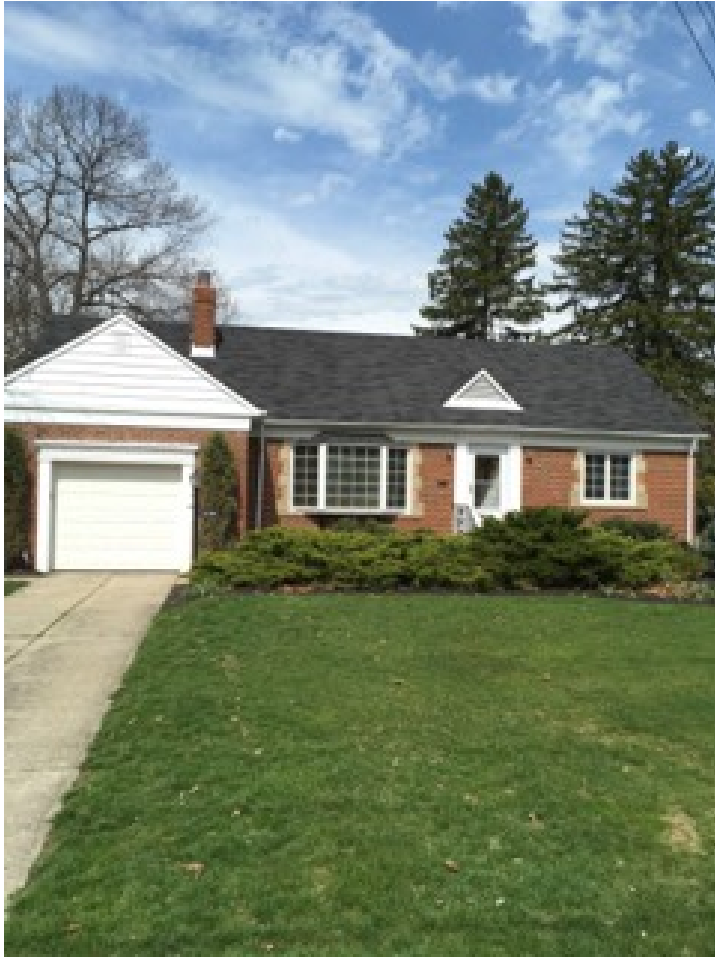
Front view of the home.

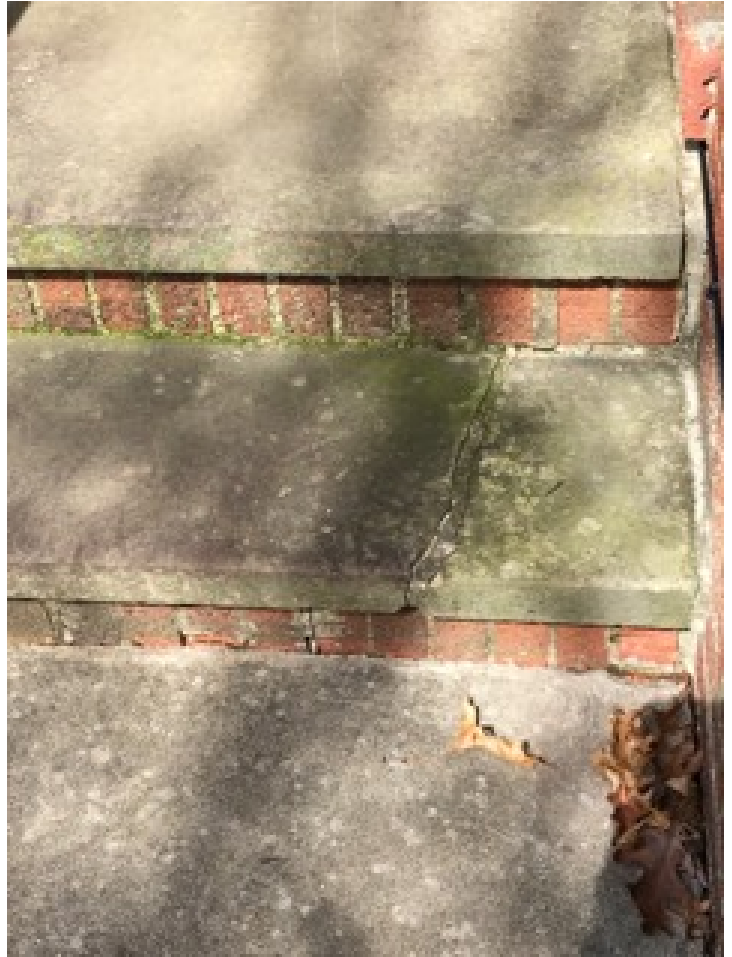
Cracked stone at the side entrance

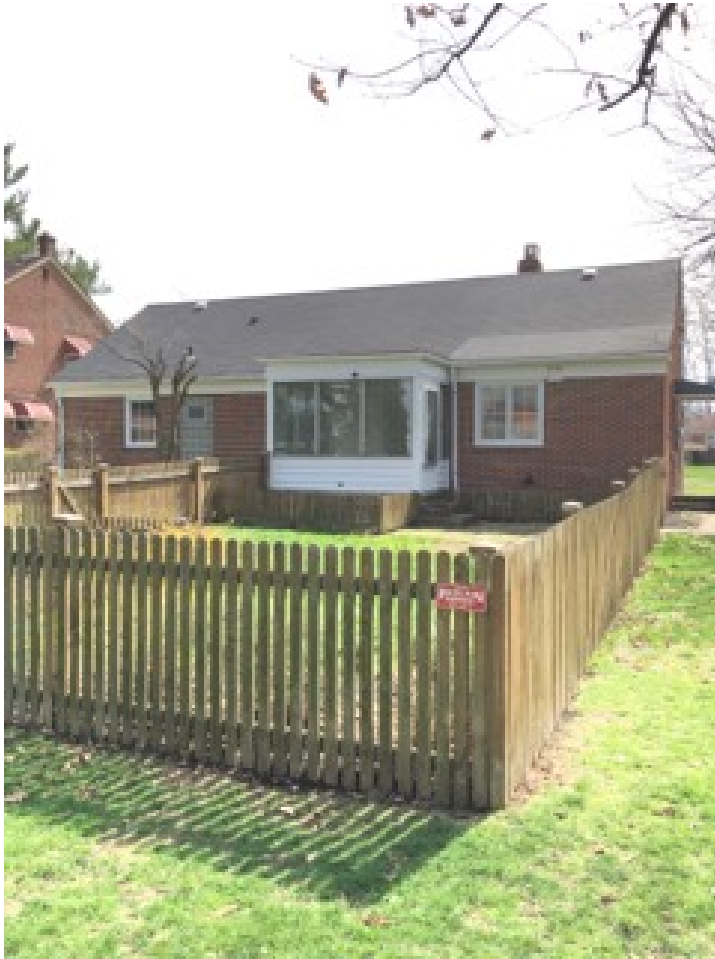
Rear view of the home

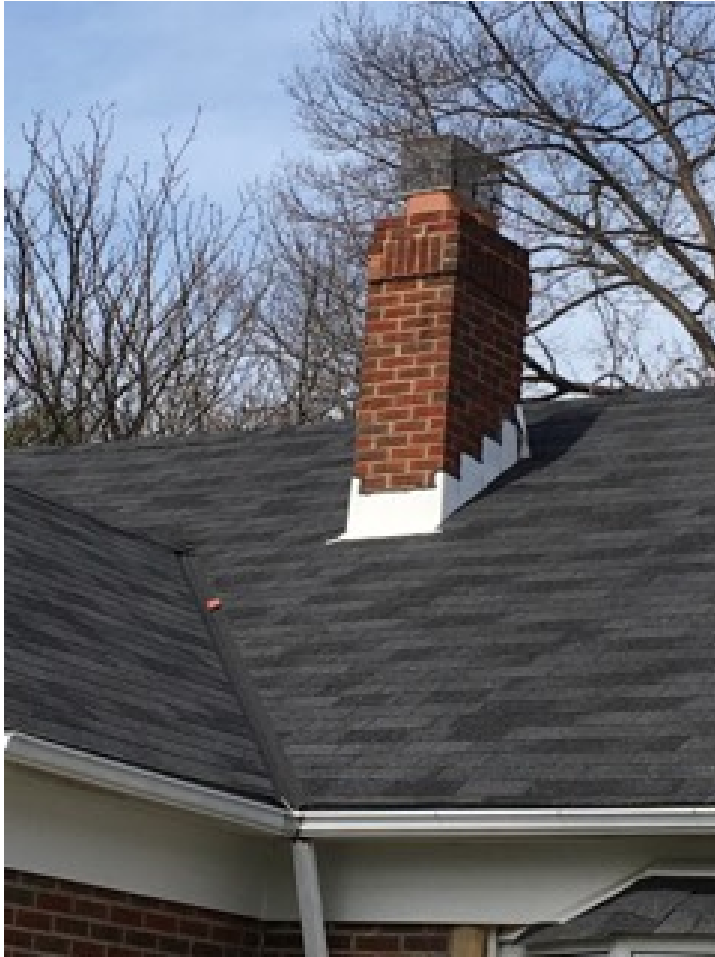
Front chimney has loose mortar joints and flaking

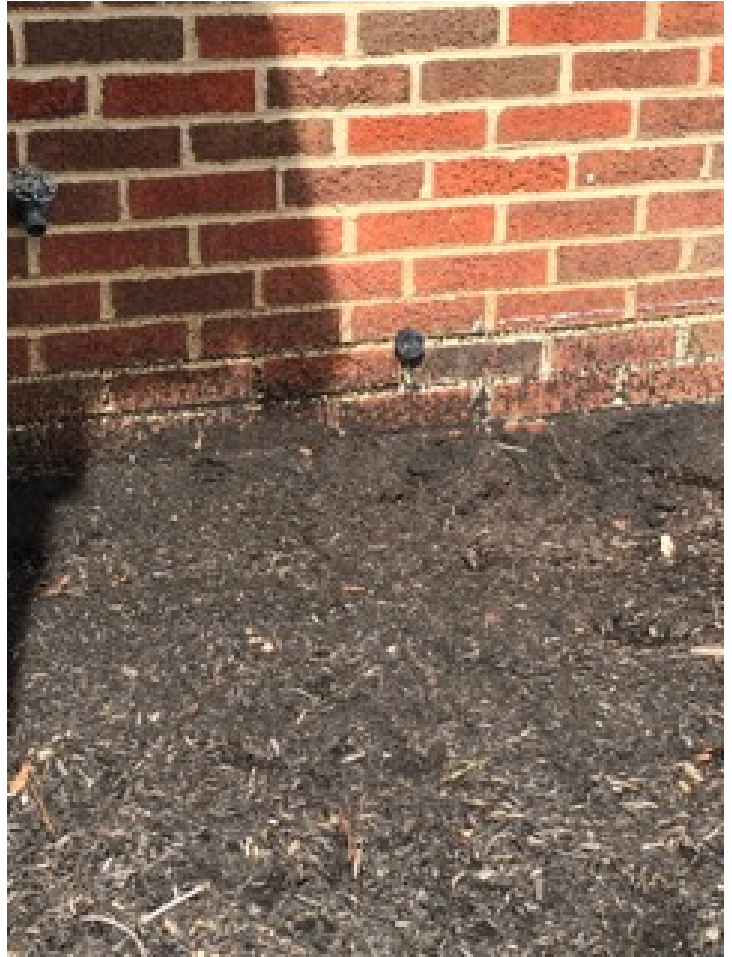
The front gutter is overflowing and splashing debris on the wall and moisture is penetrating the front bay window.

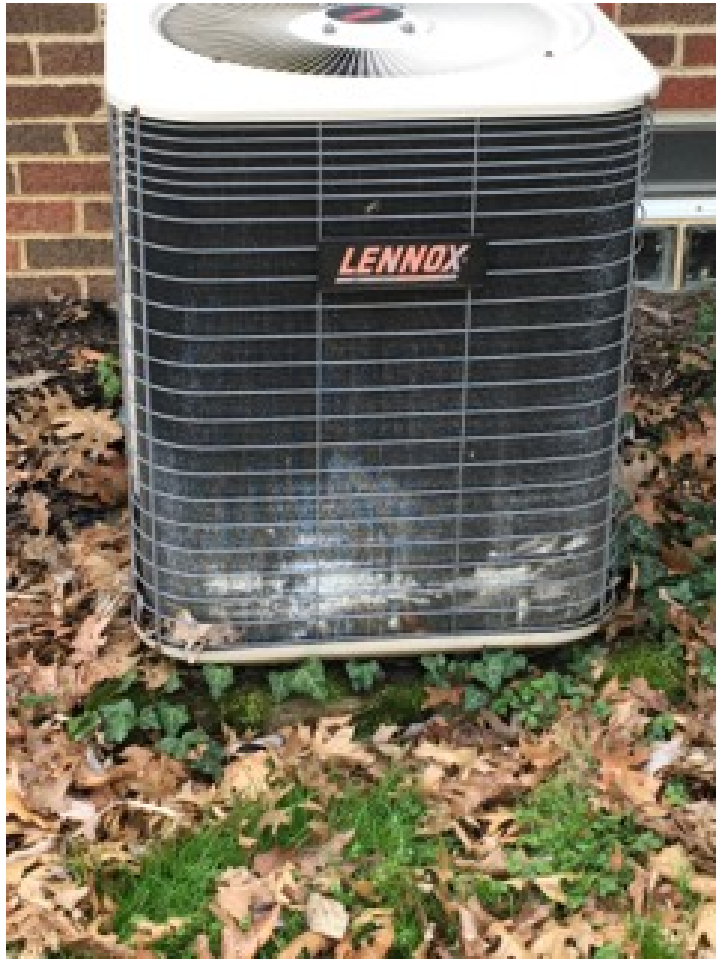
1998 Lennox air conditioner

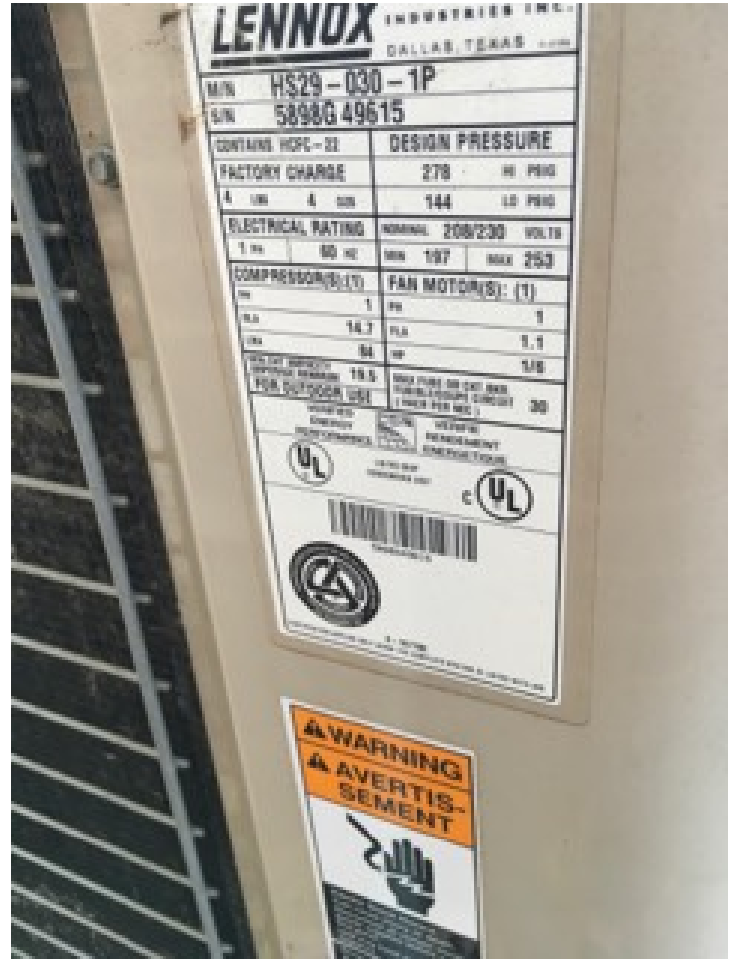
Air-conditioner information plate

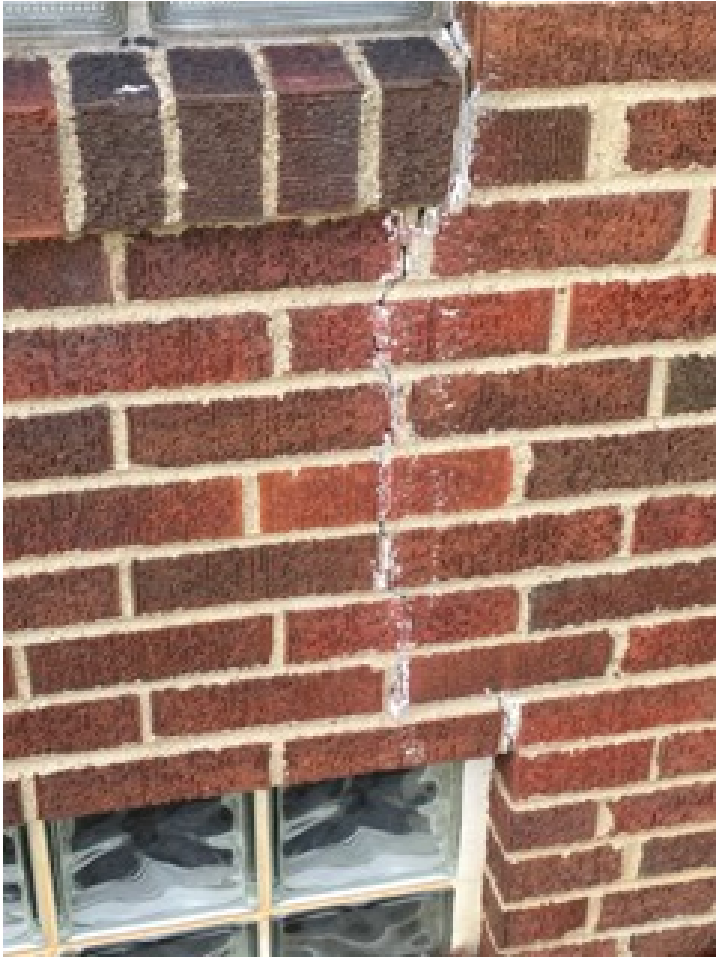
Vertical crack at the rear wall beneath the glass block window

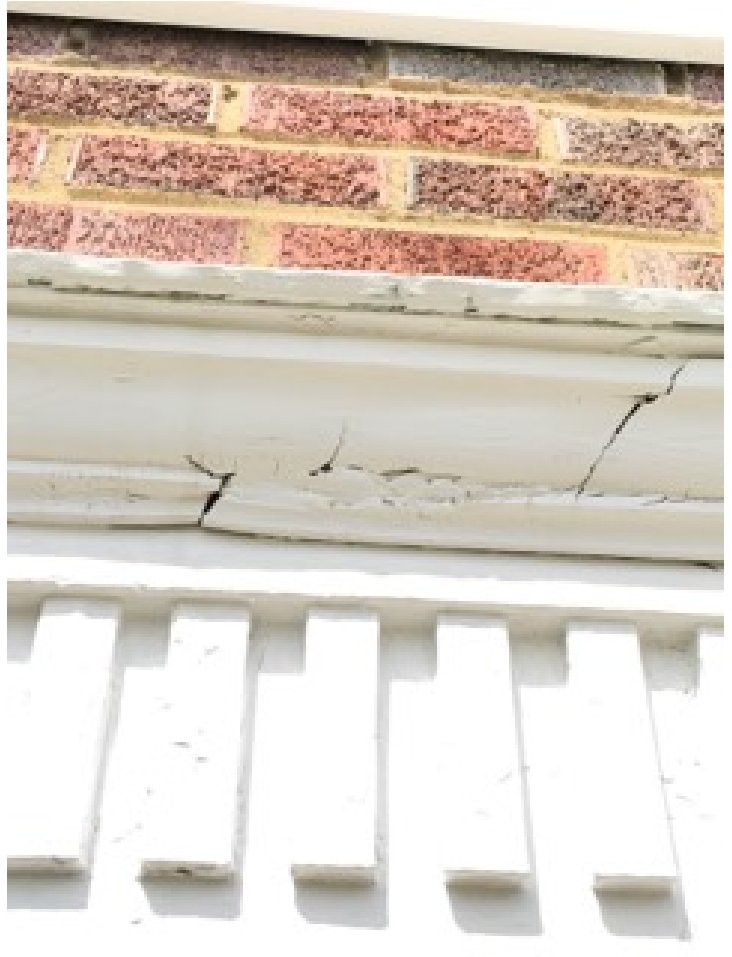
Trim damage above the garage door

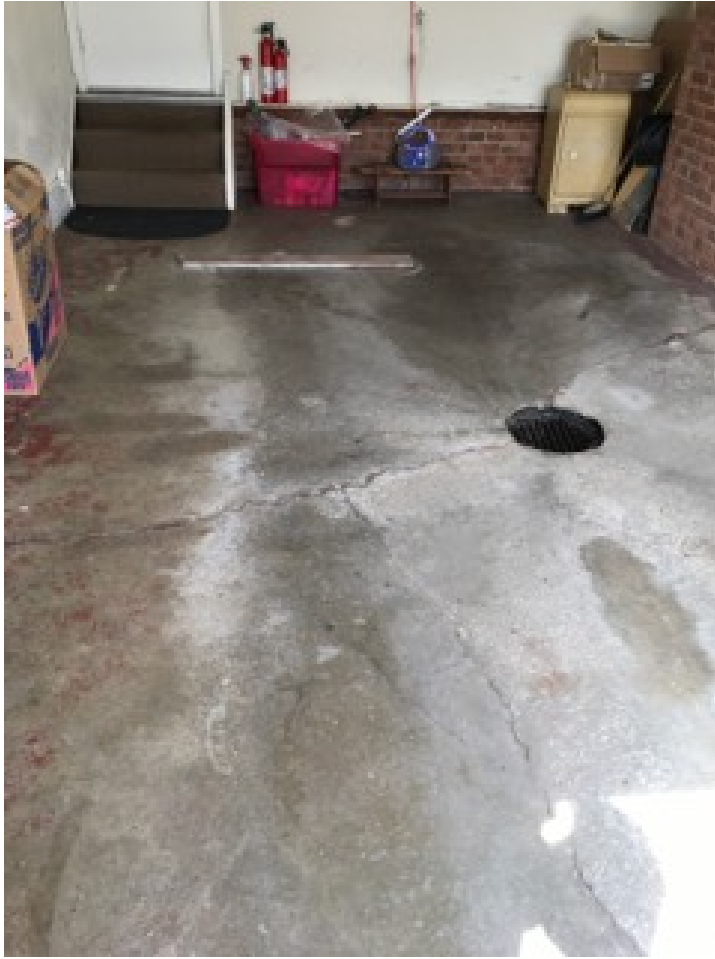
Garage/Carport Photos

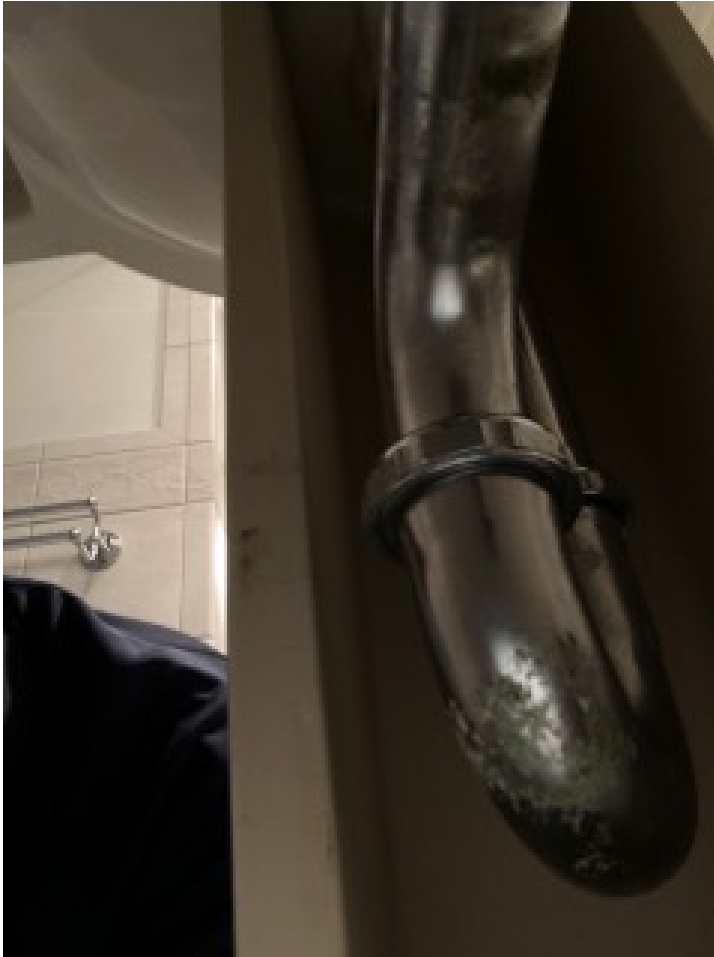
Minor corrosion on the pedestal sink drain

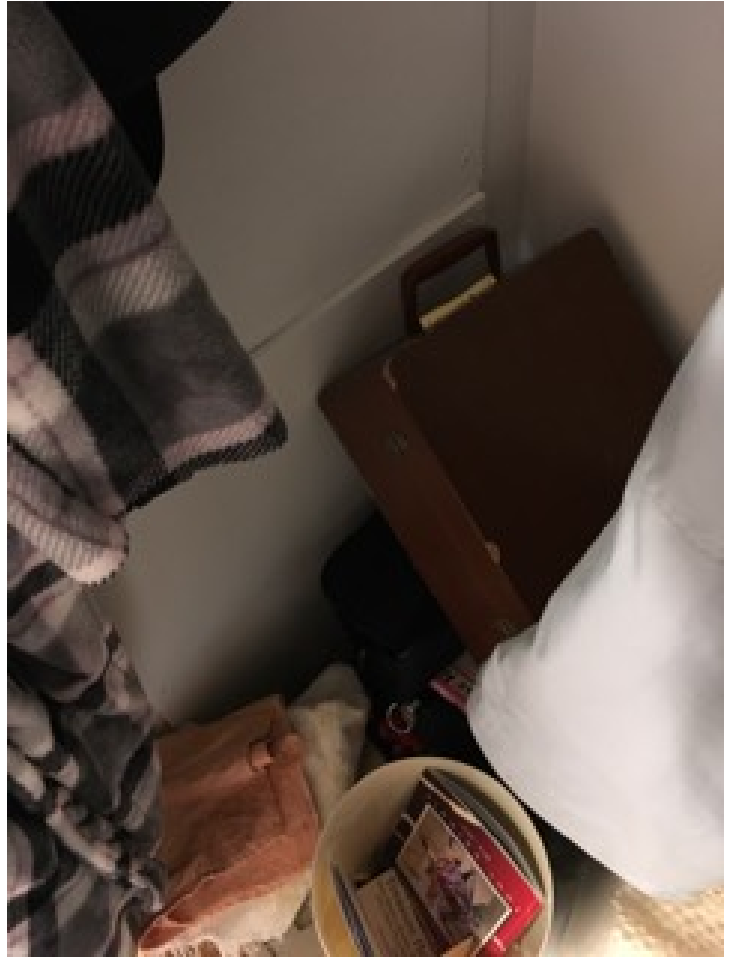
No access to the plumbing panel in the closet.

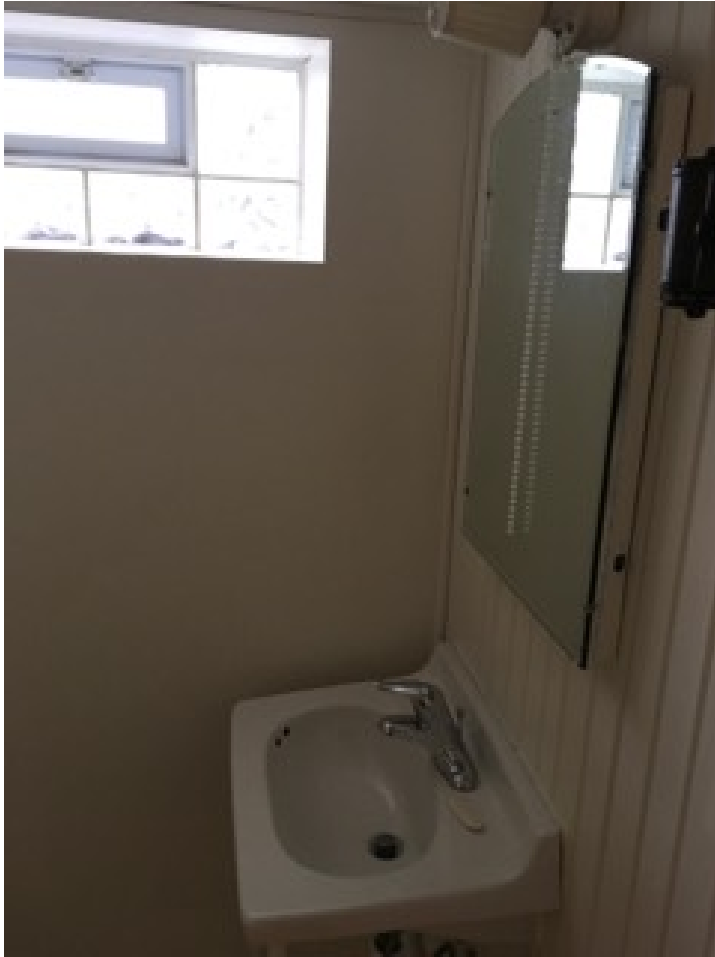
Basement half bathroom

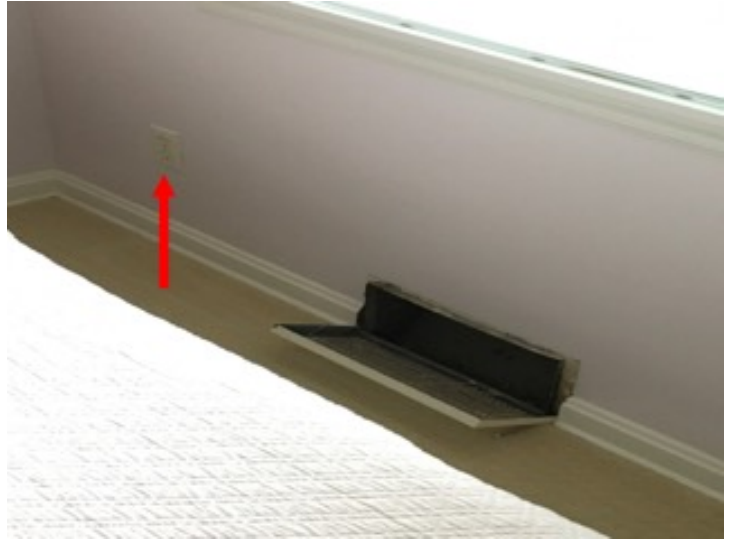
Loose heat duct cover and ungrounded three prong outlet at the north wall of the northeast bedroom

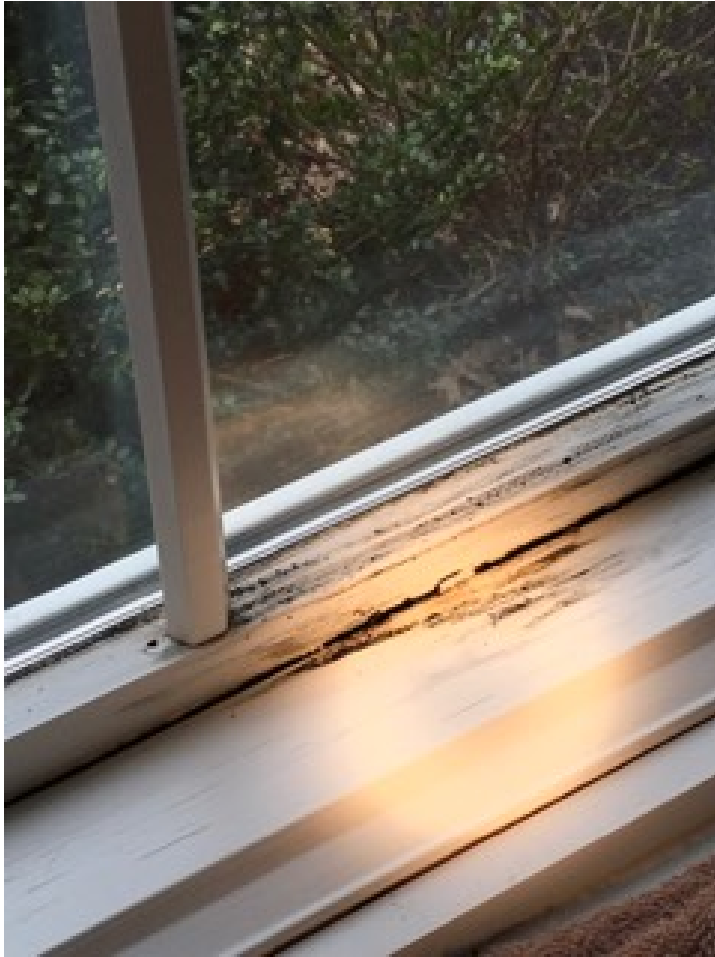
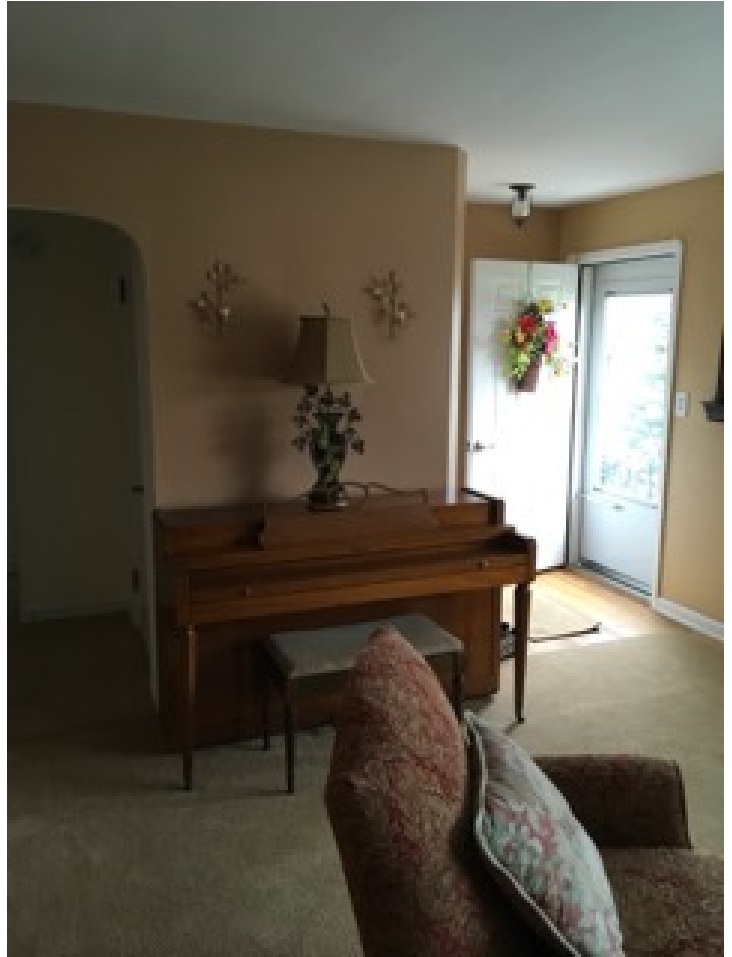
Deteriorated and moist wood at the front bay window. The front gutters are overflowing which could be causing the leak at the bay window. Recommend evaluation by a general contractor or a window company.

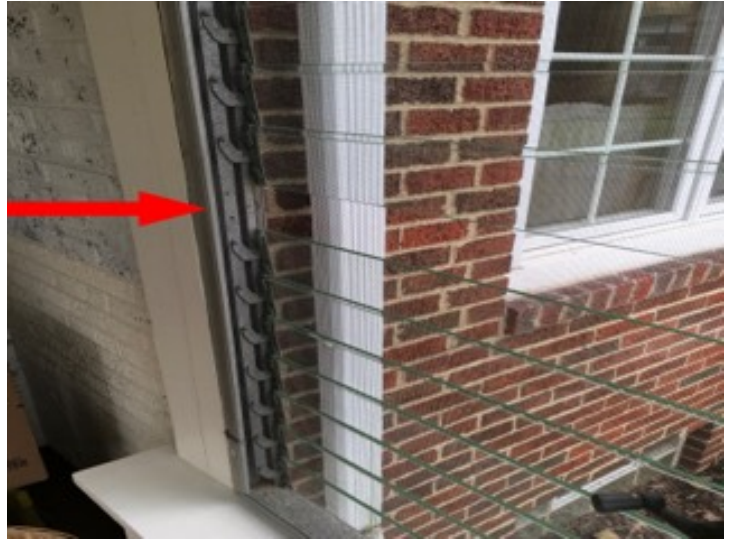
Missing pane and opening mechanism.

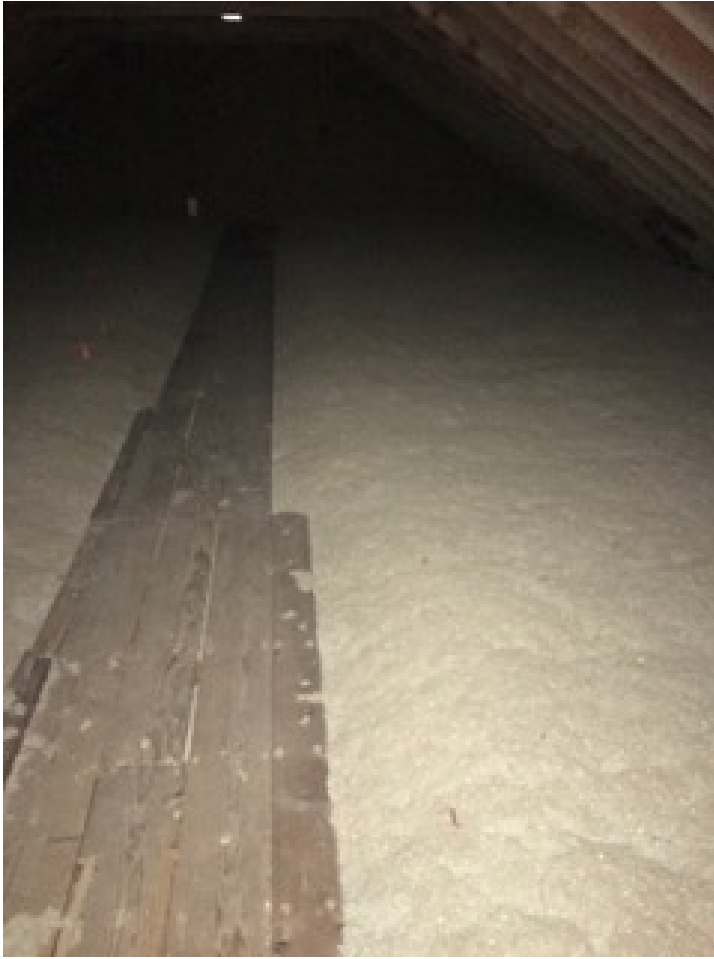
A blanket of insulation in the attic

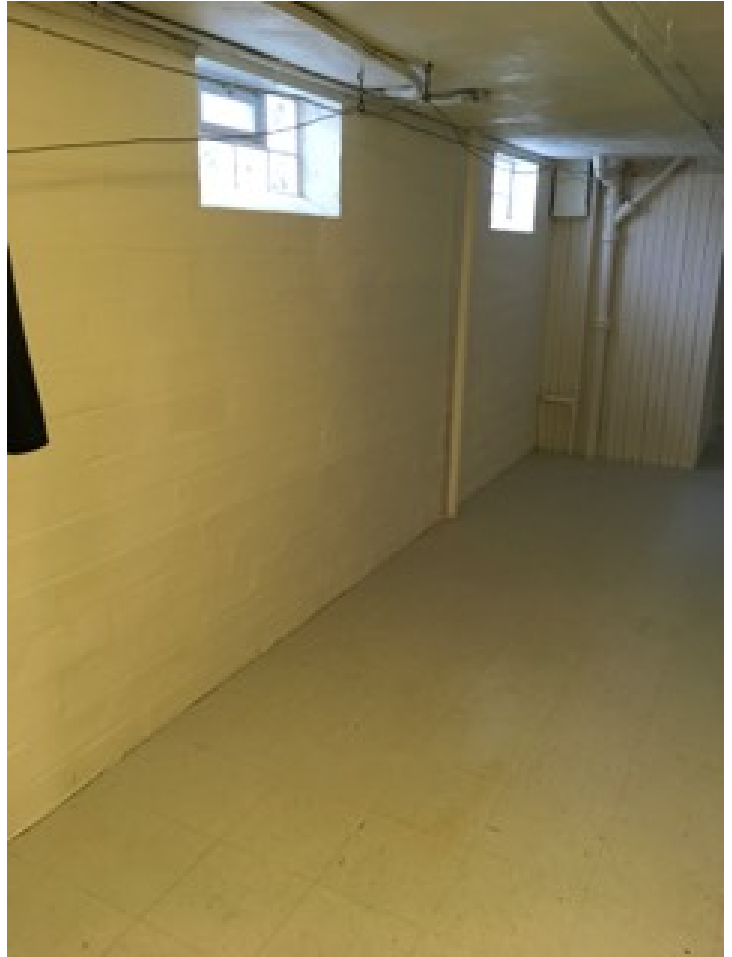
Foundation walls have been recently painted

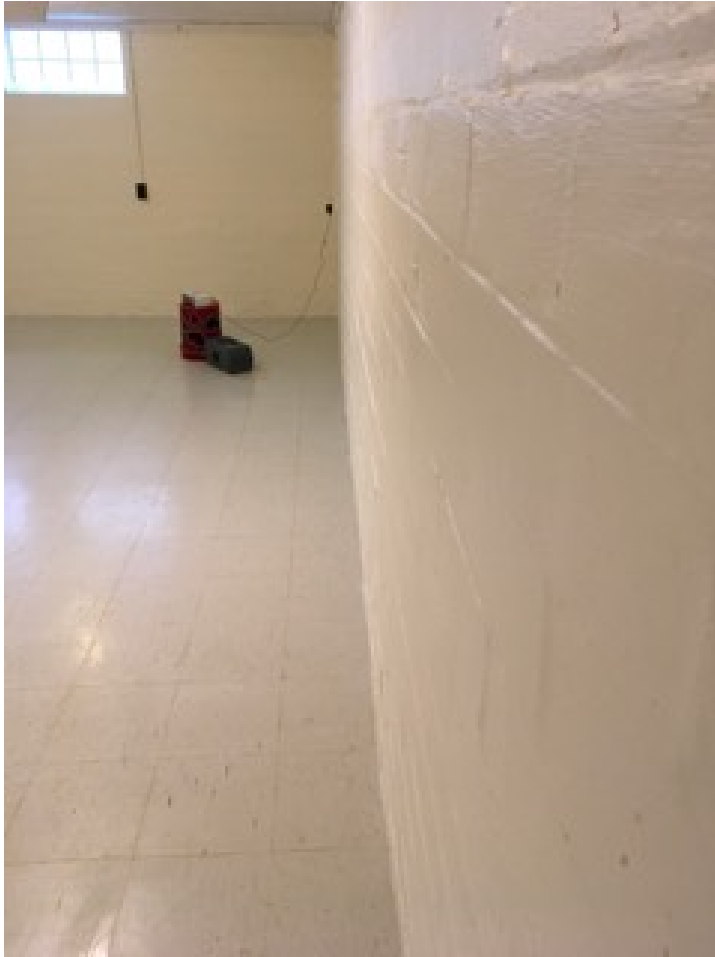
Rec room foundation wall appears to be plumb.

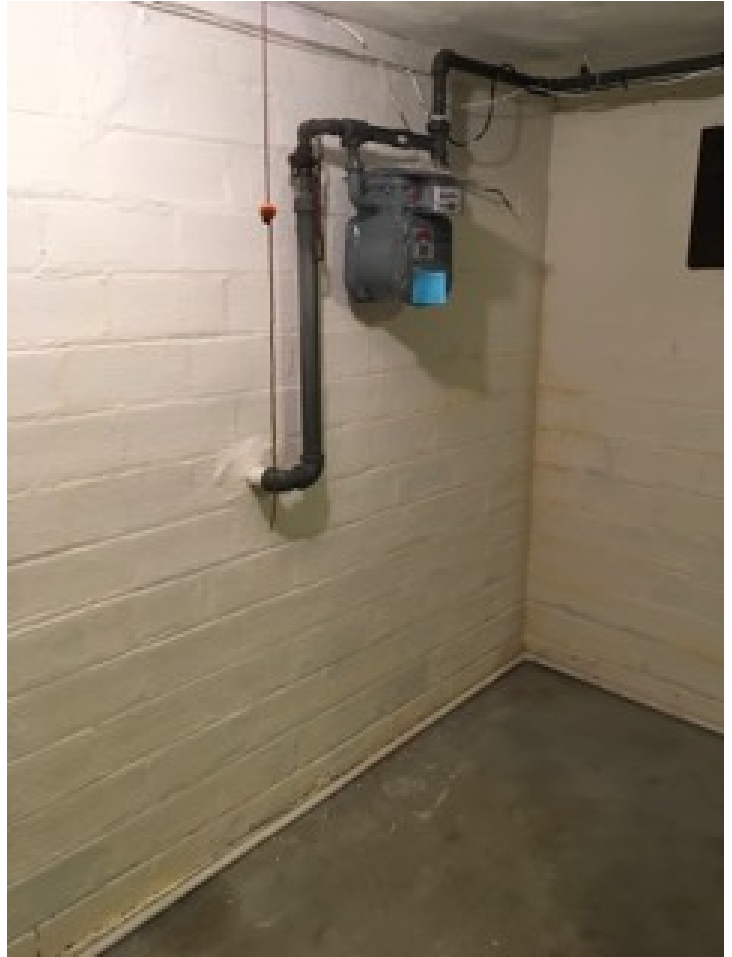
Gas meter is in the furnace room

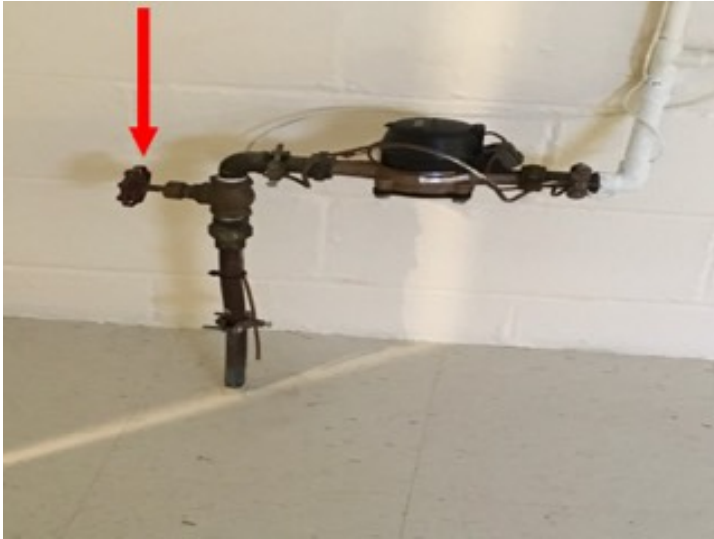
Water entry and main water shutoff valve

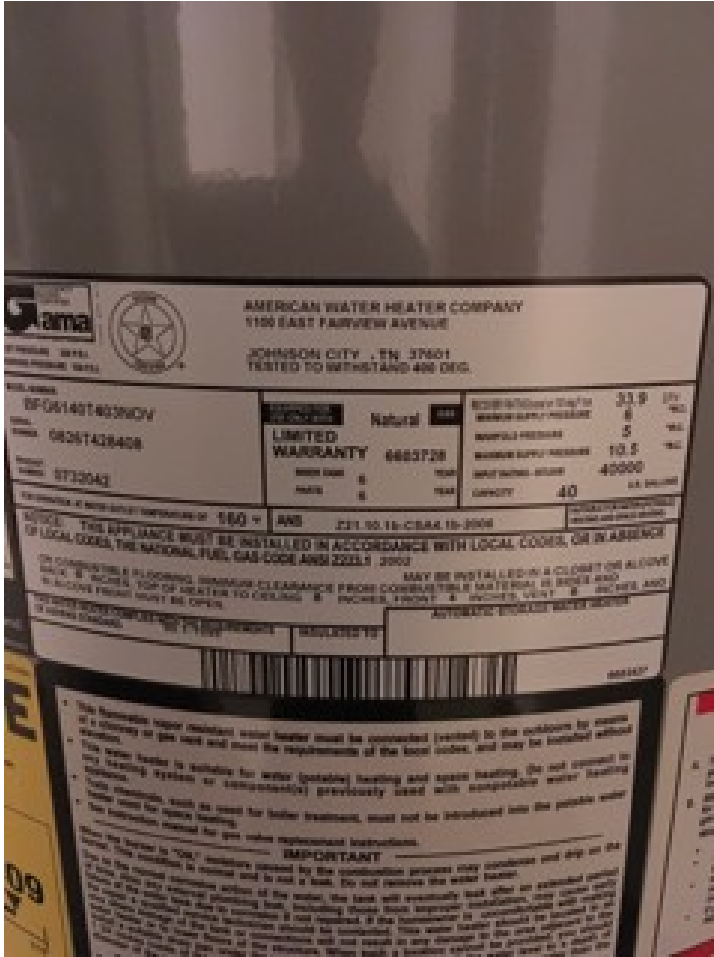
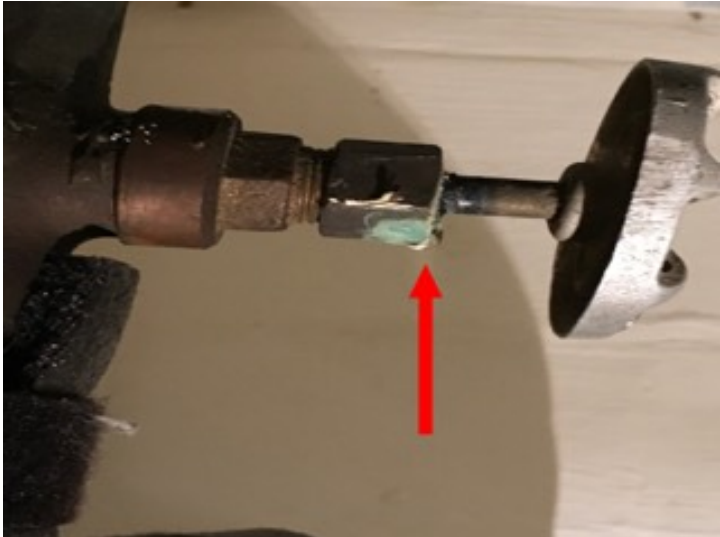
Leak at the water main shutoff valve for the hot water tank

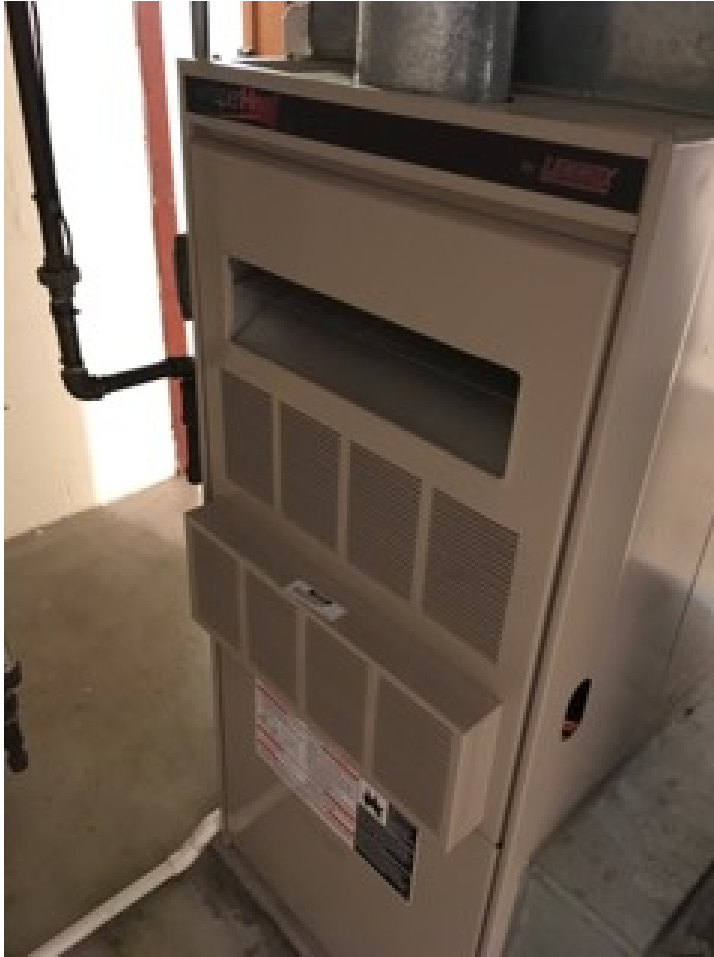
Heating System Photos

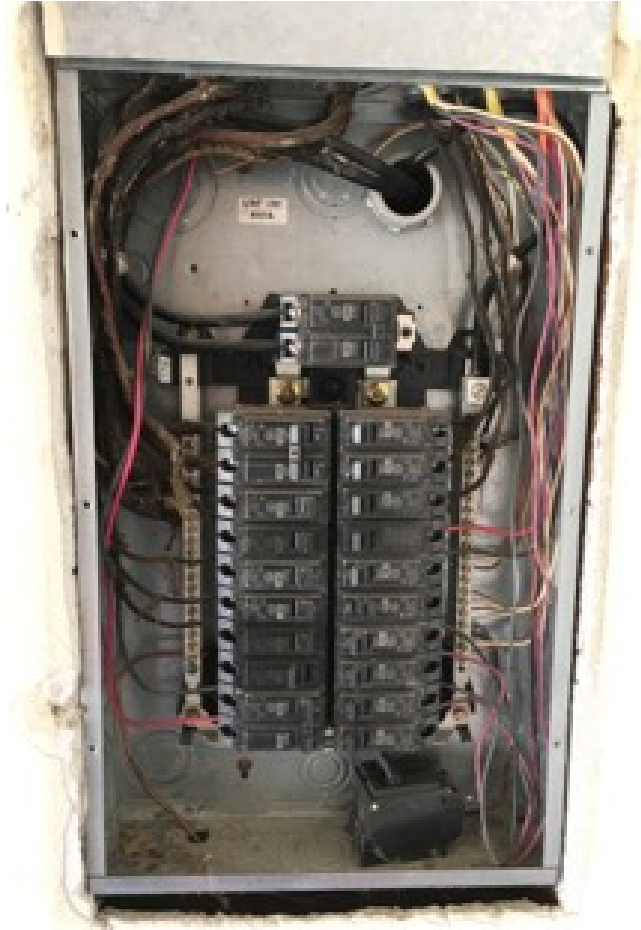
100 amp main breaker panel is properly installed and appears to be grounded

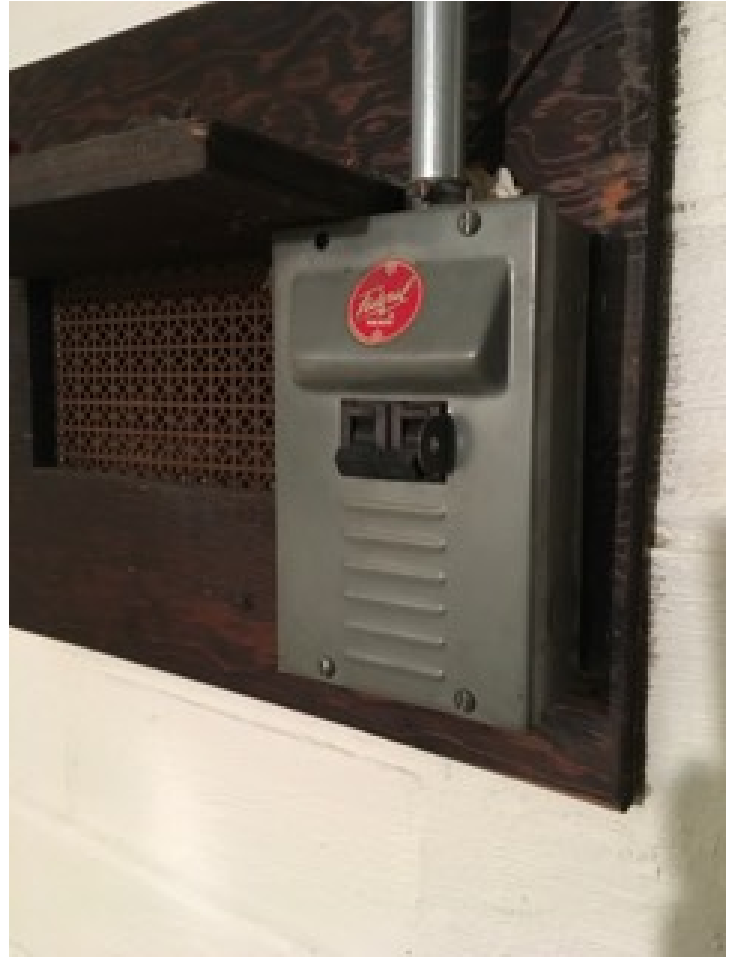
Recommend replacing the Federal Pacific breaker panel in the furnace room. Safety issue.

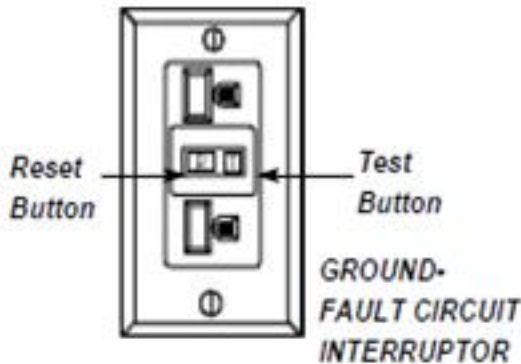
If you do have G.F.C.I.'s, it is recommended that you test (and reset) them monthly. When you push the test button, the reset button should pop out, shutting off the circuit. If it doesn't, the breaker is not working properly. If you don't test them once a month, the breakers have a tendency to stick and may not protect you when needed.
