SUMMARY
11702 Saywell Ave, Cleveland, OH
44108
Eric Leung
February 16, 2022

Mark Cherryholmes
OHI.2019005432 Exp 10/3/2022
North Ohio Property Inspection
216-219-5256

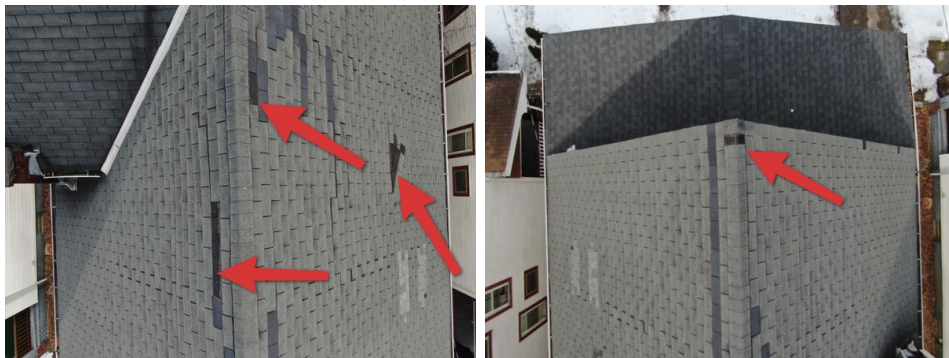
3.1.2 Coverings

MISSING SHINGLES

There were areas that were missing sufficient coverings. Missing shingles can lead to water intrusion. I recommend replacing all missing shingles.

Recommendation
Contact a qualified roofing professional.

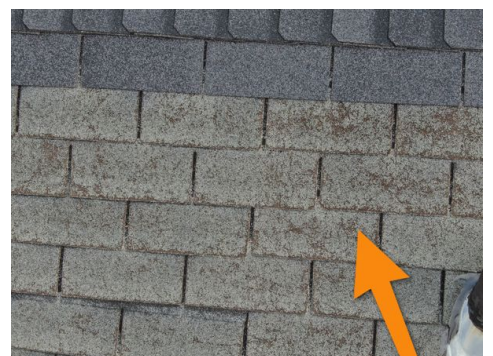
3.1.3 Coverings

MODERATE/HEAVY GRANULE LOSS AND WEAR TO ROOF

There was some moderate granule loss present on the roof coverings. This typically happens as a part of the aging process. As the roof begins to age it is common to see granule loss and even some cracking. There is heavier wear which indicates that the roof coverings are nearing the end of their life. I recommend consulting a roofing contractor to determine the remaining life and possible replacement costs.

Recommendation
Contact a qualified roofing professional.

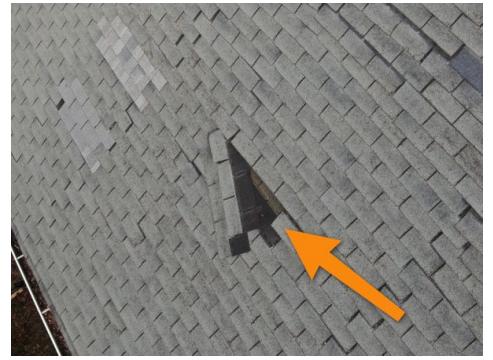
3.1.4 Coverings

SLIPPED SHINGLES

One or more shingles have slipped. This can lead to exposed fasteners. This could lead to a future leak or loss of shingles. I recommend having a roofing contractor evaluate, re-fasten the affected shingles and make any other repairs deemed necessary.

Contact a qualified roofing professional.

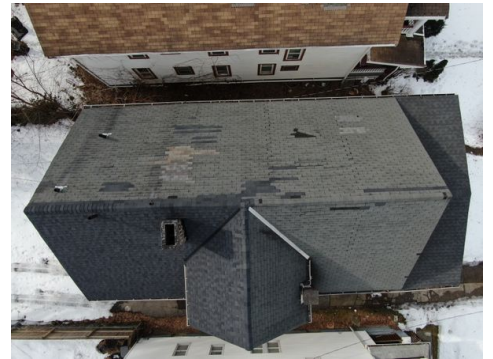
3.1.5 Coverings

EVIDENCE OF PRIOR ROOF REPAIR

There is evidence of prior repairs made to the roof coverings. Repairs appear to be properly done. I recommend inquiring as to the nature of the repairs and any warranties that may be available and monitoring for changes.

Contact the seller for more info

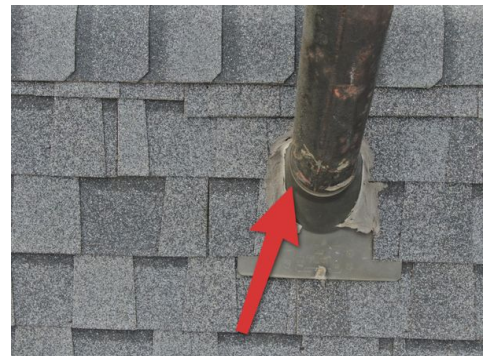
3.3.1 Flashings

SEWER VENT STACK FLASHING CRACKED/DETERIORATED

The rubber flashing on a sewer vent stack was cracked or deteriorated. This could lead to a roof leak in the future. I recommend replacing the flashing boot to prevent leaks.

Contact a qualified roofing professional.

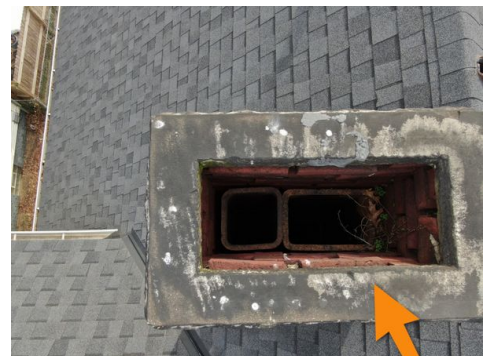
3.4.1 Skylights, Chimneys & Other Roof Penetrations

CHIMNEY CAP MISSING

No chimney cap was observed. This is to protect from moisture intrusion and protect the chimney. I recommend installing a chimney cap.

Contact a qualified chimney contractor.

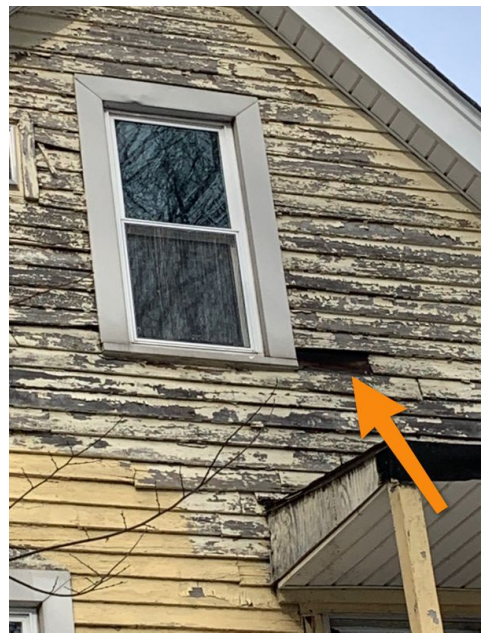
4.1.1 Siding, Flashing & Trim

WOOD ROT-EXTERIOR

Wood on the exterior of the structure has some areas that are rotted/deteriorated. I recommend replacing any rotted wood and properly priming and painting the areas.

Contact a qualified general contractor.

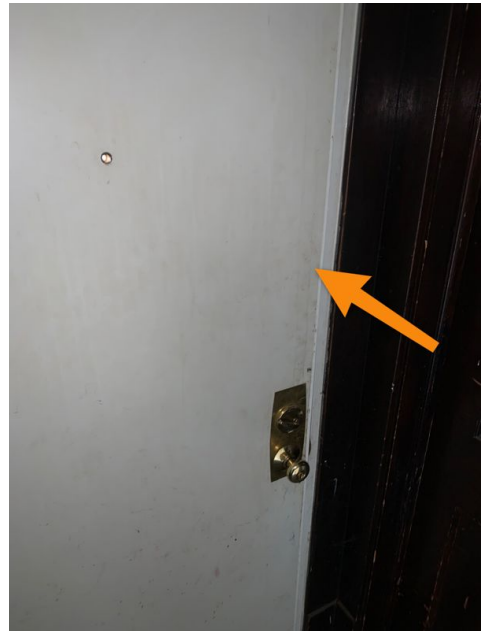
4.2.1 Exterior Doors

EXTERIOR DOOR NAILED SHUT

2ND FLOOR BALCONY

An exterior door was nailed shut. It may not operate properly. I recommend evaluation/repair.

Contact a qualified general contractor.

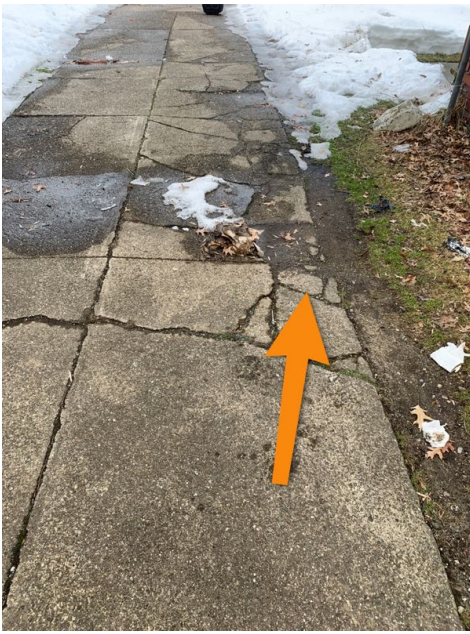
4.3.1 Walkways, Patios & Driveways

DRIVEWAY SETTLING

There was some settling on the driveway. It is possible that this could become a tripping hazard. I recommend having a concrete contractor level the affected areas of the driveway.

Contact a qualified concrete contractor.

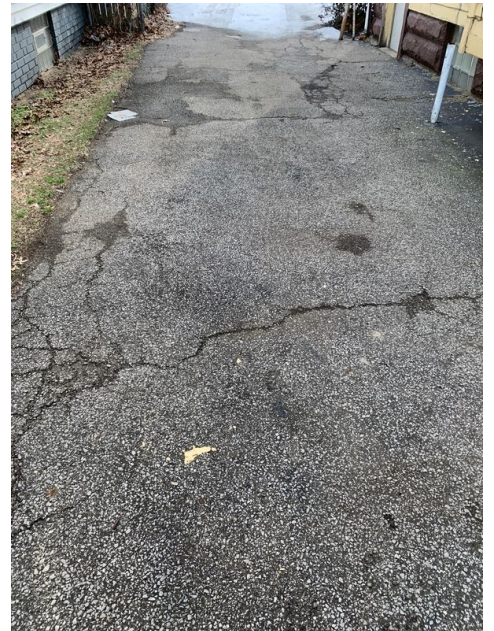
4.3.2 Walkways, Patios & Driveways

ASPHALT RESURFACING -MINOR

Minor resurfacing is needed on the driveway. I recommend resurfacing the necessary areas of the driveway.

Contact a qualified driveway contractor.

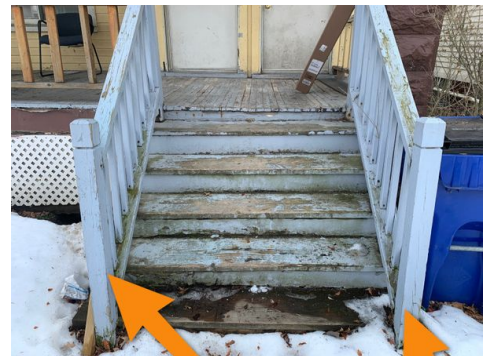
4.4.1 Decks, Balconies, Porches & Steps

LOOSE HANDRAIL-EXTERIOR

A handrail is loose on the exterior of the home. I recommend securing the handrail to prevent trips/falls.

Contact a qualified general contractor.

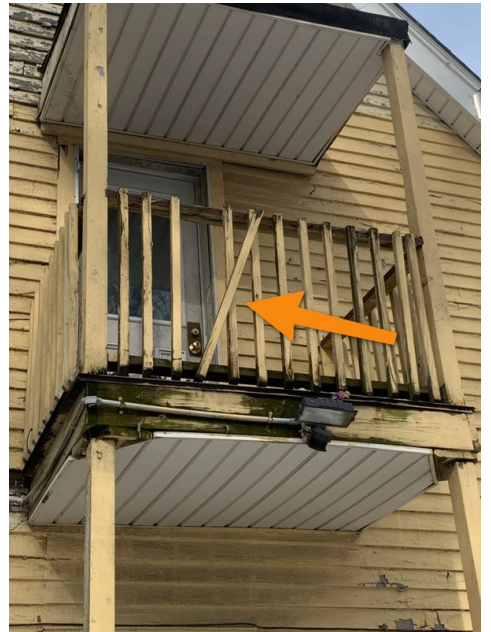
4.4.3 Decks, Balconies, Porches & Steps

DAMAGED SPINDLES ON DECK

There were damaged spindles on a deck. This could create an unsafe opening where someone could fall and reduces the strength of the railing. I recommend repairing or replacing the damaged spindles.

Recommendation
Contact a qualified deck contractor.

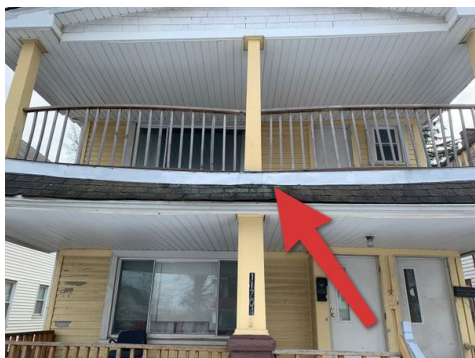
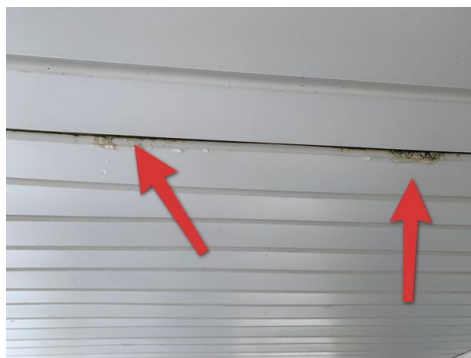
4.4.4 Decks, Balconies, Porches & Steps

BALCONY SAGGING/WATER INTRUSION

The balcony on the front of the house is sagging and has indications of water intrusion and potential wood rot. It is possible that there are structural issues with the second floor balcony. I recommend evaluation and repair by a general contractor.

Recommendation
Contact a qualified general contractor.

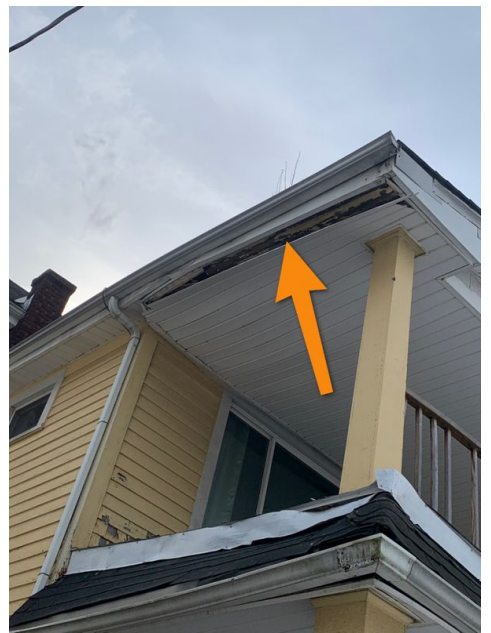
4.5.1 Eaves, Soffits & Fascia

SOFFIT LOOSE

There is a loose area of soffit. This could catch in the wind and cause the remaining soffit to pull off. I recommend securing the loose soffit.

Recommendation
Contact a qualified siding specialist.

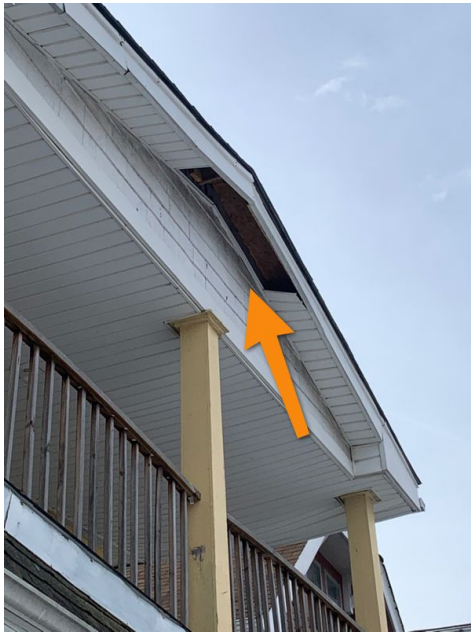
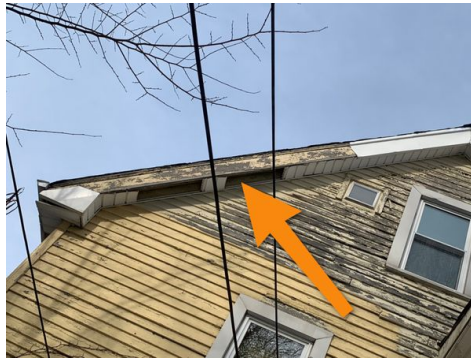
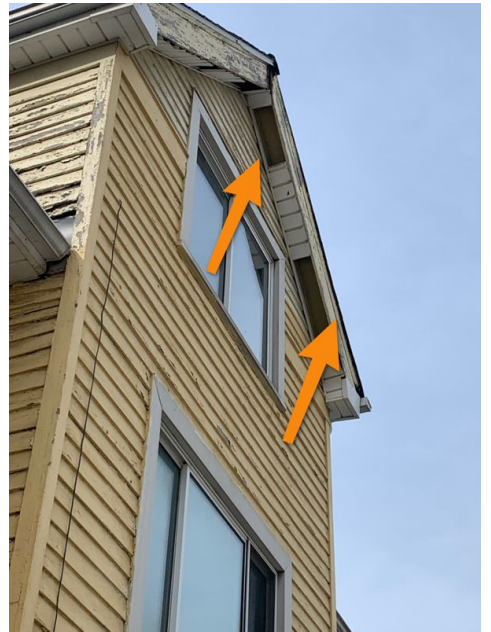
4.5.2 Eaves, Soffits & Fascia

SOFFITS DAMAGED

There was damage to the soffits. I recommend evaluation/repair.

Recommendation
Contact a qualified general contractor.

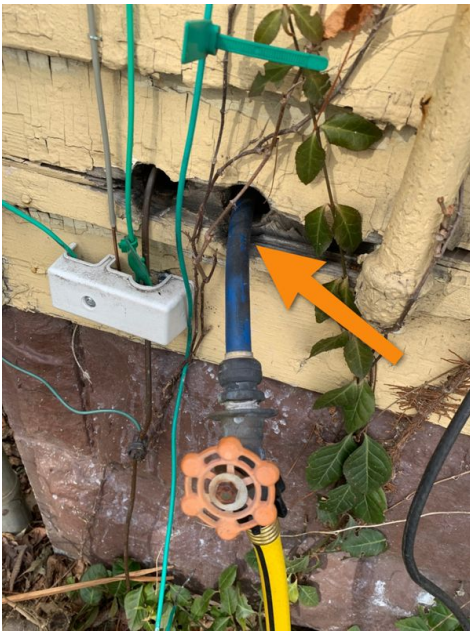
4.7.1 Exterior fixtures

SPIGOT NOT SECURE

An exterior spigot was not secure. This could lead to a future leak. I recommend securing and properly caulking the spigot.

Recommendation
Contact a qualified handyman.

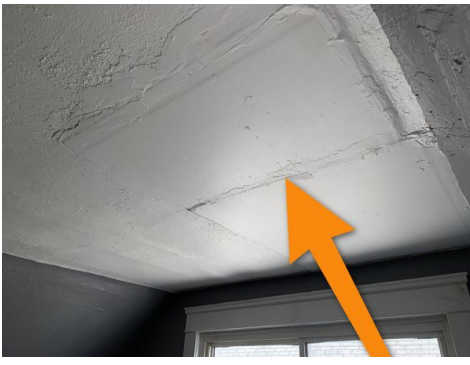
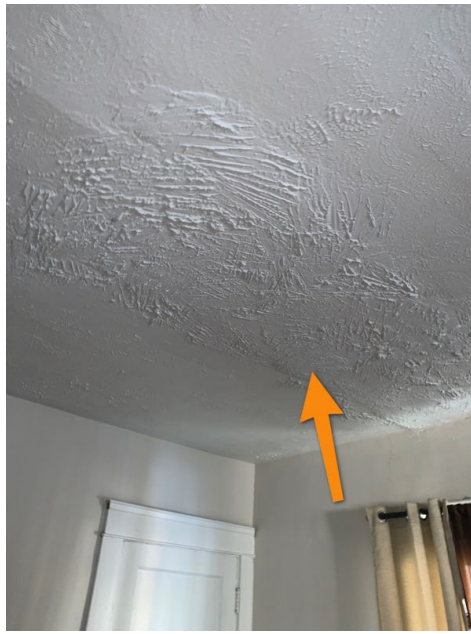
6.5.1 Ceilings

INDICATIONS OF PRIOR CEILING REPAIR

3RD FLOOR LIVING ROOM, 2ND FLOOR LIVING ROOM

There are indications of a prior repair on the ceiling. At the time of inspection it does not appear that there is an active leak as elevated moisture levels were not detected. I recommend requesting information from the seller regarding the nature of the repair and monitor for future changes.

Recommend monitoring.

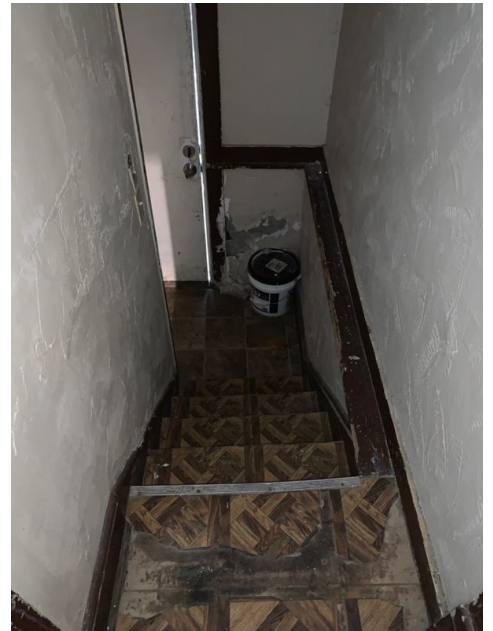
6.6.1 Steps, Stairways & Railings

NO HANDRAIL

SEVERAL LOCATIONS

A staircase had no graspable handrails. Handrails are required when there are 4 or more risers. This may create a safety hazard. This may also cause an issue during the appraisal process. I recommend installing a continuous graspable handrail in accordance with building guidelines.

Contact a qualified handyman.

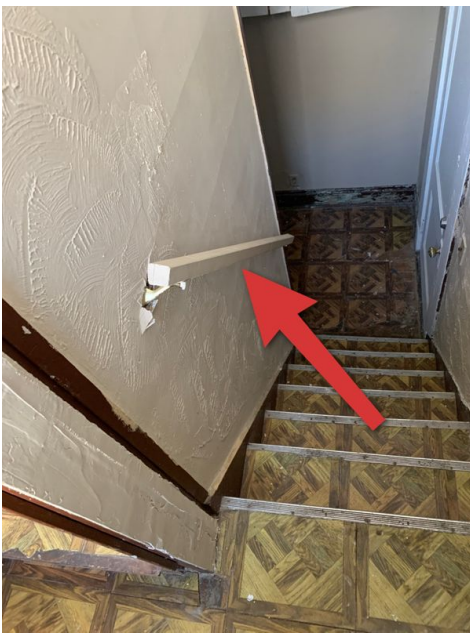
6.6.2 Steps, Stairways & Railings

LOOSE HANDRAIL

There is a loose handrail in the home. If weight is placed on this handrail it could come loose and lead to a fall. I recommend having a contractor evaluate and repair handrail.

Contact a qualified general contractor.

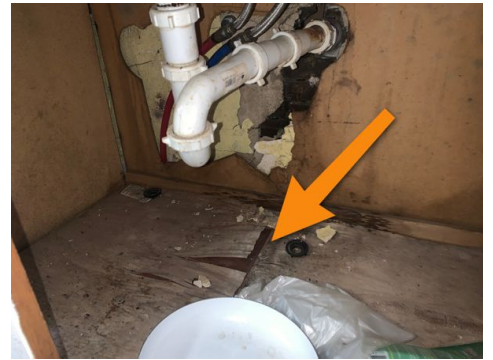
6.7.1 Countertops & Cabinets
SINK BASE DAMAGE -DRY

A sink base is damaged from a prior leak. I recommend removing and replacing any damaged wood at the base of the cabinet.

Recommendation
Contact a qualified general contractor.

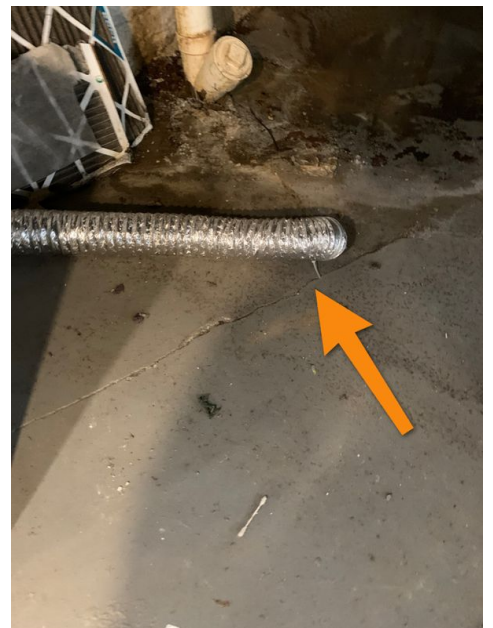
7.3.1 Dryer
VENT NOT CONNECTED-DRYER

The vent on the dryer was not connected at the time of inspection. I recommend connecting the dryer vent and venting to the exterior.

Recommendation
Contact a qualified professional.

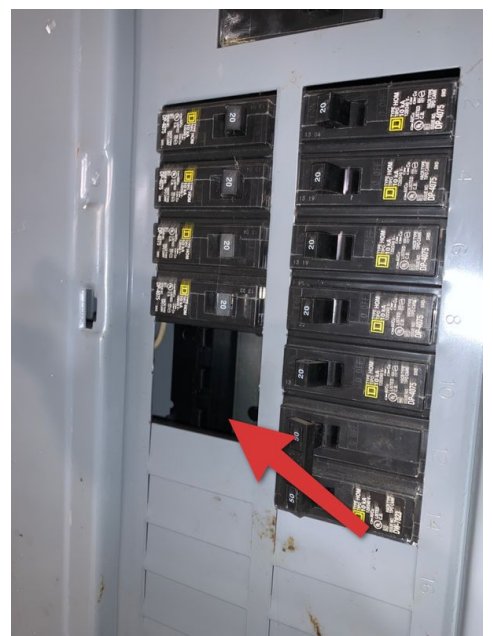
KNOCKOUTS MISSING

"Knockouts" are missing on the electric panel. This creates an opening where you could accidentally stick your finger through and be shocked. Knockout covers are available at low cost to cover the opening. This could also be corrected by placing breakers in the openings. I recommend covering the open knockout.

Contact a handyman or DIY project

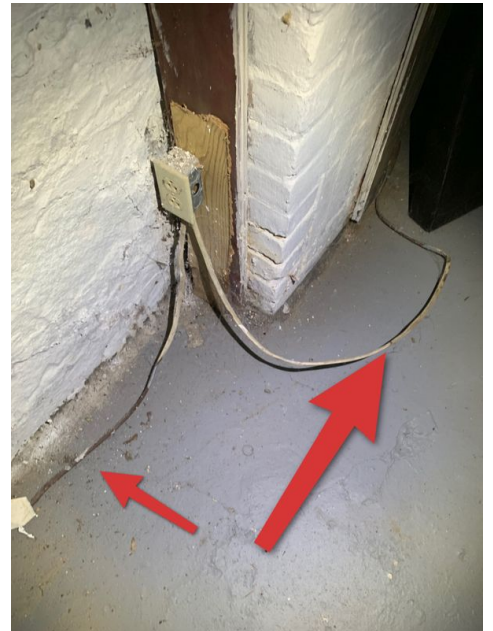
WIRING HANGING LOOSE NOT SUPPORTED

BASEMENT

There is wiring hanging loose that is not supported. I recommend properly securing the wiring.

Contact a qualified electrical contractor.

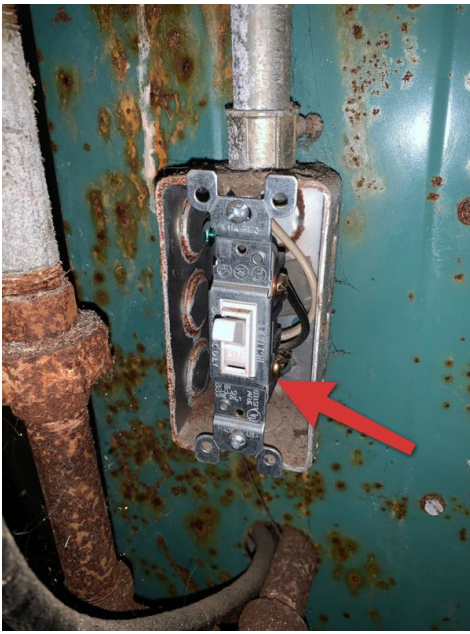
COVER PLATE MISSING

SEVERAL LOCATIONS

There were missing cover plates. This can expose the hot terminals which could cause short and shock risk. This may also create an issue during the appraisal process. I recommend installation of cover plates in all areas that are missing them.

Contact a handyman or DIY project

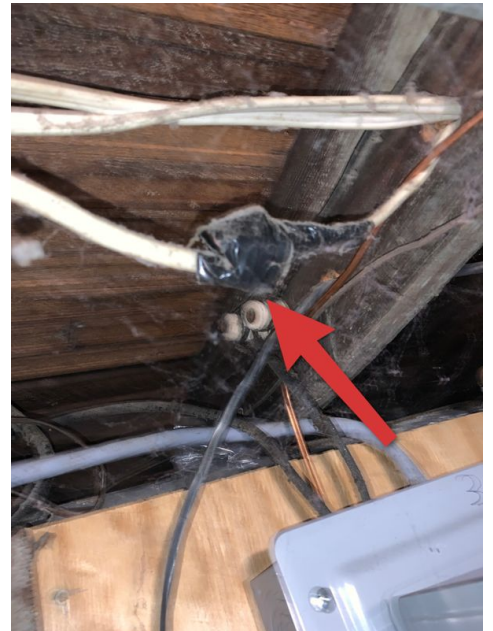
8.6.2 Lighting Fixtures, Switches & Receptacles

WIRING CONNECTIONS NOT IN JUNCTION BOX

BASEMENT

There was a wiring connection that was not in a junction box. This can expose live wiring and create a shock hazard. This may also be a problem during the appraisal process. I recommend enclosing all wiring connections inside of a junction box to prevent accidental shock hazards.

Contact a qualified electrical contractor.

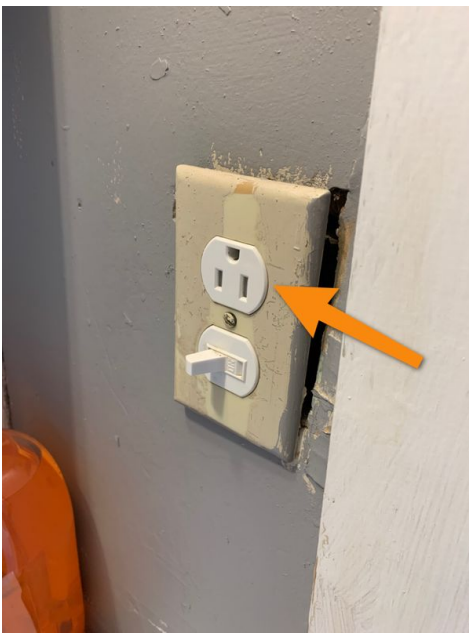
8.6.3 Lighting Fixtures, Switches & Receptacles

NO POWER TO OUTLET

3RD FLOOR BATHROOM

An outlet did not register as being energized with an outlet tester or multimeter. It is possible that there was a switch that was not located. I recommend verifying proper operation with the seller. If proper operation can't be verified, I recommend having a qualified electrician troubleshoot and make necessary repairs.

Contact a qualified electrical contractor.

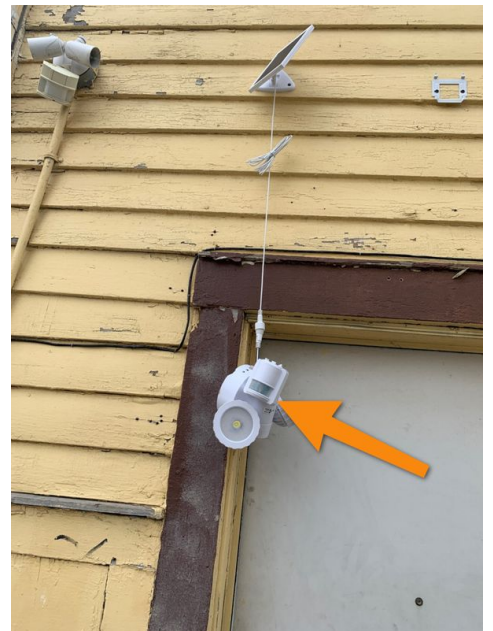
8.6.4 Lighting Fixtures, Switches & Receptacles

DAMAGED LIGHT

A light fixture has physical damage. I recommend repair/replacement.

Contact a qualified handyman.

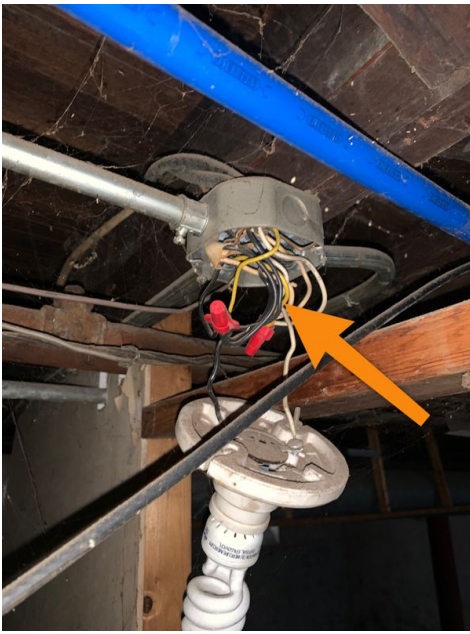
8.6.5 Lighting Fixtures, Switches & Receptacles

LOOSE LIGHT FIXTURE

A fixture is loose. I recommend securing the fixture properly.

Contact a handyman or DIY project

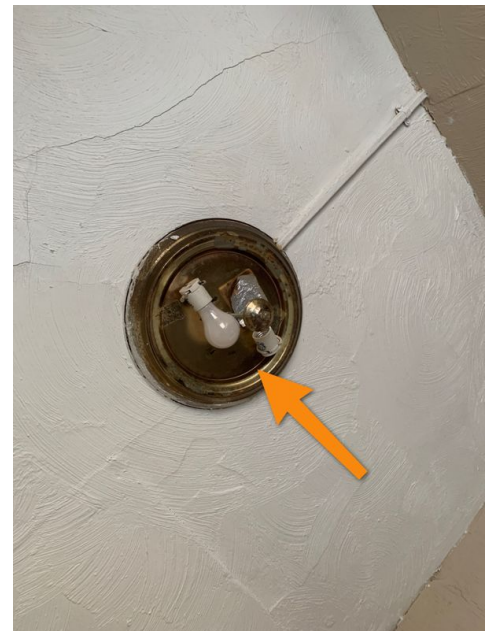
8.6.6 Lighting Fixtures, Switches & Receptacles

MISSING LIGHT GLOBE

SEVERAL LOCATIONS

The globe was missing on an interior light fixture. This can make it easier to accidentally break a bulb. I recommend replacing the globe.

Contact a handyman or DIY project

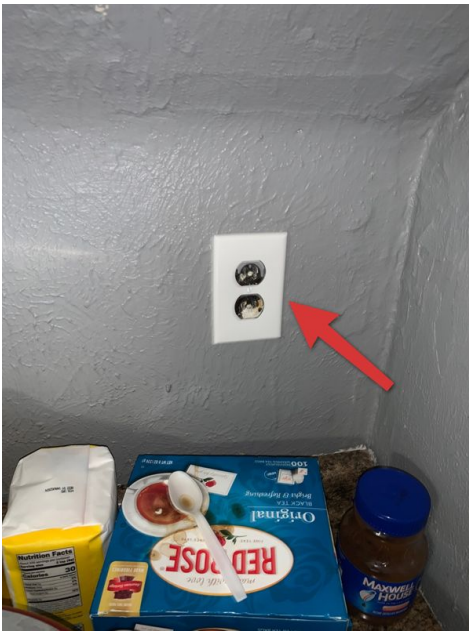
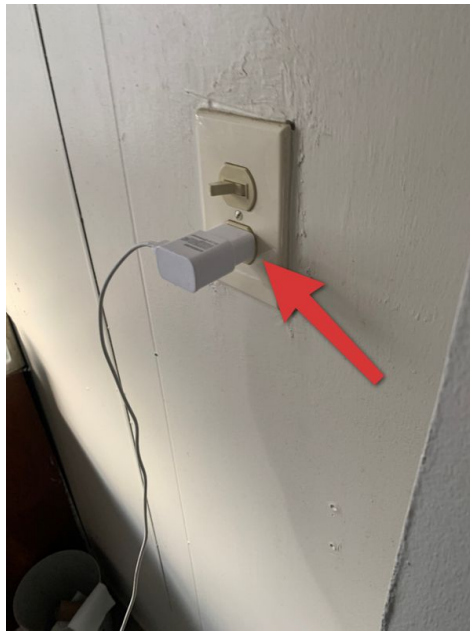
8.7.1 GFCI & AFCI

NO GFCI PROTECTION INSTALLED

3RD FLOOR KITCHEN, 1ST FLOOR 2ND FLOOR BATHROOM

An outlet in a required area did not have GFCI protection. Although GFCI protection may not have been required at the time the building was built, for safety reasons, it is recommended that electrical receptacles located in basements, crawlspaces, garages, the exterior, and interior receptacles located within 6 feet of a plumbing fixture be provided with ground fault circuit interrupter (GFCI) protection in good working order to avoid potential electric shock or electrocution hazards. I recommend installing GFCI protection in any required areas.

Contact a qualified electrical contractor.

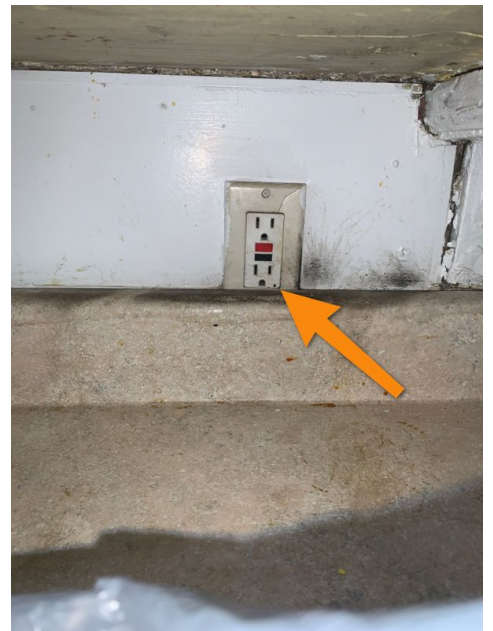
8.7.2 GFCI & AFCI

GFCI INOPERABLE- WON'T SUPPLY POWER

A GFCI outlet is inoperable. The outlet was not supplying power at the time of inspection and would not reset. It is common for GFCI outlets to fail after a period of years and it is likely that it simply needs replaced. It is also possible that there is a GFCI upstream that is tripped or a switch that is turned off. I recommend evaluation/correction.

Contact a qualified electrical contractor.

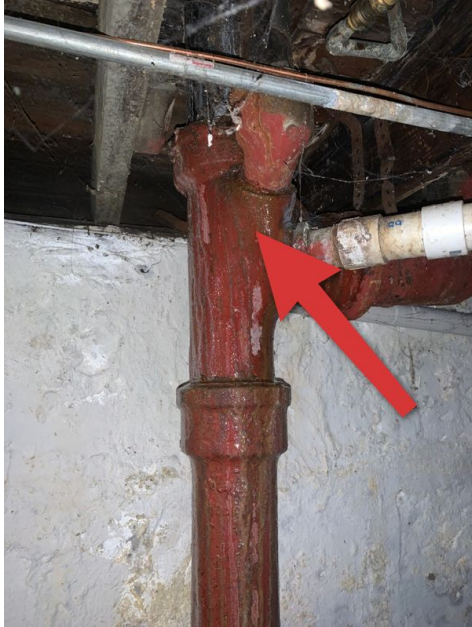
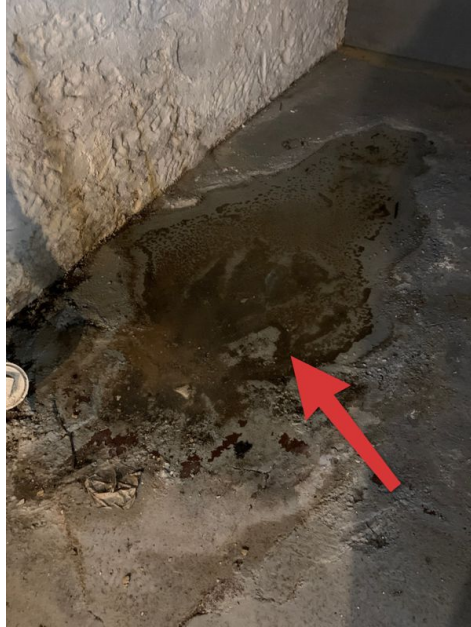
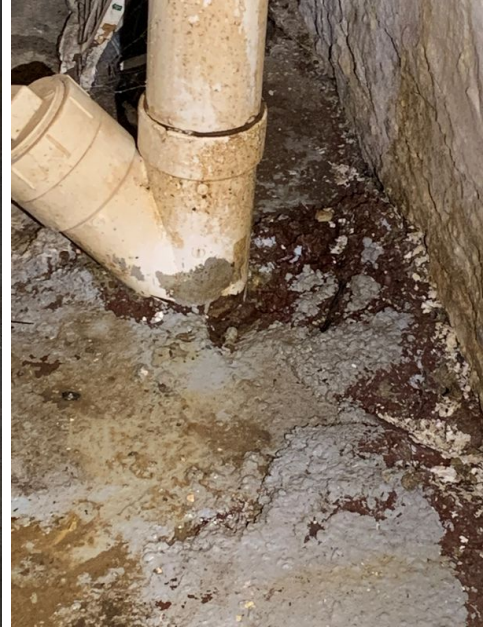
9.2.1 Drain, Waste, & Vent Systems

LEAKING DRAIN PIPE

A drain pipe was leaking. I recommend properly repairing the leak and replacing any damaged materials.

Recommendation
Contact a qualified plumbing contractor.

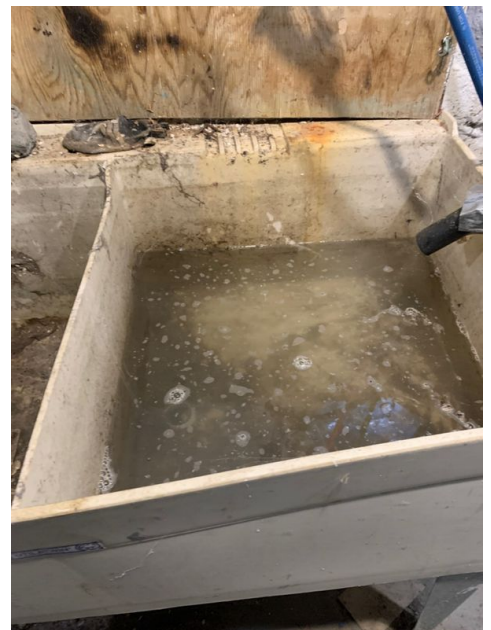
9.2.2 Drain, Waste, & Vent Systems

SINK - SLOW DRAIN

UTILITY TUB, 1ST FLOOR BATHROOM

A sink had slow/poor drainage. Typically this is due to hair or other buildup in the trap. I recommend evaluation/repair.

Recommendation
Contact a qualified plumbing contractor.

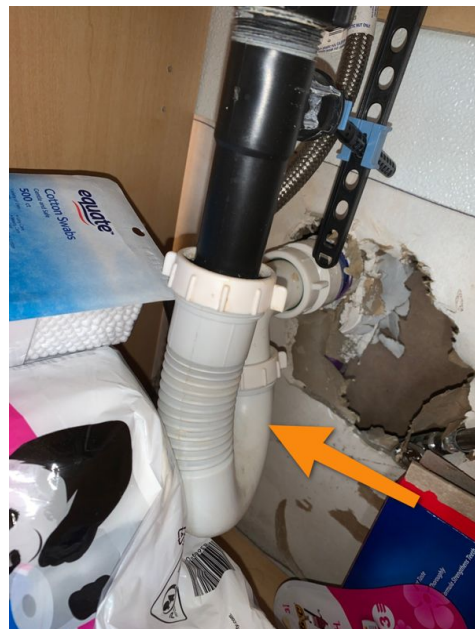
9.2.3 Drain, Waste, & Vent Systems

FLEX LINE USED FOR DRAIN

3RD FLOOR BATHROOM

There was flexline used for a drain line on a fixture. Flex lines are more prone to collecting material which could lead to backups. I recommend replacing flex lines with straight pipes.

Recommendation
Contact a qualified plumbing contractor.

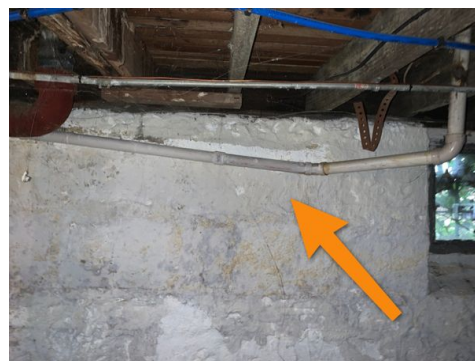
9.2.4 Drain, Waste, & Vent Systems

DRAIN LINE RUNS UPHILL

A drain line was improperly installed. The line was running uphill. This can prevent proper drainage and lead to leaks and clogs. I recommend evaluation/correction.

Recommendation
Contact a qualified plumbing contractor.

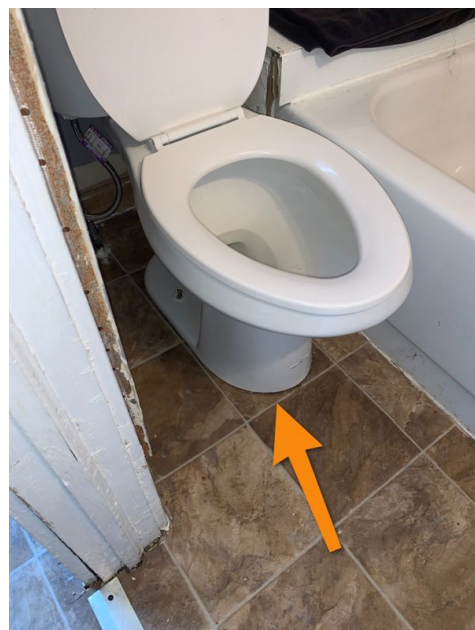
9.3.1 Water Supply, Distribution Systems & Fixtures

TOILET LOOSE

Toilet is loose from floor mounting bolts. This could lead to a future leak. I recommend tightening the toilet and replacing the wax ring and any rotted wood if necessary.

Recommendation
Contact a qualified plumbing contractor.

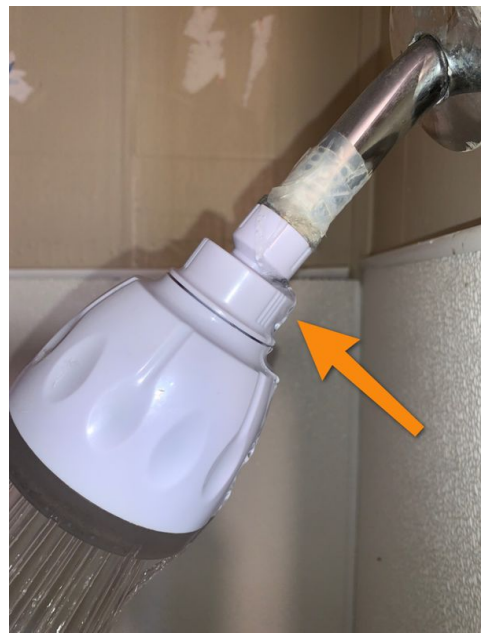
9.3.2 Water Supply, Distribution Systems & Fixtures

LEAK FROM SHOWER HEAD

1ST FLOOR BATHROOM

There is water leaking from the connection to the shower head. I recommend repair or replacement.

Recommendation
Contact a handyman or DIY project

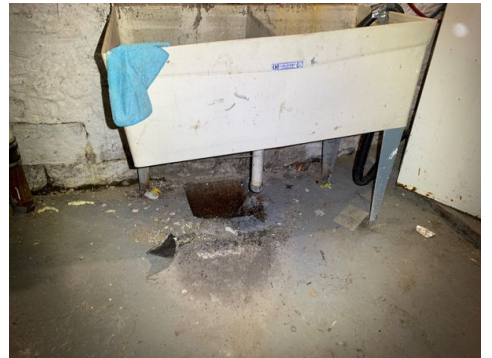
9.3.3 Water Supply, Distribution Systems & Fixtures

UTILITY TUB MISSING LEG

The basement utility tub is missing a leg. This will cause the tub to crack and or come loose from the wall. I recommend replacement of the utility tub by a plumbing contractor.

Recommendation
Contact a qualified plumbing contractor.

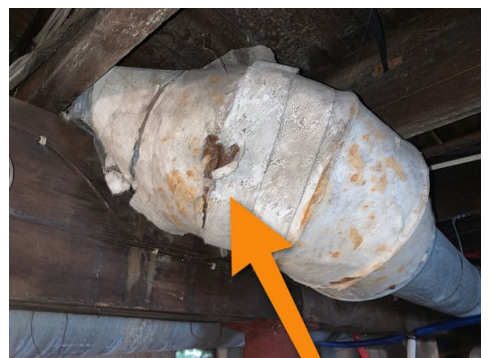
10.4.1 Distribution Systems

LIKELY ASBESTOS -DUCT TAPE-TORN/RIPPED

There was tape on the ducts that likely contains asbestos. The tape is torn in areas. This can release asbestos fibers into the air. I recommend evaluation and correction by an asbestos abatement contractor.

Recommendation
Contact a qualified professional.

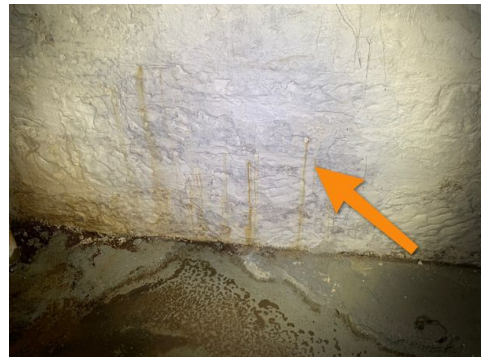
12.1.1 Foundation

STAINING ON BASEMENT WALLS-NO OBSERVED MOISTURE

There is some staining on the basement walls. Usually when there is staining to basement walls it is due to moisture in the soil wicking through the block. Sometimes there is no visible moisture present with these type of stains but it is also possible that there was prior leakage. There was no elevated moisture at the time of inspection. I recommend requesting additional information from the sellers to verify if there was any history of water intrusion or dampness. If additional information is not available I recommend monitoring and making adjustments to drainage or grading as necessary.

Contact a qualified general contractor.

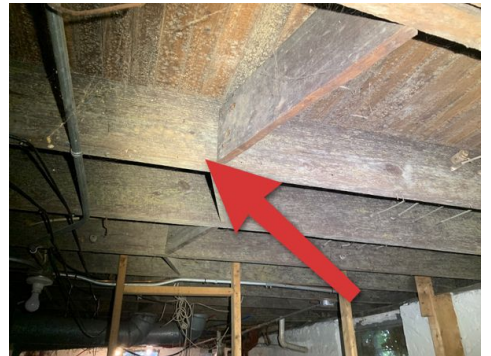
12.4.1 Floor Structure

LIKELY MOLD-BASEMENT

There were areas of possible/likely mold found in the basement. I recommend correcting any moisture source and cleaning/replacing any affected materials.

Contact a qualified mold remediation contractor
