Home Inspection Report

5235 Wedgewood Media Ohio 44256

Ambassador Construction Consultants LLC.

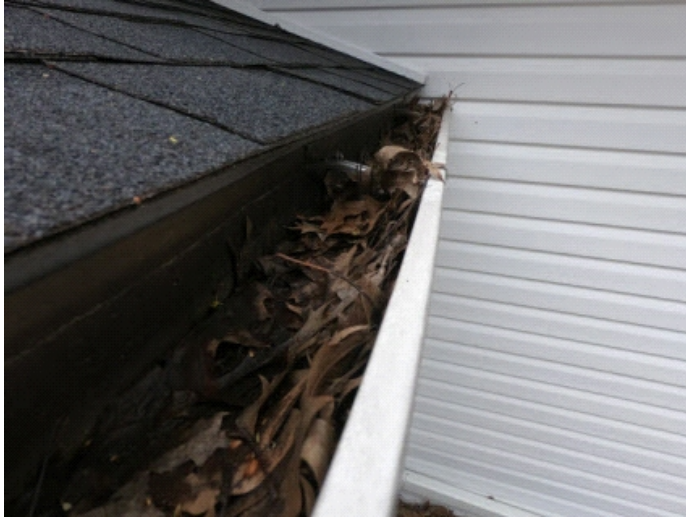
Gutters and downspouts need maintenance, cleaning and or adjustments.

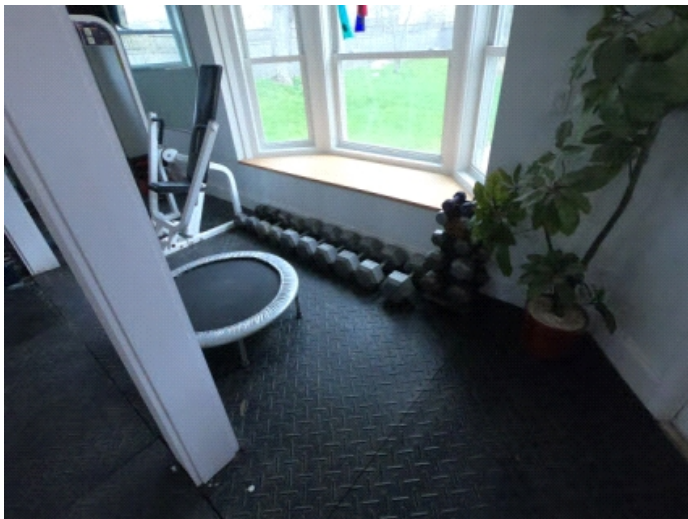
Windows may need cleaning to check to make sure if seals are good.

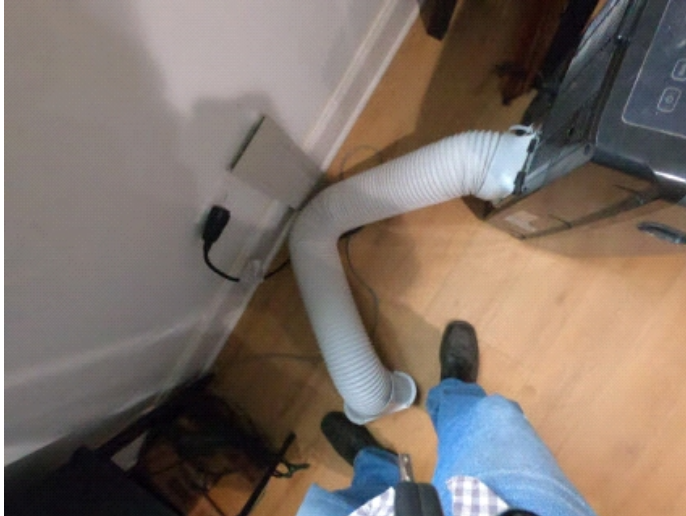
Garage second floor may need supplemental AC.

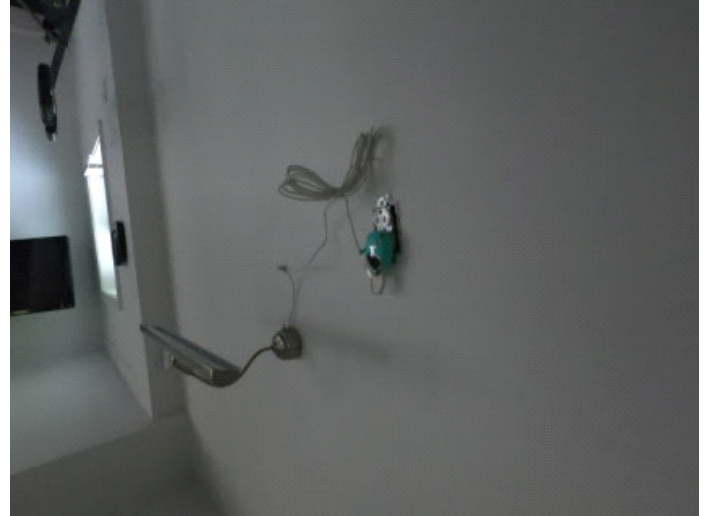
Some electrical outlets need cover plates

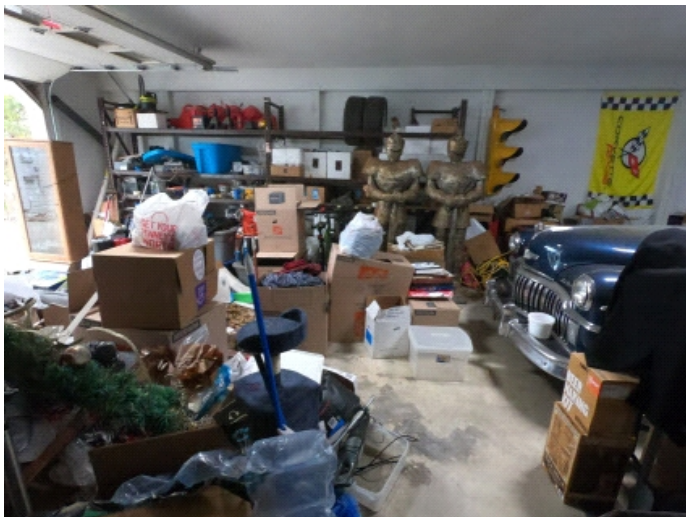
Main garage as all finished walls and ceilings.
Some floor stains.
Room full 90%.
Garage is a pole barn construction.

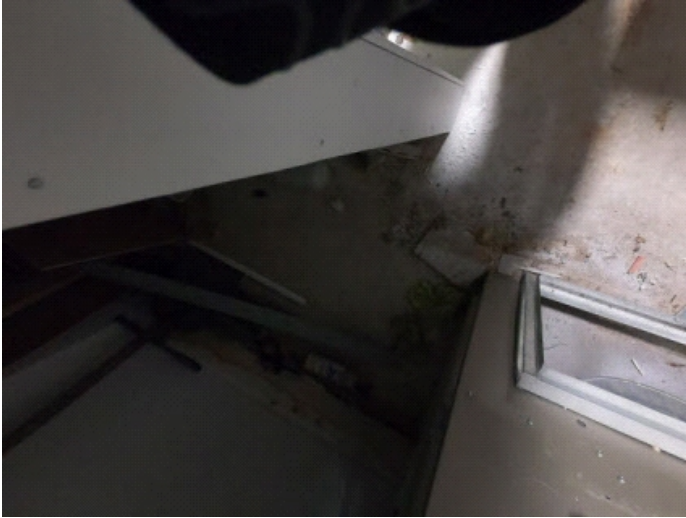
HVAC ductwork may need cleaning and filter.

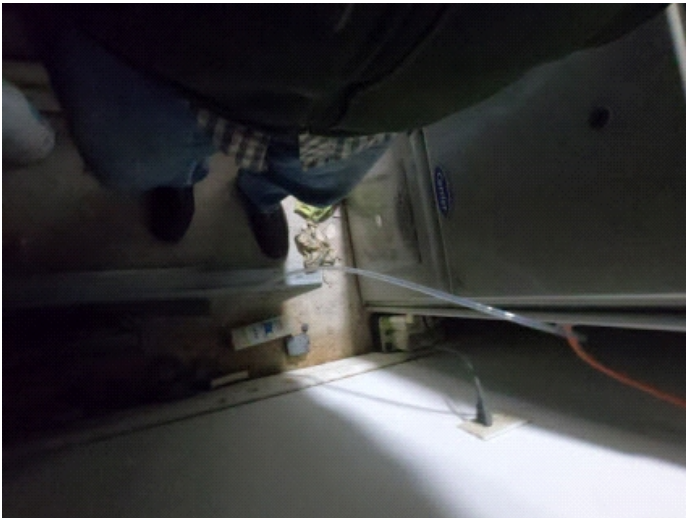
Furnace discharge drain is not connected.

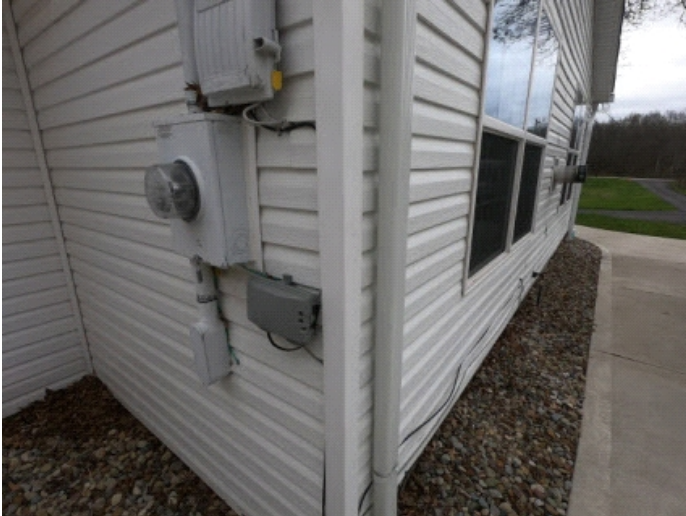
The main electrical meter.

Phone, cable, Internet, low voltage, Wi-Fi and other subsystems not inspected or evaluated.

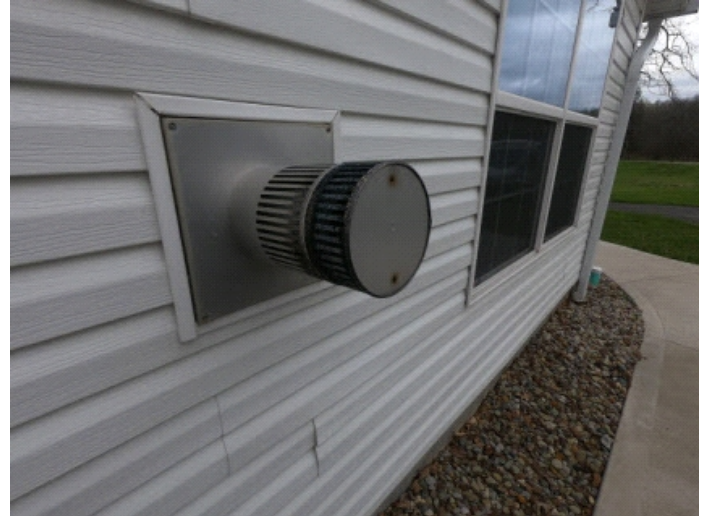
Gas fireplace need to be inspected tested and certified prior to use.

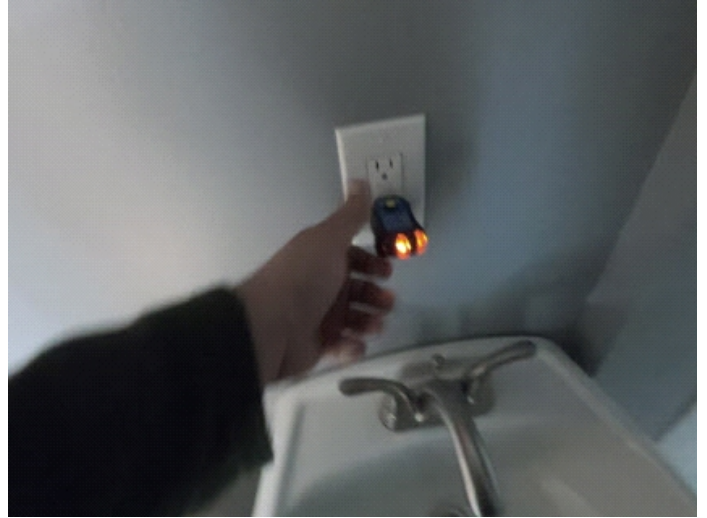
Outlets properly function.

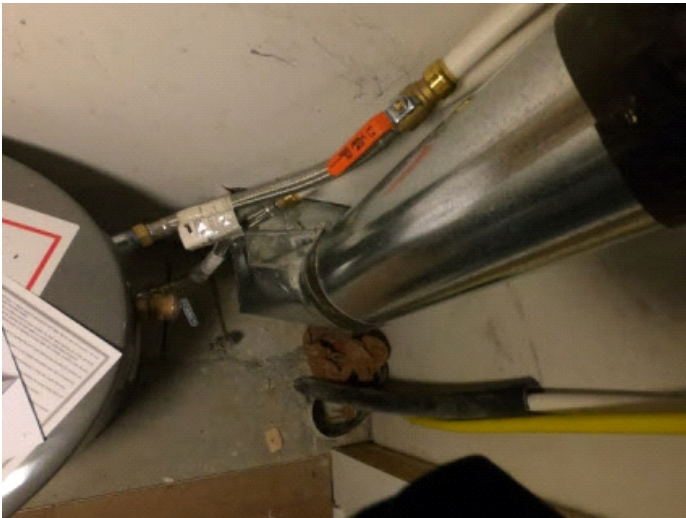
Small electric hot water heater located in garage.
No floor drain in this utility closet.

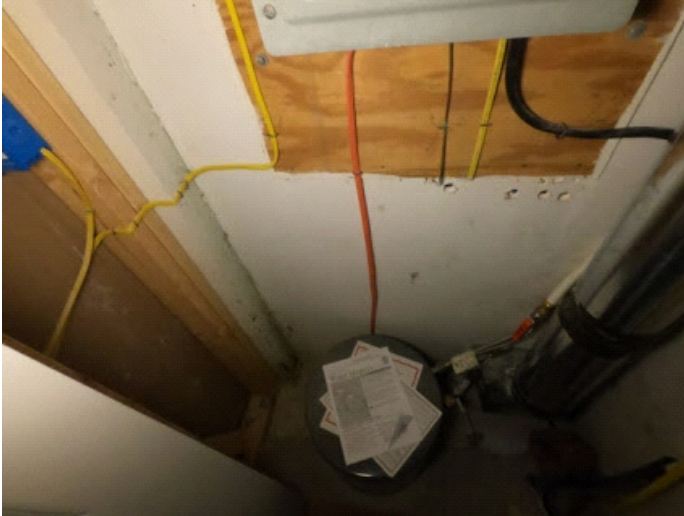
Electrical should be in conduit.

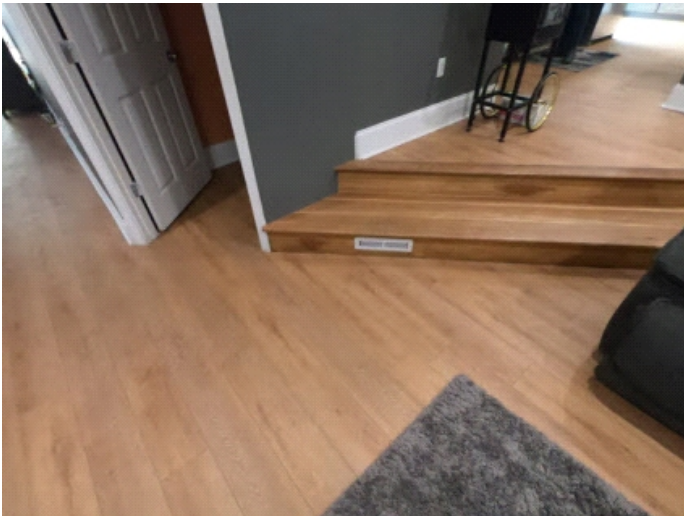
No access under steps or crawlspaces or under slab's.

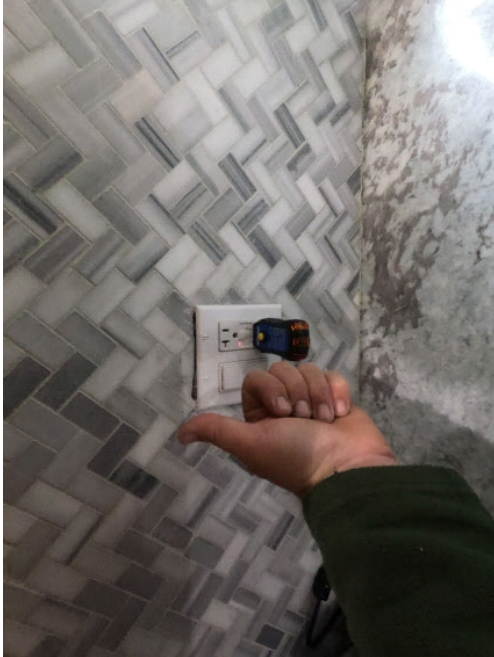
GFI's properly function.

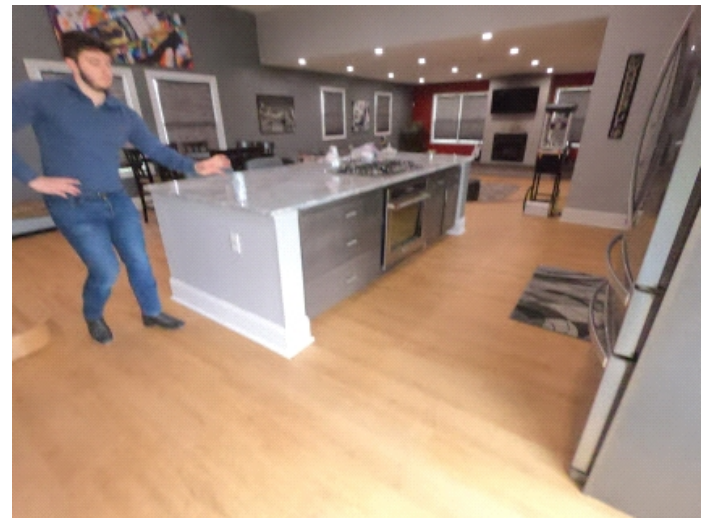
Floors appear to be in a shape.

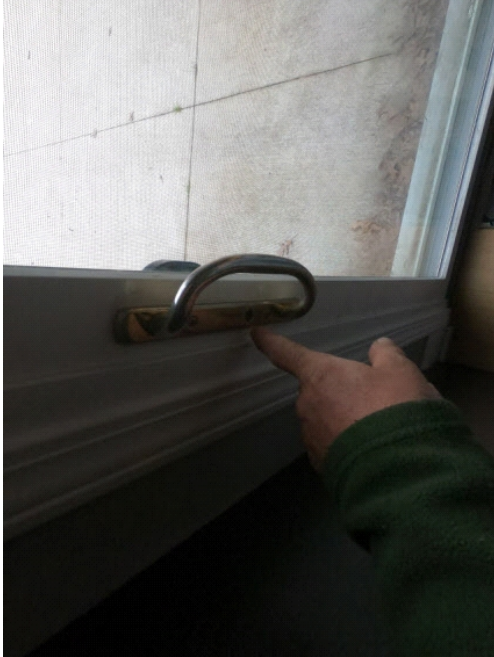
Sliding door lock needs adjustment.

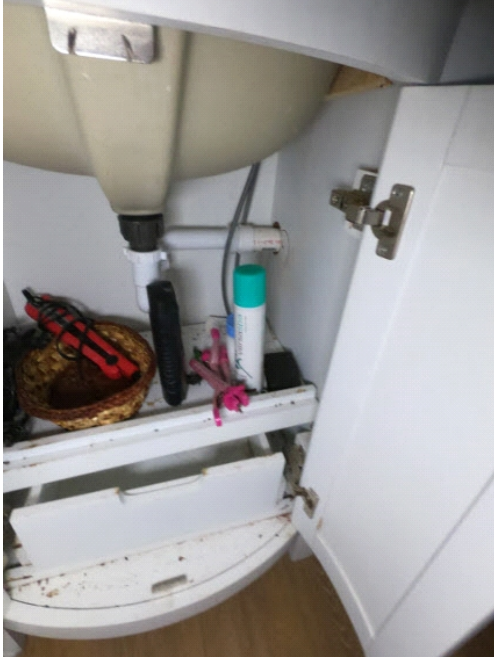
Drain needs adjustment.

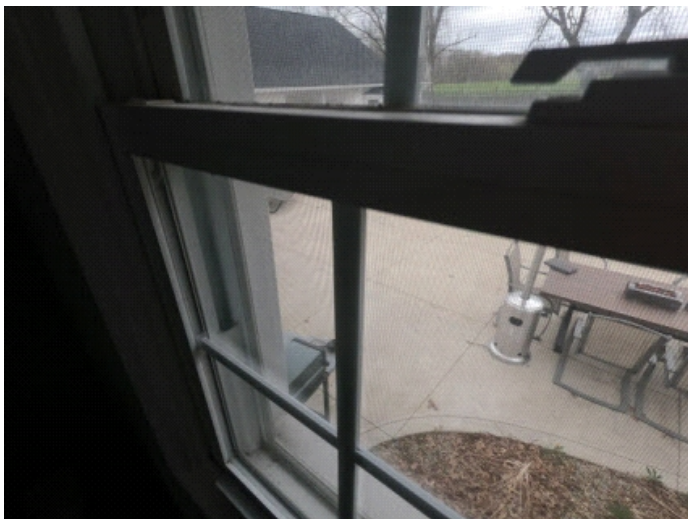
Most screens intact.

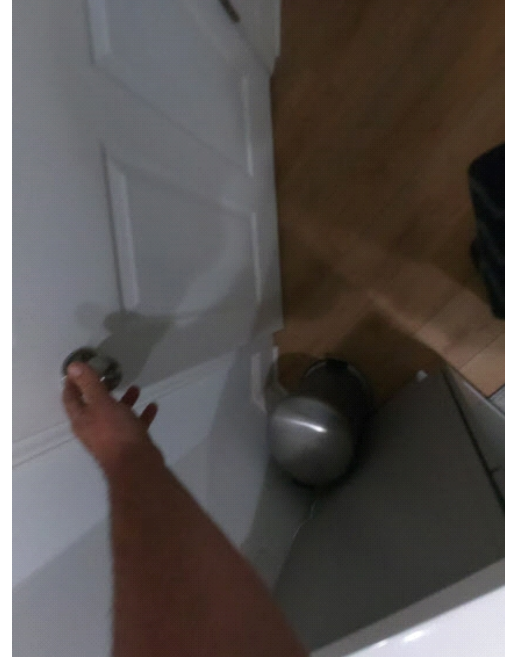
Doors were functional. Some doors may need adjustments.

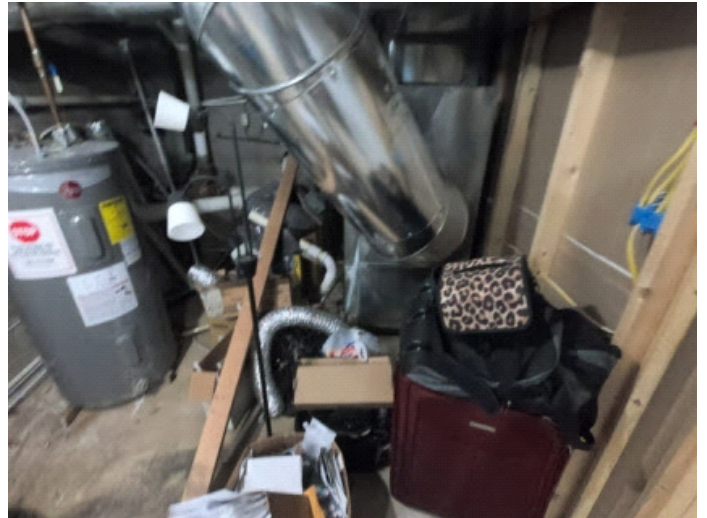
Sylvester things close to HVAC units.
No drain pans for electric water heaters.

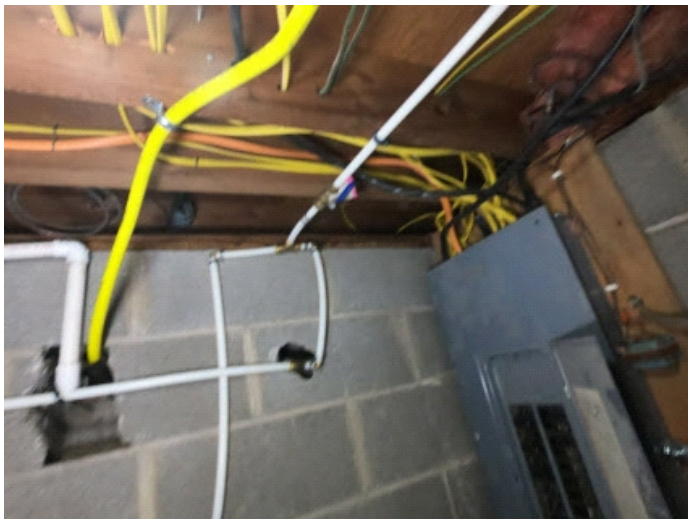
Plastic, PEX and copper domestic plumbing.

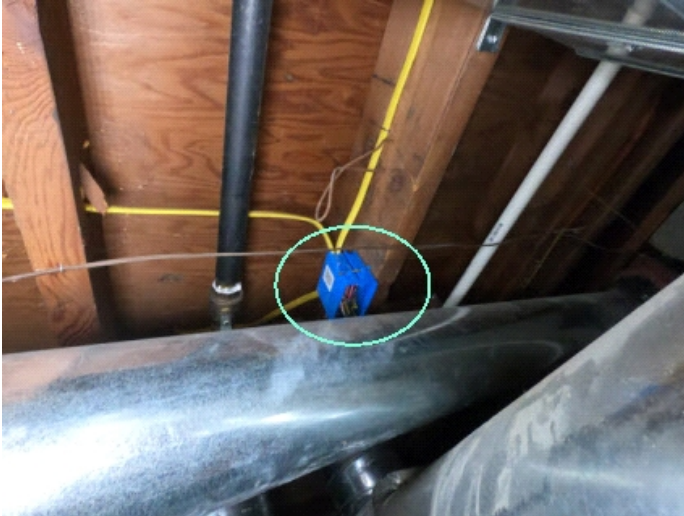
Numerous areas have sloppy wiring or require cover plates.

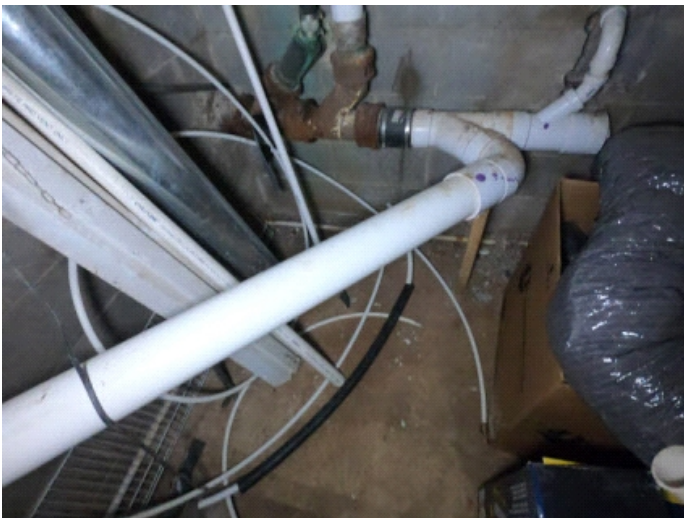
Most drains were PVC.

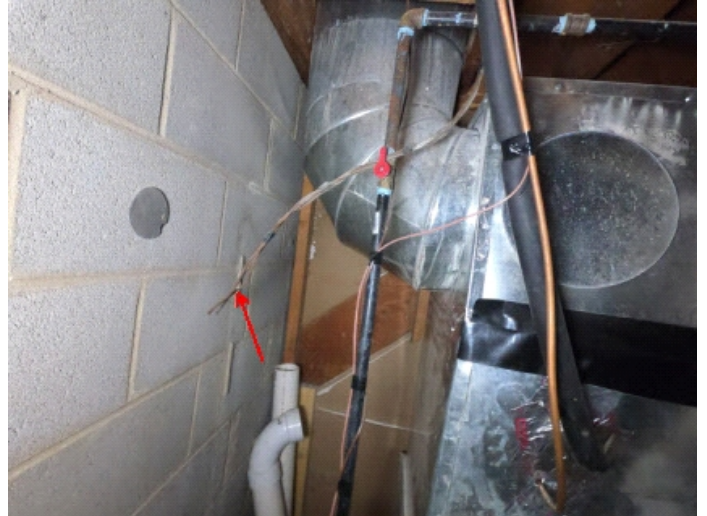
Unknown low-voltage. low voltage, phone, cable and other subsystems not evaluated.

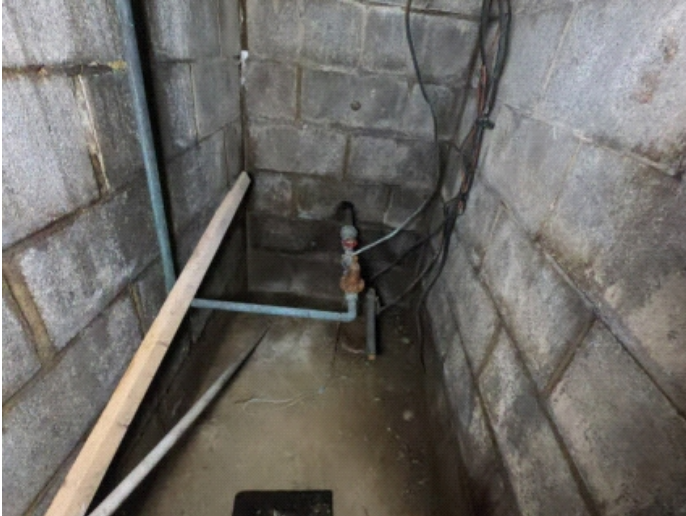
Main water line with pressure reducer.

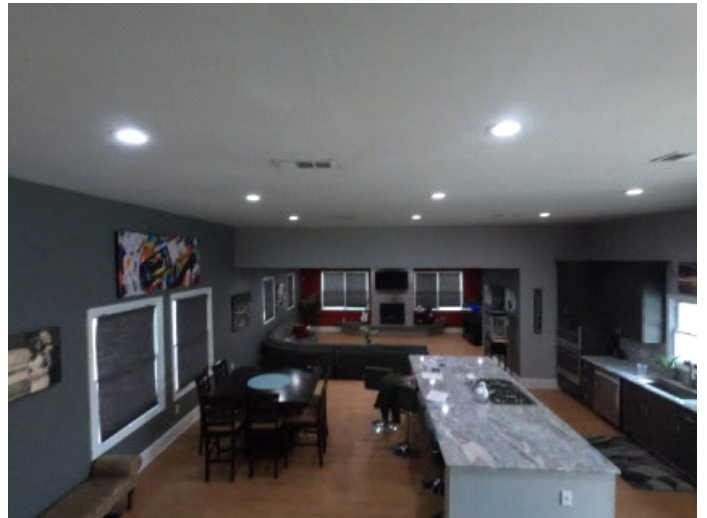
Sometimes can't recessed lights or ceiling penetrations contribute to heat loss to the unconditioned attic space. This can create or contribute to winter ice dams.

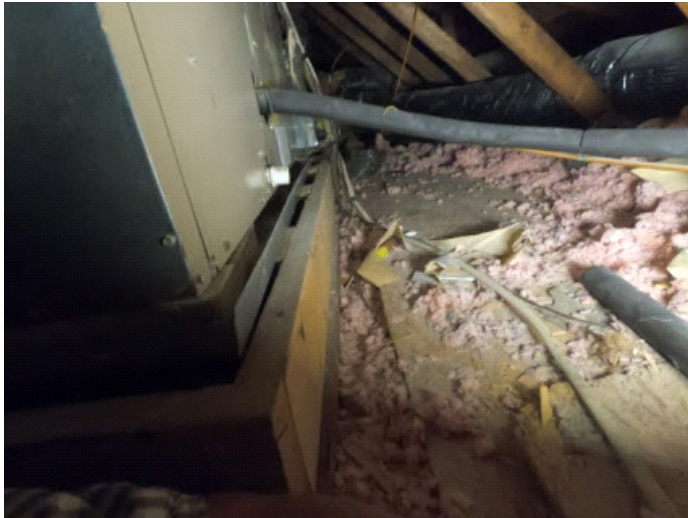
Attic partially floored.
