## Inspection Tech Home Inspection Report

**620 Oak St**

**Medina, OH 44256**

Inspected on Mon, Sep 11 2017 at 12:30 PM

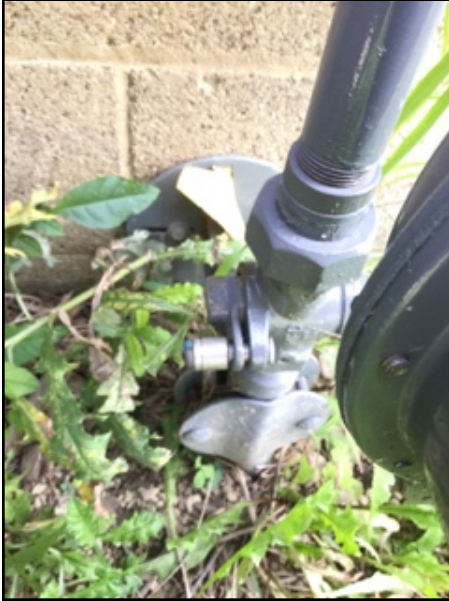
Figure 1-1

Gas shut off at meter. Unable to inspect gas mechanicals.

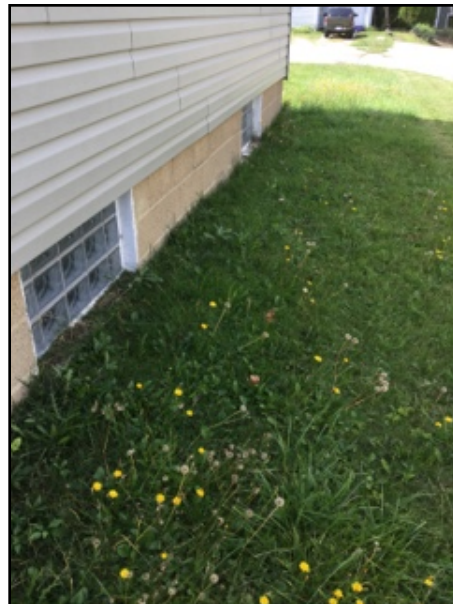
Figure 8-2

Negative grade at exterior of house. Recommend additional backfill.

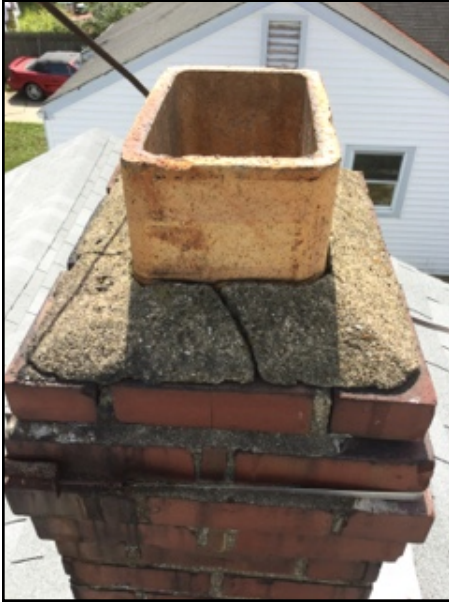
Figure 12-1

Comment 12:  
Cracks at chimney cap. Recommend repair.  
Missing weather cap. Recommend repair.

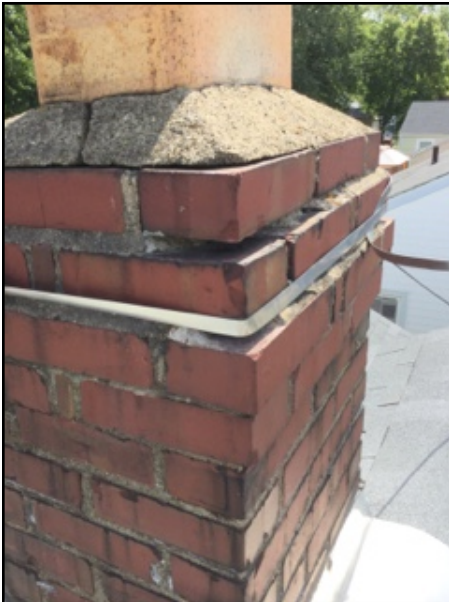
Figure 13-1

Comment 13:  
Tuck pointing needed at chimney. Recommend repair.

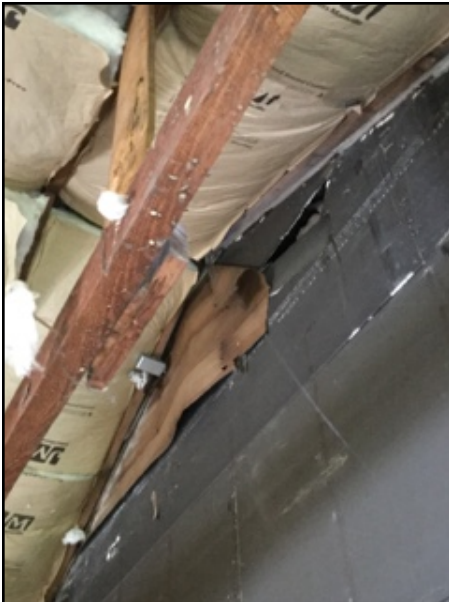
Figure 16-1

Comment 16:  
Damaged drywall at ceiling leading into attic space. Not complete firewall.  
Recommend repair.

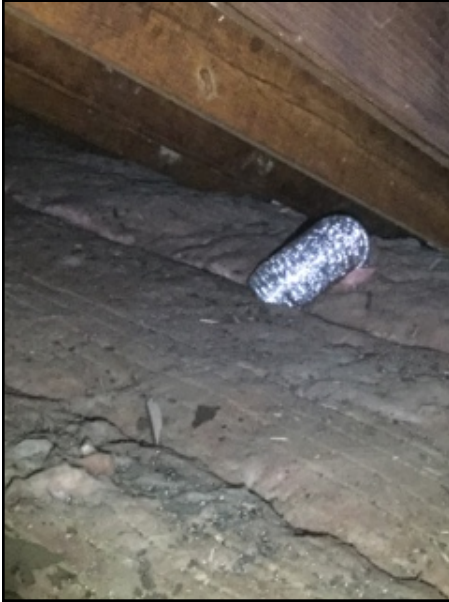
Figure 21-1

Bathroom exhaust vents into attic space. Recommend venting to outside to prevent moisture issues.

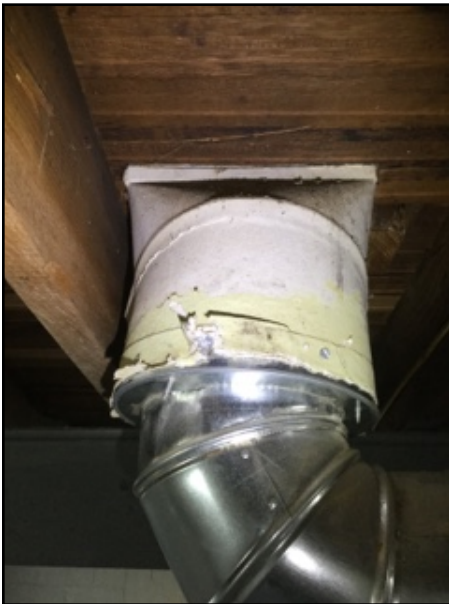
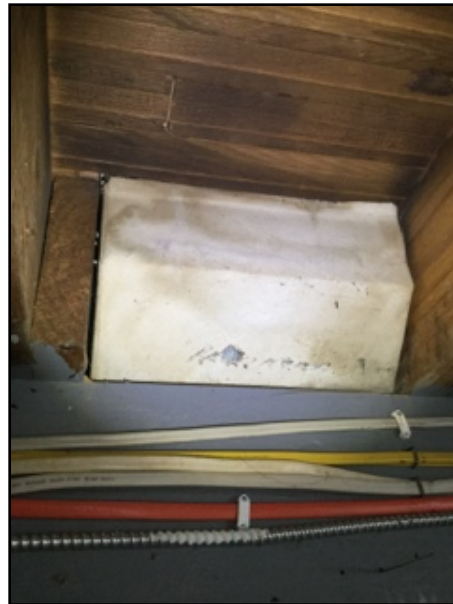
Heating ducts may have asbestos wrapping. Do not disturb.

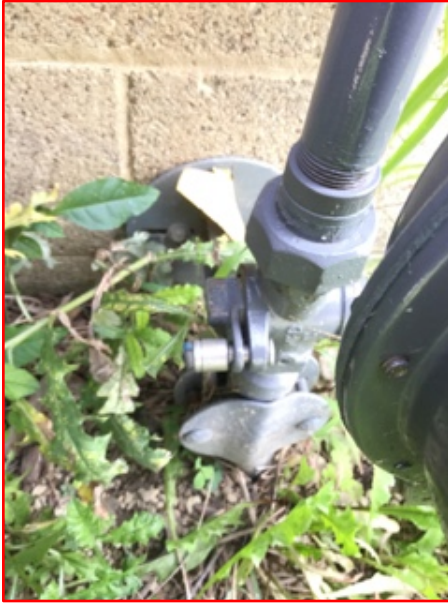
Figure 1-1

1) Gas shut off at meter. Unable to inspect gas mechanicals.

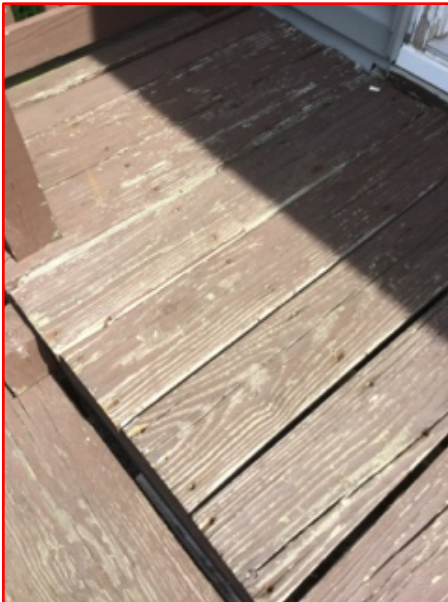
Figure 2-1

2) Porch is weathered and needs paint or stain. Recommend repairs.

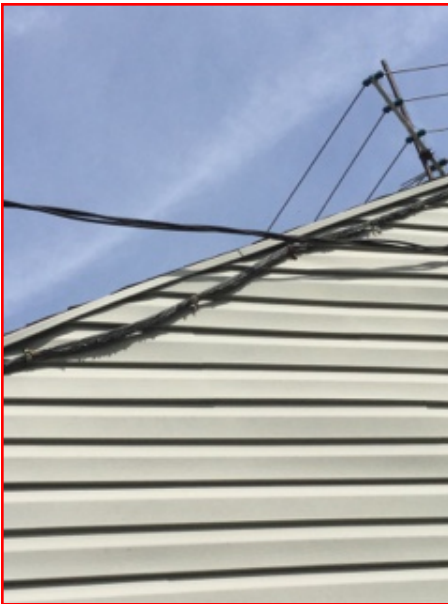
Figure 4-1

4) Insulation at service line is deteriorating. Recommend repair.

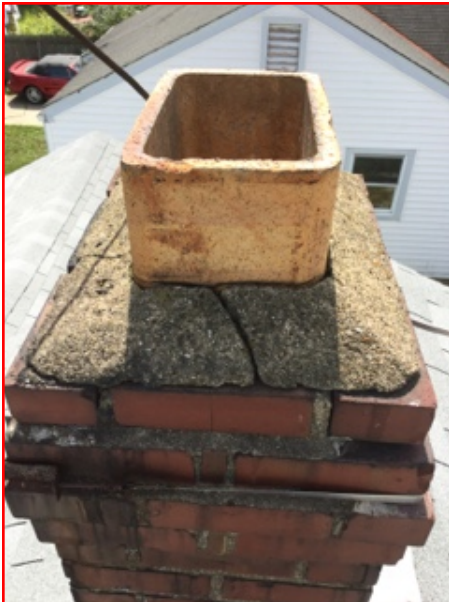
Figure 12-1

12) Cracks at chimney cap. Recommend repair.  
Missing weather cap. Recommend repair.

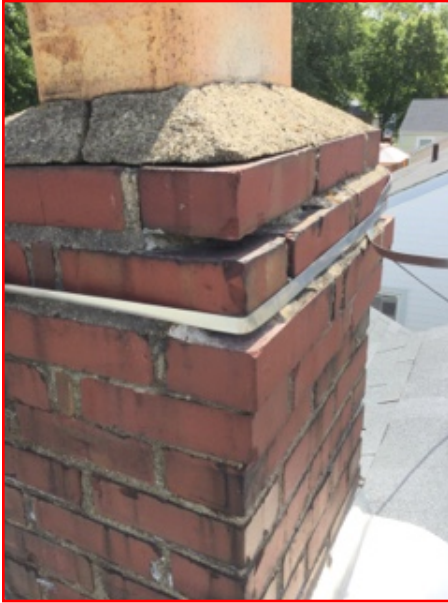
Figure 13-1

13) Tuck pointing needed at chimney. Recommend repair.

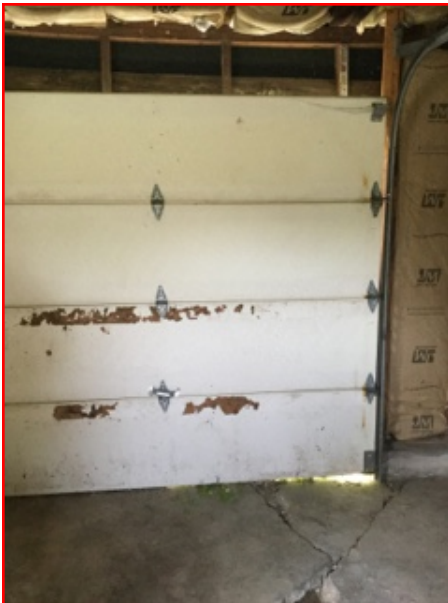
Figure 14-1

14) Garage door did not open properly. Recommend adjusting.

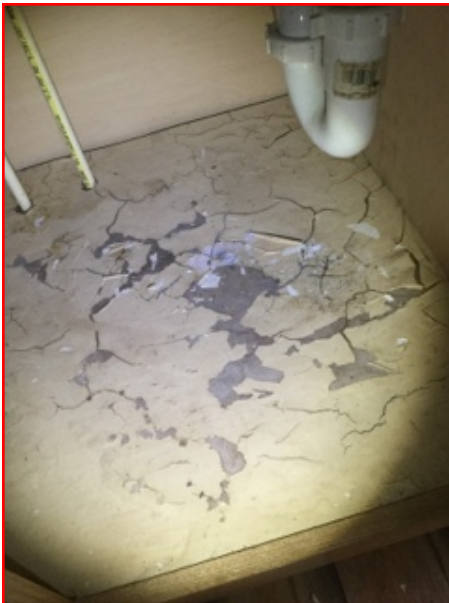
Figure 32-1

32) Base of cabinet has deteriorated. Recommend repair.

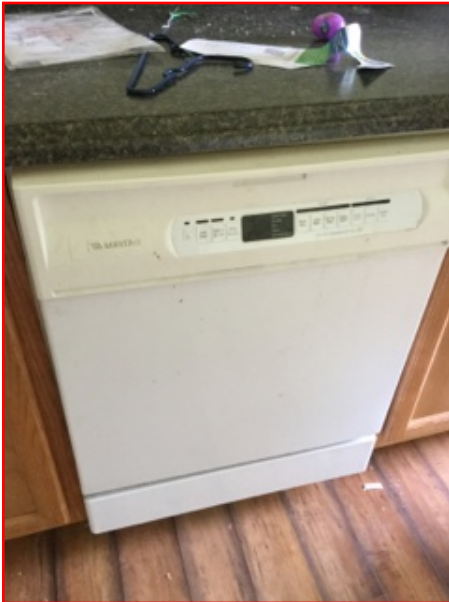
Figure 35-1

34) Dishwasher did not operate. Recommend repair.

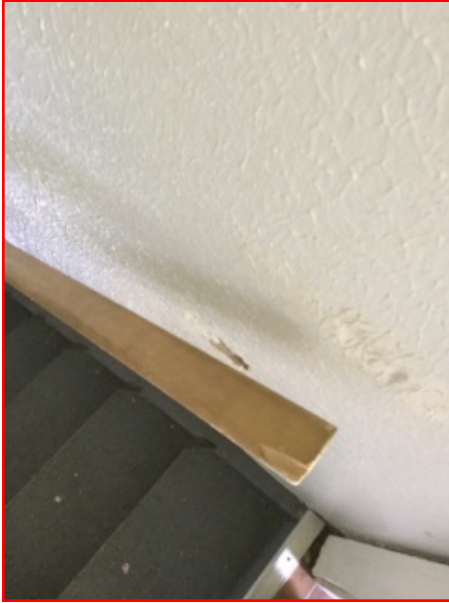
Figure 37-1

35) Missing hardware at railing. Safety Hazard. Recommend repair.

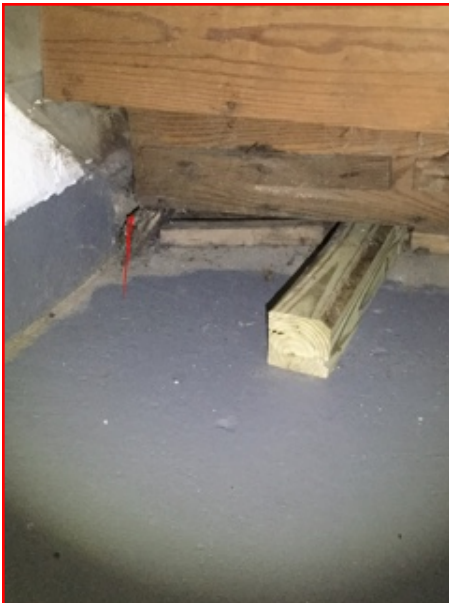
Figure 38-1

36) Damage present at bottom step. Recommend repair.

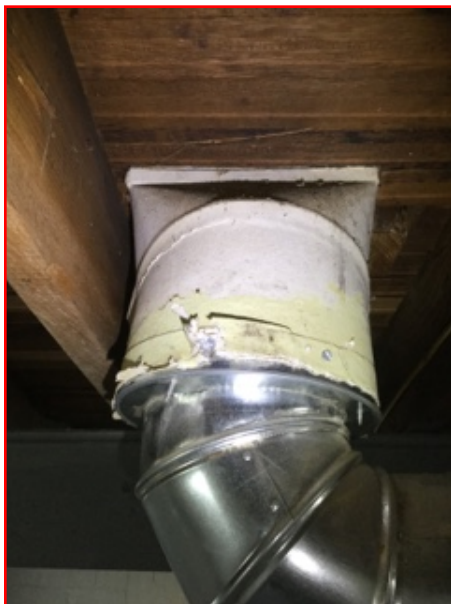
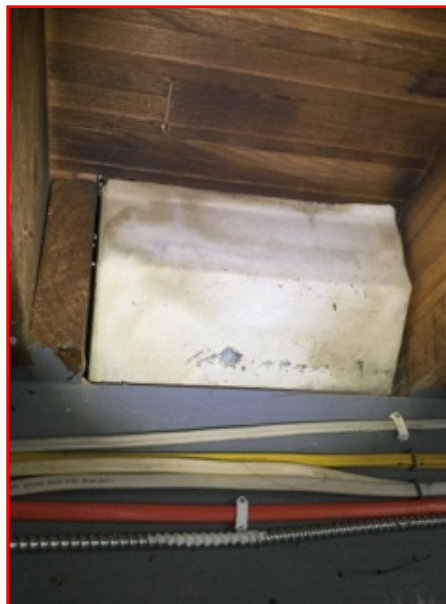
37) Heating ducts may have asbestos wrapping. Do not disturb.

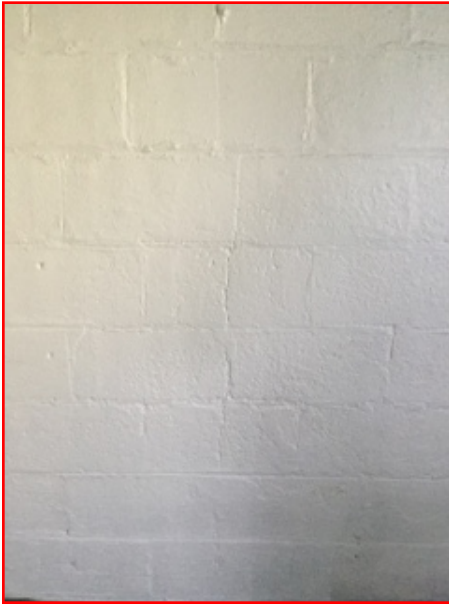
Figure 40-3

38) Typical vertical cracks. No movement noted. Recommend monitor and repair as needed.

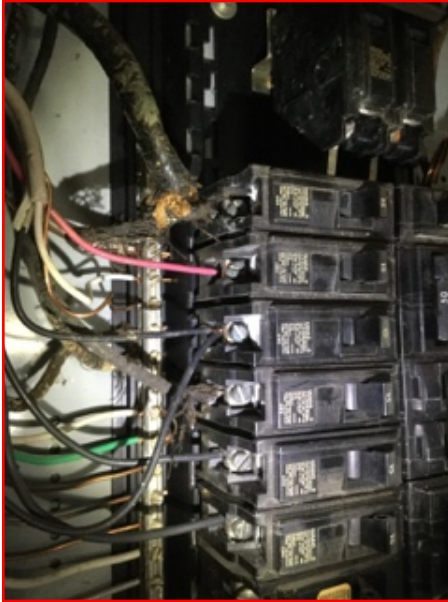
Figure 44-1

40) Double tapping present at breakers in main electrical panel. Recommend repair.

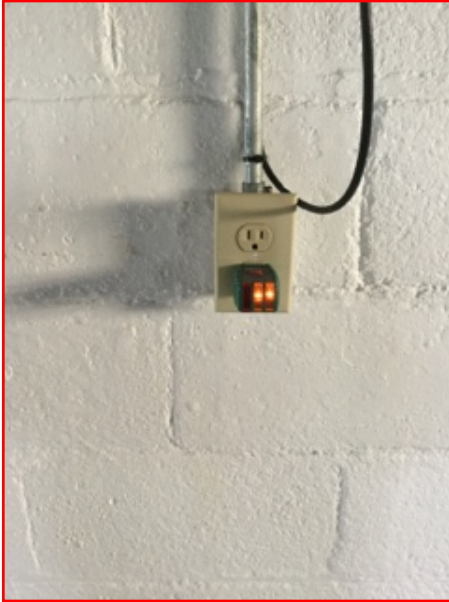
Figure 46-1

42) Outlet is grounded but is not GFCI protected. Safety Hazard. Recommend replace with GFCI outlets.

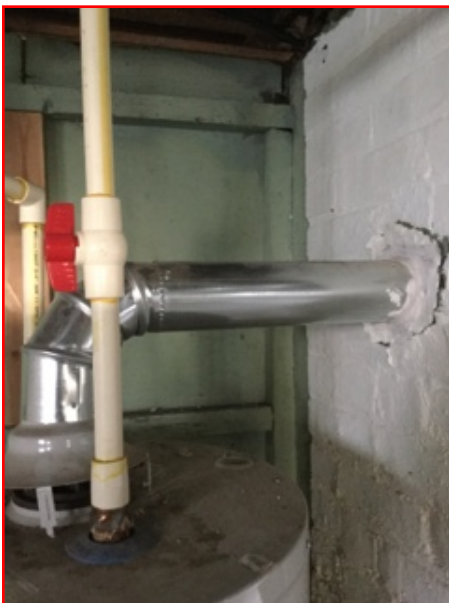
Figure 48-1

43) Metal Vent Pipe has improper pitch. Safety Hazard. Recommend repair or replace.

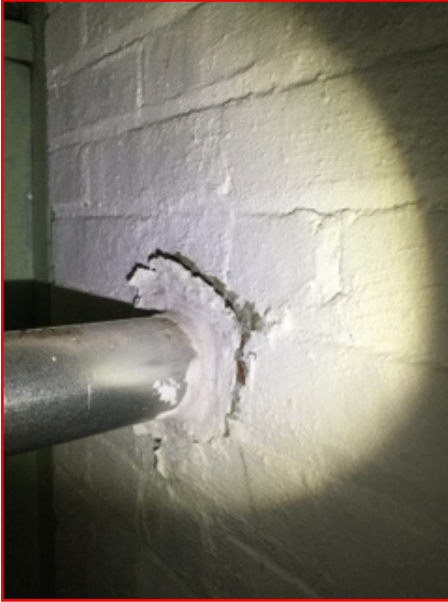
Figure 49-1

44) Water heater vent pipe is not properly sealed at chimney. Safety Hazard. Recommend repair.

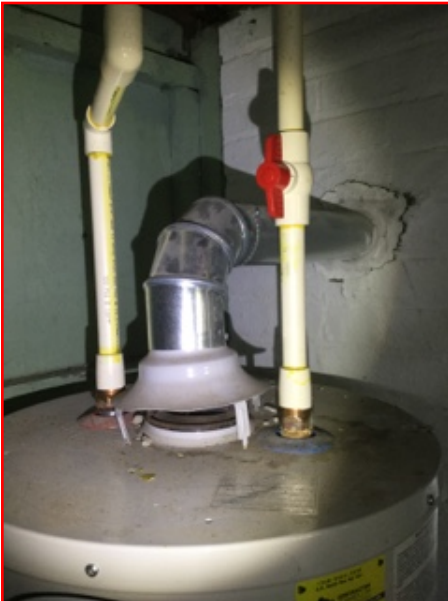
Figure 50-1

45) Improper piping material at water heater. Recommend repair.
