Home Inspection Report

5235 Wedgewood Media Ohio 44256

Ambassador Construction Consultants LLC.

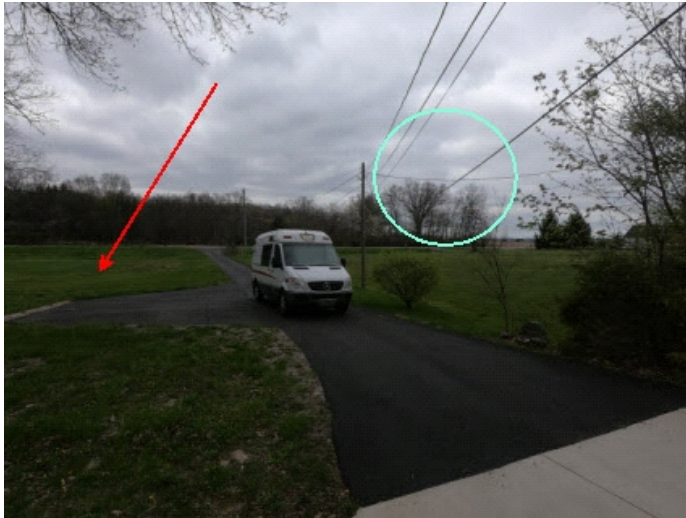
Phone line a bit low.

Front yard has low spot. Possible wet area or ponding water during peak rain falls.

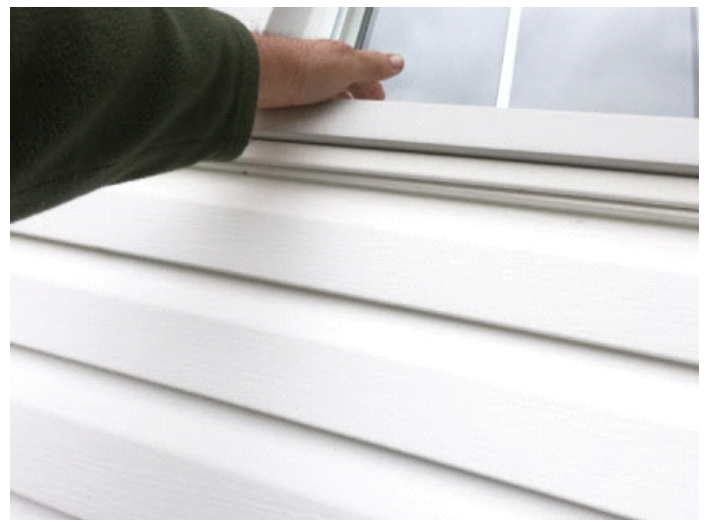
Newer windows.
Newer siding.

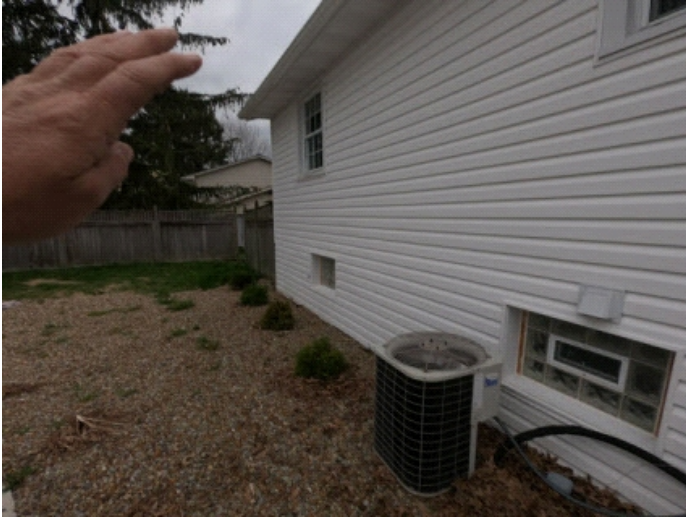
AC unit is roughly 13 years old.
The home has mostly older appliances.
We recommend getting an appliance warranty.

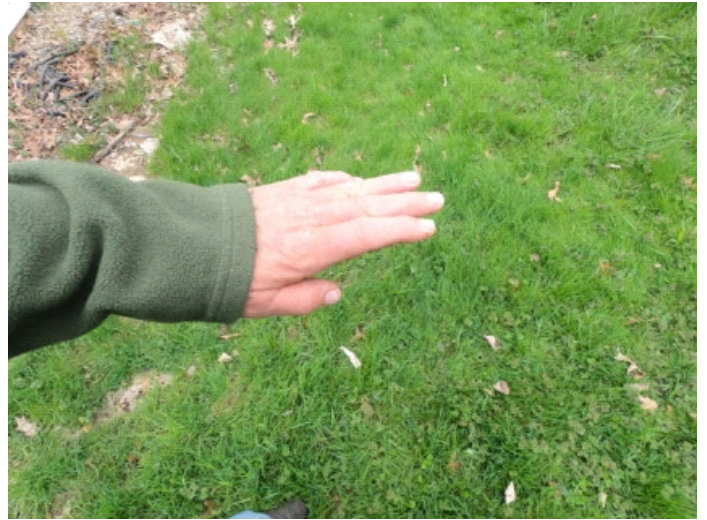
Some low spots in grass areas.

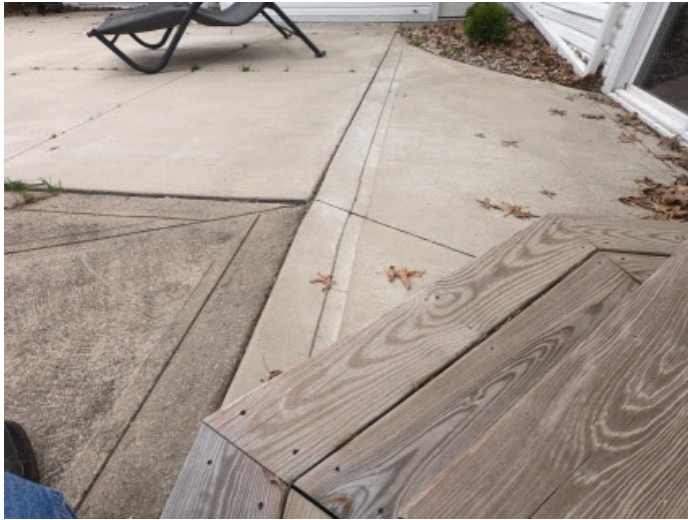
Grading this rather flat.

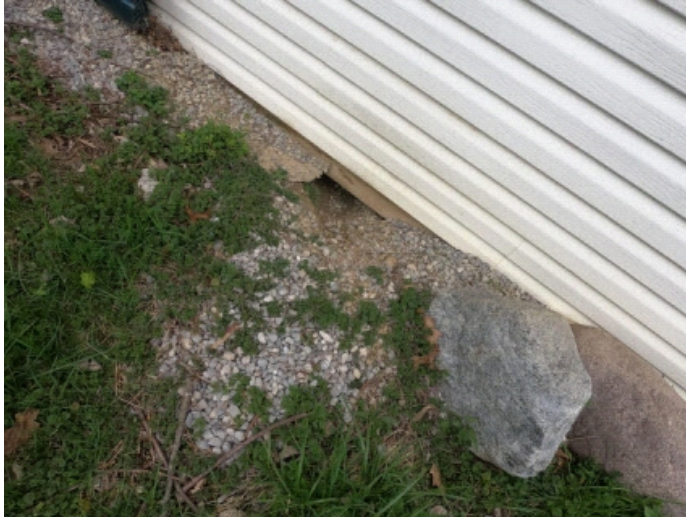
Groundhogs digging under pole barn.

10. The pole barn structure has groundhogs digging and undermining. We recommend you employ a trapper to remove groundhogs and fill groundhog holes. We recommend you control mice indoors. This home is located in an area that is susceptible to field mice. We recommend you control ants and other insects. We recommend you employ a pest company to perform regular maintenance for pests, vermin, insects, etc.

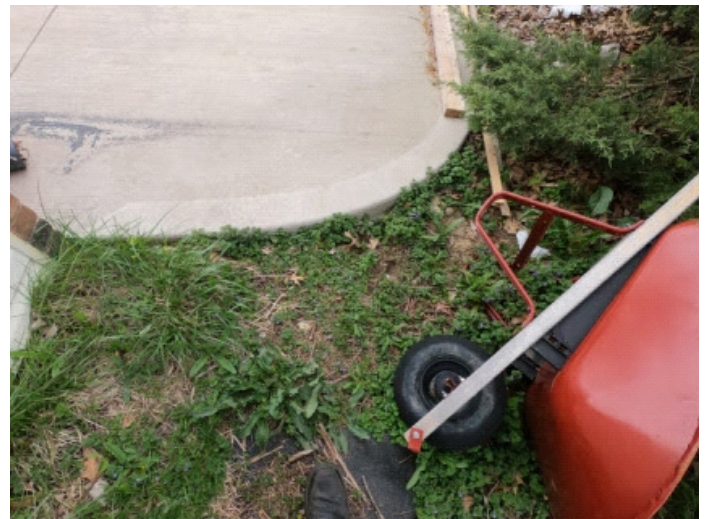
Newer concrete.

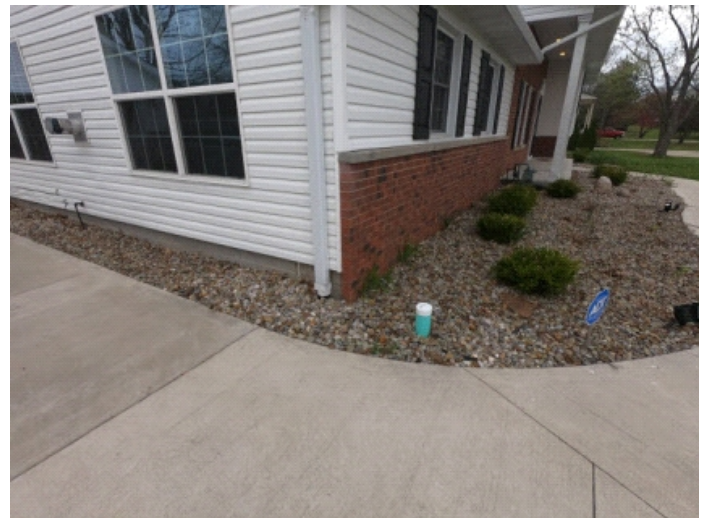
Landscaping nice.

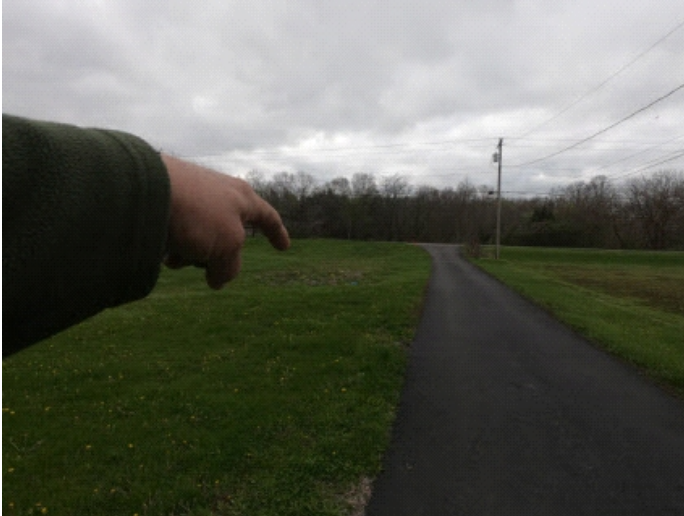
Asphalt pavement is functional and may require sealcoating from time to time.
Small parking area was older concrete with asphalt cover.
May need to add some type of yard drainage front property.

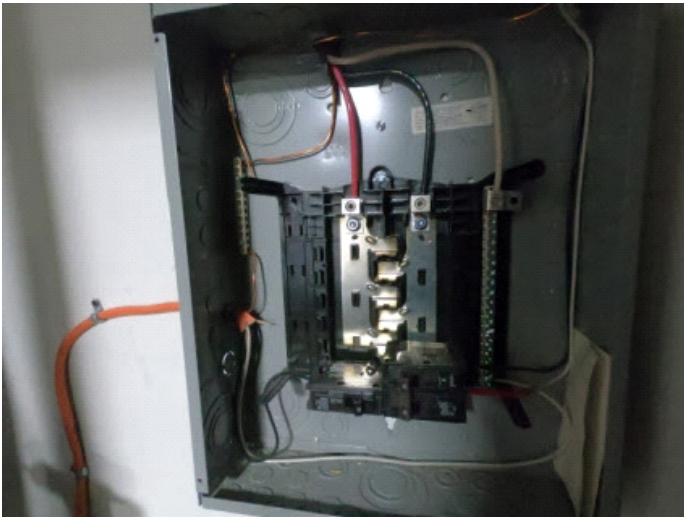
Garage electrical panel. Panel has some room.

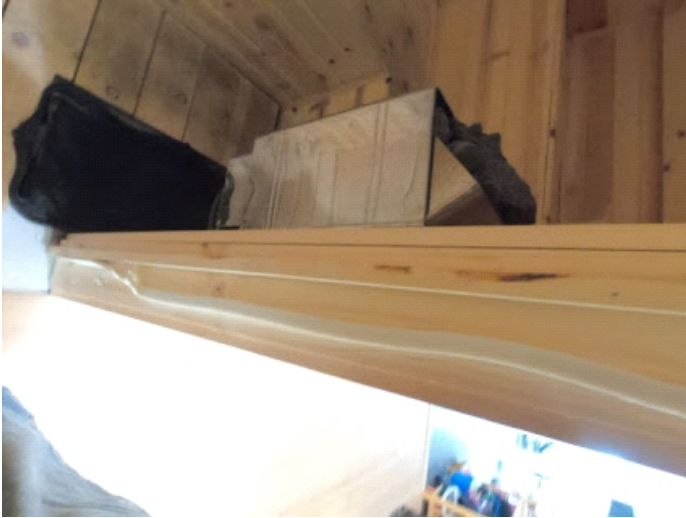
Sauna not tested nor inspected.

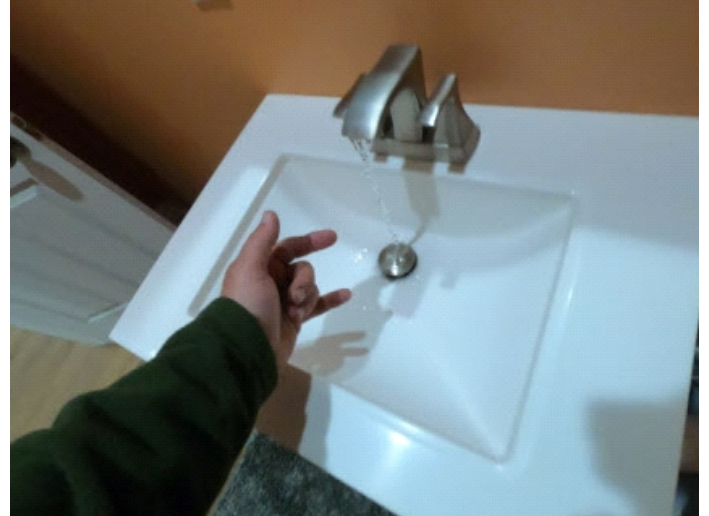
Water pressure a bit low at this particular sink.

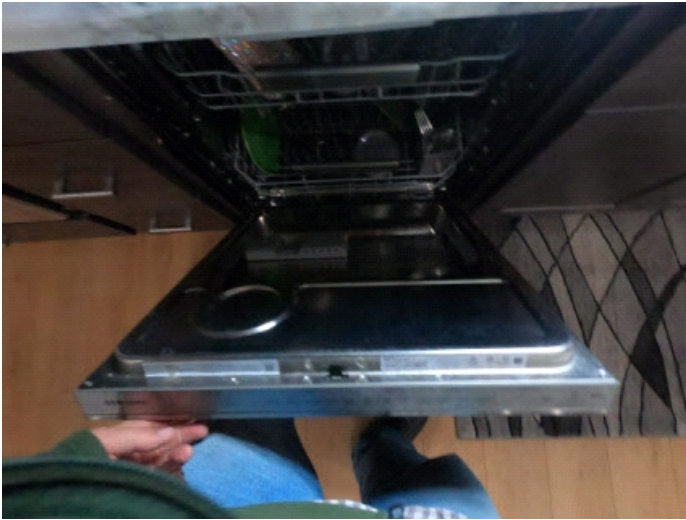
Recommend getting an appliance warranty.

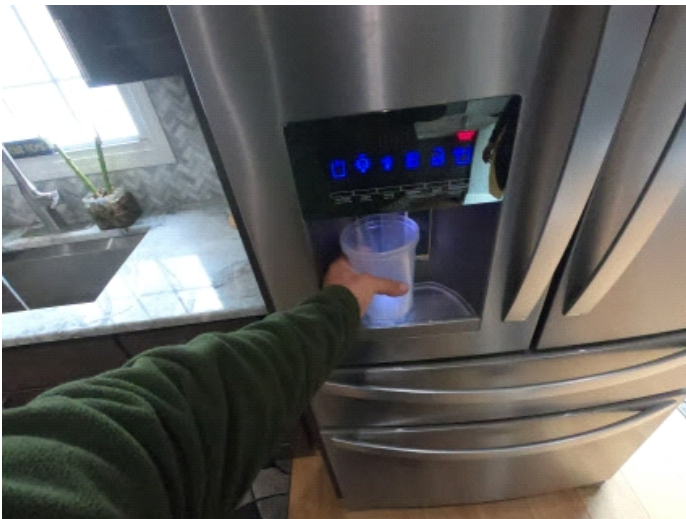
Works.

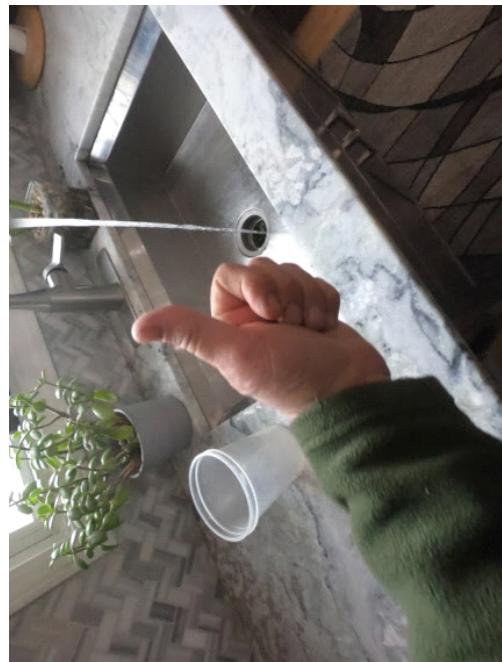
Disposal works.

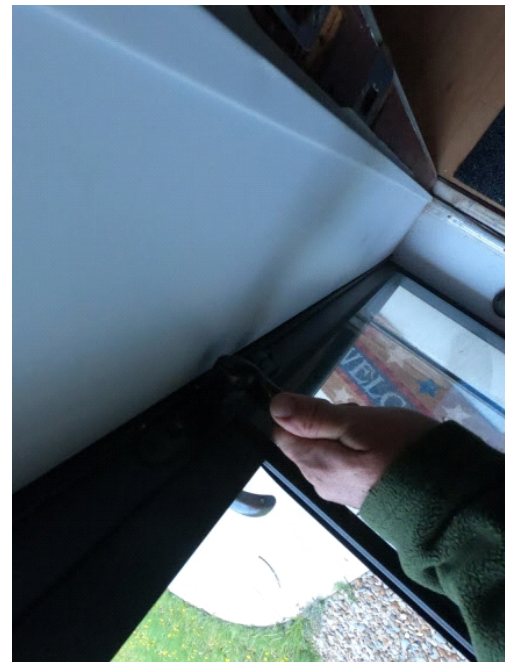
Locks need adjustment.

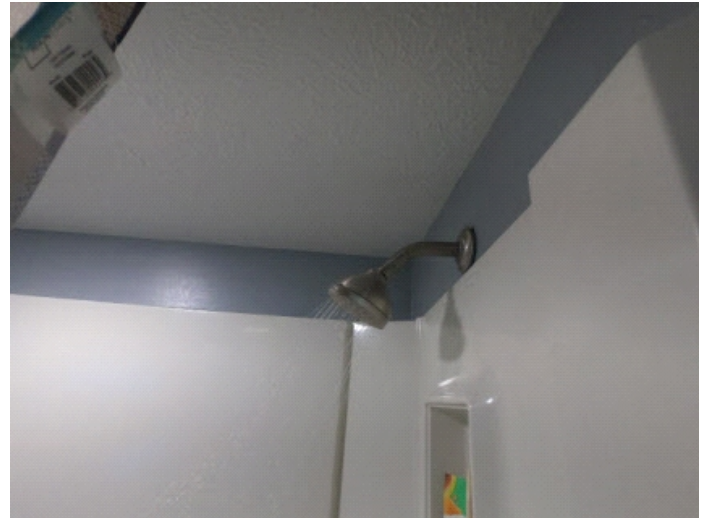
Works.

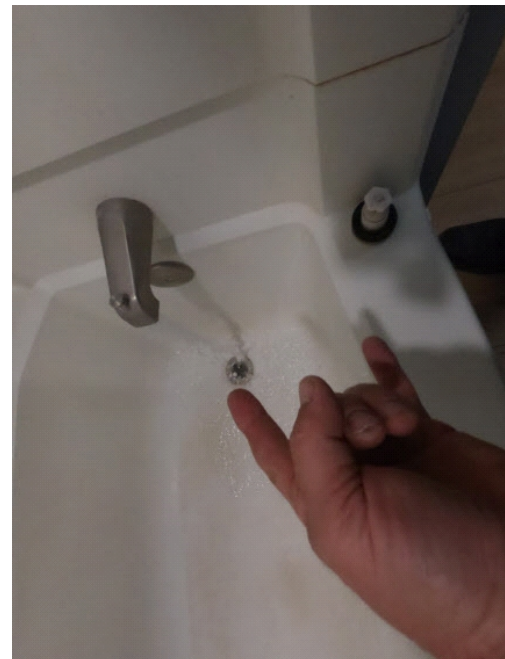
Stopper needs adjustment.

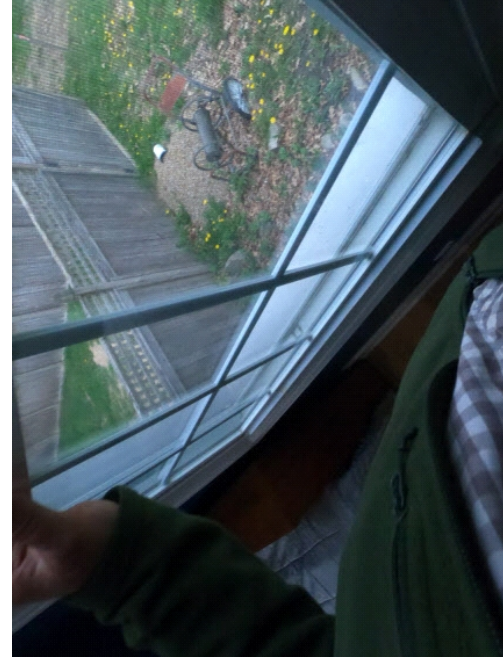
Window function.
Some windows may need adjustment.

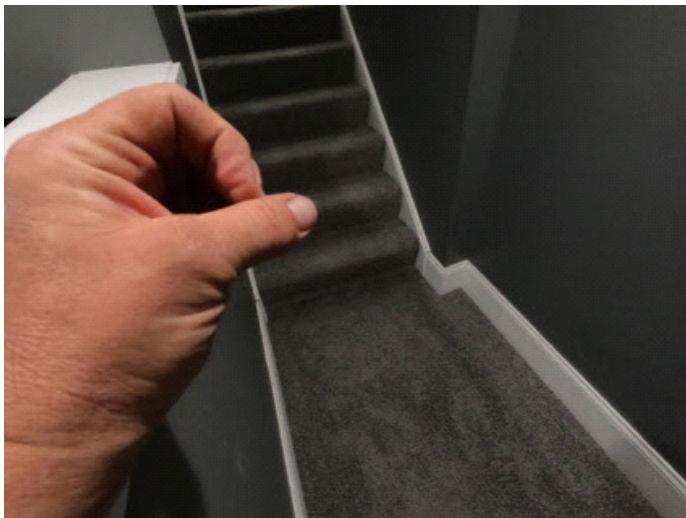
No handrail.

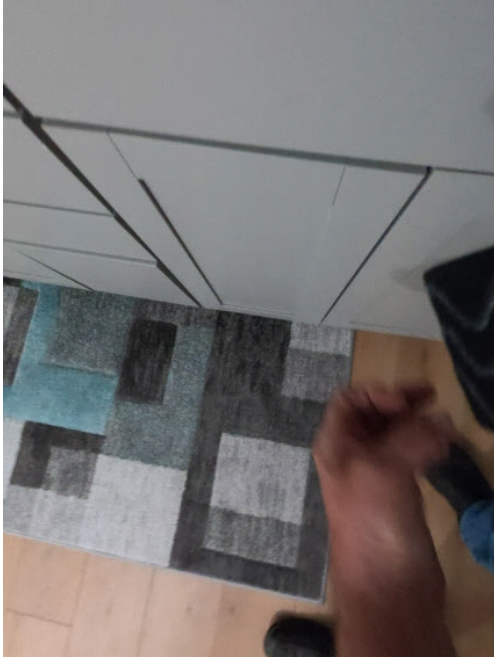
Cabinets and vanities and countertops were functional.

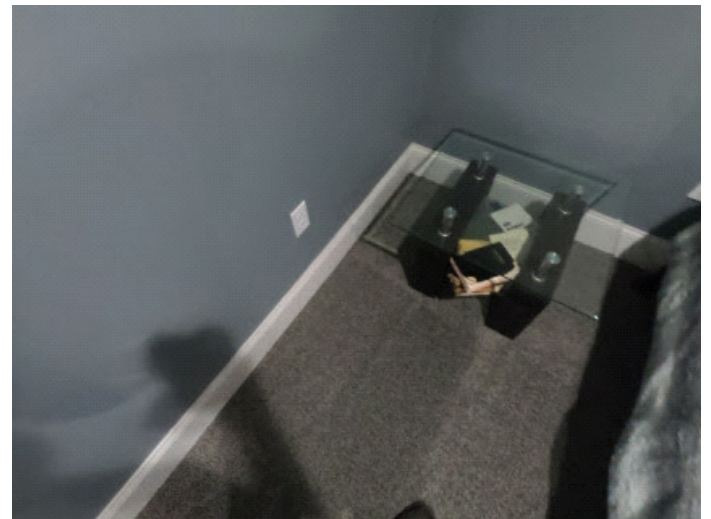
Carpets are in good shape

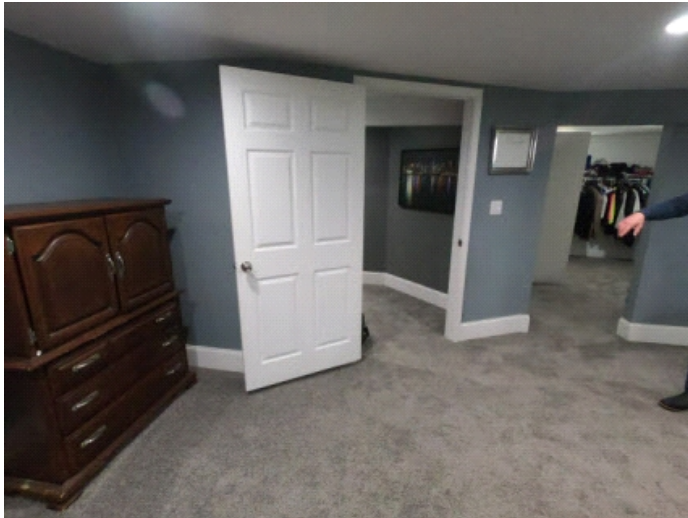
Some lower ceiling heights.

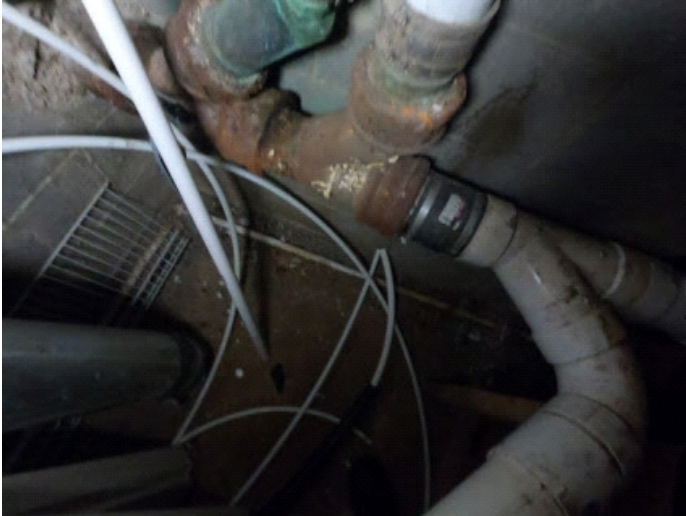
Drains all appeared to be draining.
Septic system needs to be evaluated, tested, inspected and certified by septic professional.

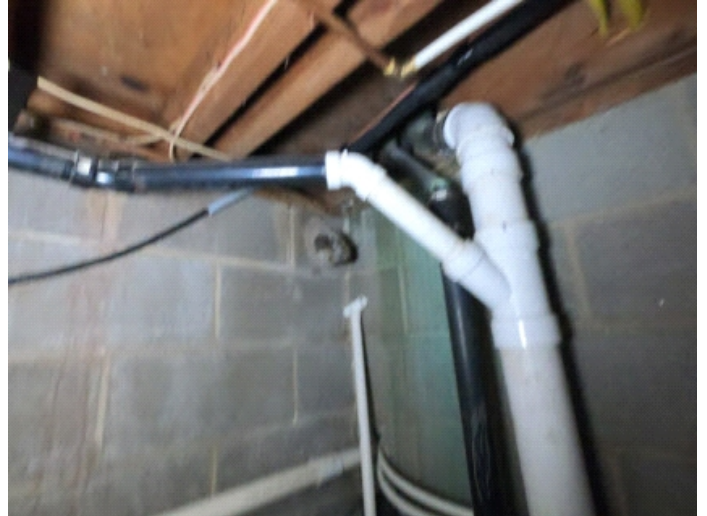
No plumbing leaks same. Inspector did not evaluate plumbing design or vent design. Everything did appear to work and function.

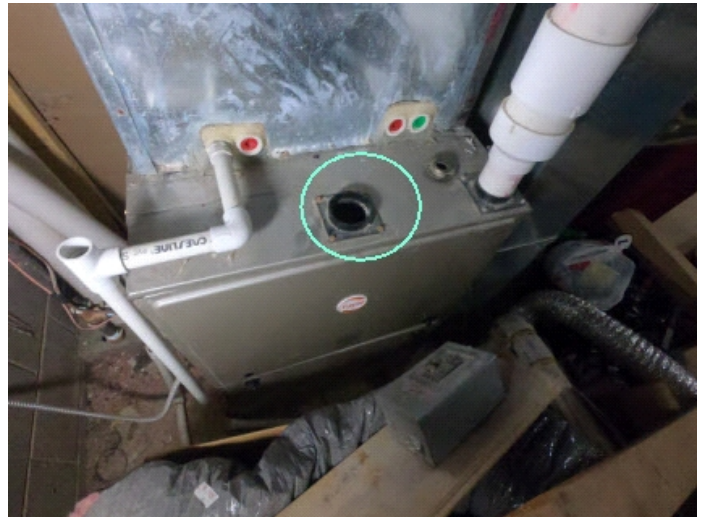
Combustion air comes from basement.

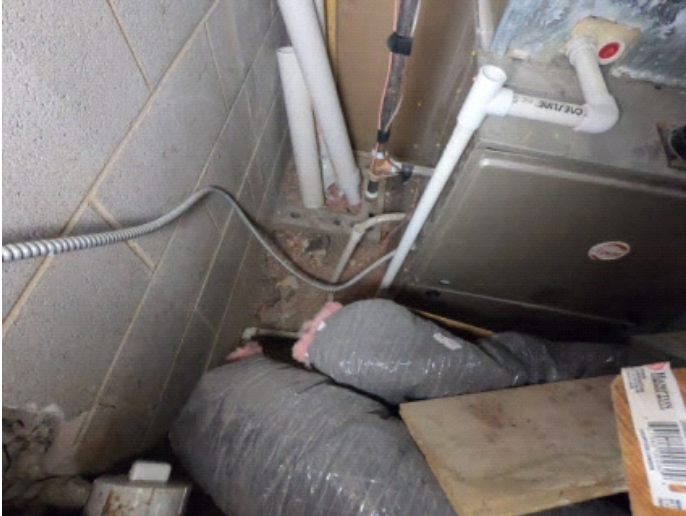
Control mice.

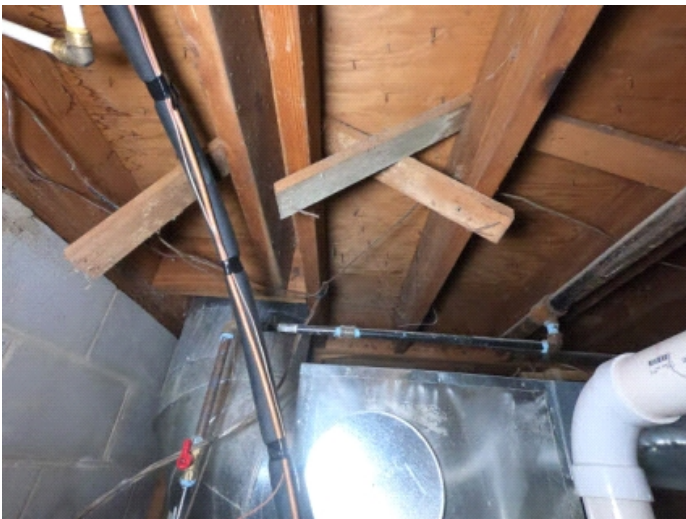
Sloppy bracing.

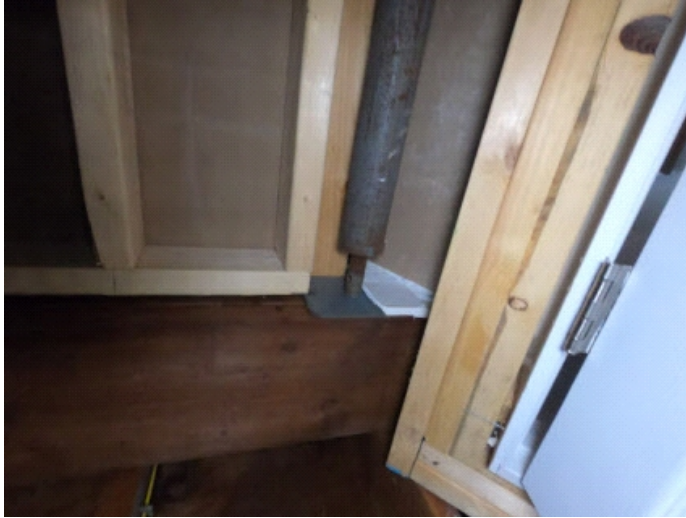
Steel columns supports appears to function.
Unknown footing conditions due to concealed were covered.
Unknown foundation wall conditions due to concealed or covered.
Unknown wall conditions due to finished walls and finished ceilings.

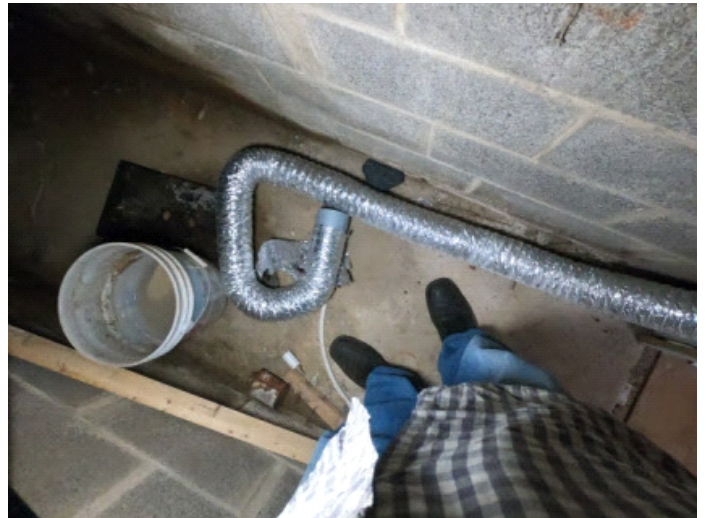
Dryer vent not completed.

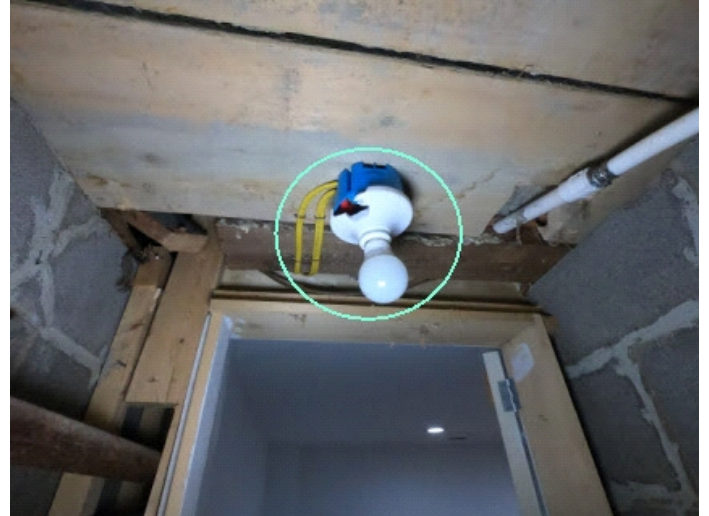
Sloppy electrical.

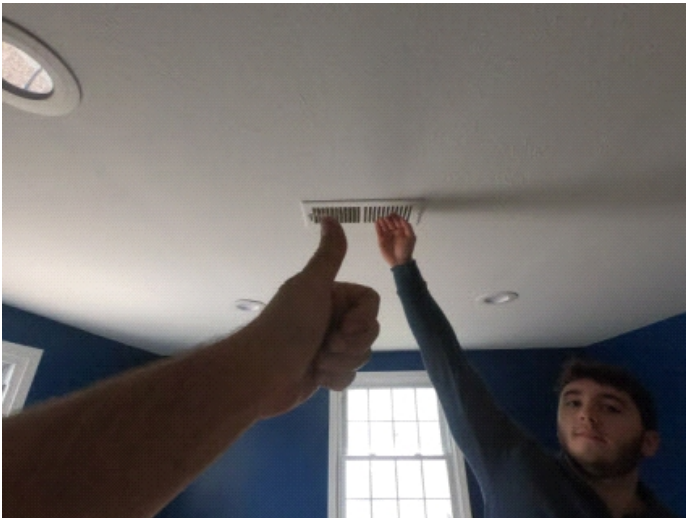
HVAC system functions.

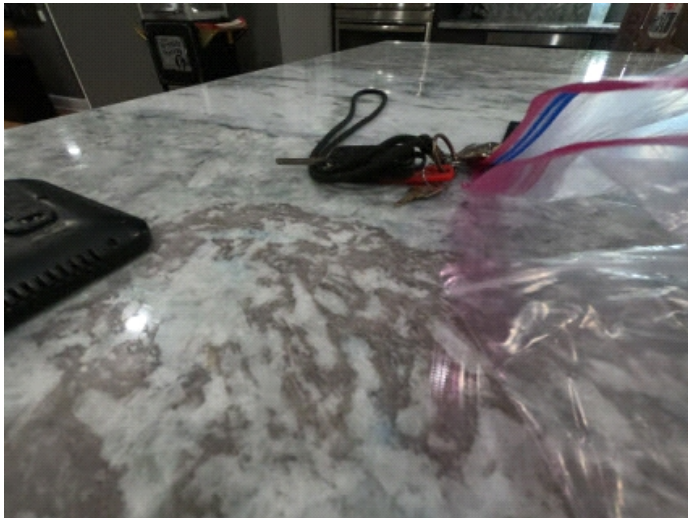
Countertops and cabinets appear to be functional.
